CULTURAL HERITAGE IMPACT ASSESSMENT

43-51 King Street East, Hamilton, ON
Former S.S. Kresge & Co. Store

FINAL REPORT

28 Feb 2017

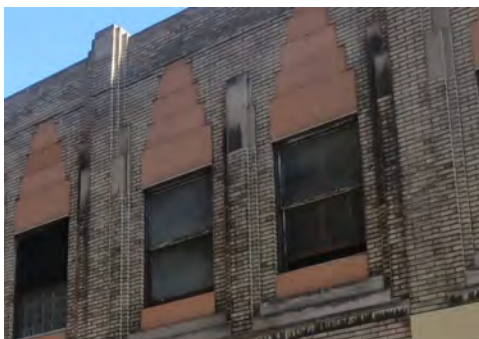
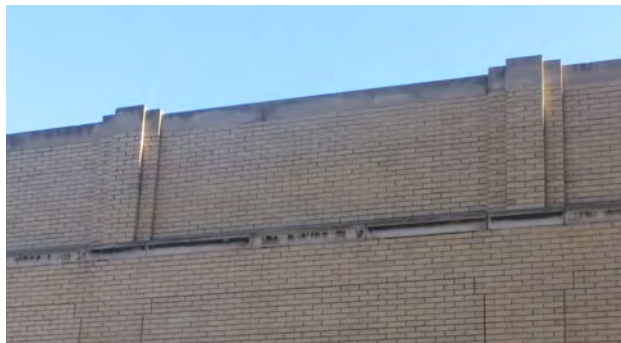
The masonry is generally in good condition but the lower section of the walls along Hughson and King William Street has been painted and masonry on the Hughson Street elevation is fairly soiled from pollution due to the heavy traffic volume at this intersection.

Brick and stone is generally in good condition with moderate soiling from pollution, particularly on the Hughson Street elevation.

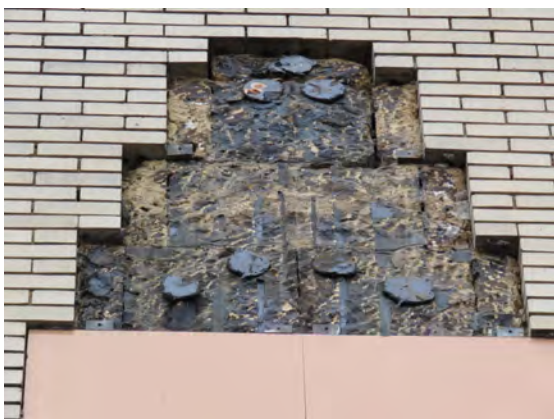
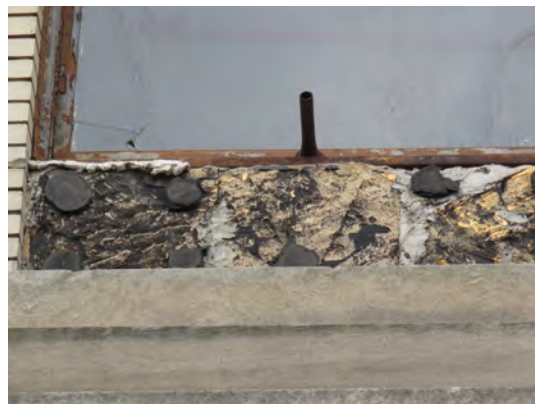
Panels above and below the 2nd storey windows are stone with vitrolite tile cladding in some locations and plywood in other locations. The surface of the stone window panels is very irregular and some of the cavities have been filled with cement. Traces of gold paint were visible in some areas. The surface appears to have been sealed with a bituminous waterproof coating and there are daubs of black mastic glue adhered to the surface that were used to attach the vitrolite tiles.

Vitrolite panels above and below the 2nd floor window is affixed to masonry with black mastic

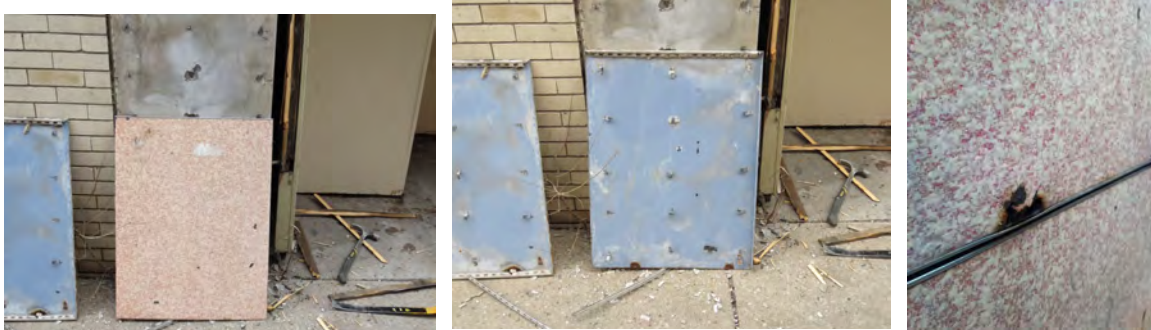
Rose coloured enameled panels are used as cladding around entrances on all three elevations. These panels are masonry units with an enameled that a enameled steel panels. The majority of these panels show evidence of corrosion that has created small holes in the surface of the panels. A panel was removed to determine the cause of the

rust and revealed that each panel is attached with 15 steel clips that are set in concrete. The clips have corroded and rust has penetrated through to the surface in areas where the clips are located.

Porcelain enameled panels with concrete backing. Each panel is attached with 15 steel clips. The majority of these clips have corroded through to the surface.

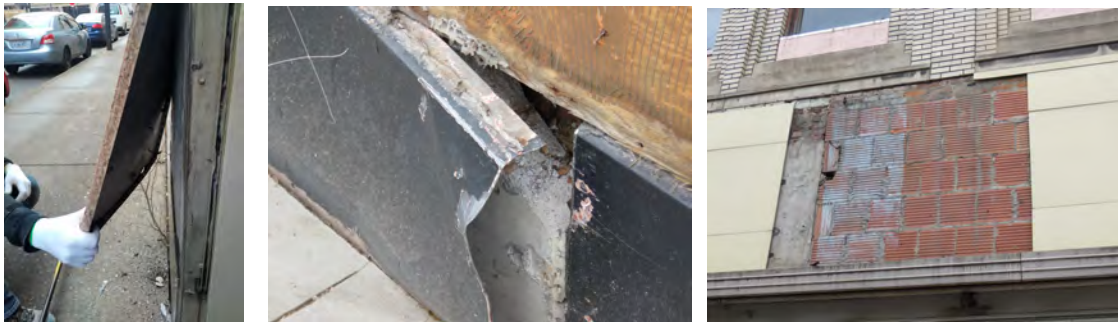
Enamel panels remaining on the King Street elevation have been painted over with black paint. Some of the metal has buckled indicating that the clips have failed or the masonry backing has deteriorated. Investigation of the cladding in the fascia board area above the King Street storefront revealed that it is modern sheet metal and there is a mix of concrete and clay speed tile behind.

Enameled panels on the King Street elevation painted over with black paint (left and centre) or replaced with synthetic cladding (right).

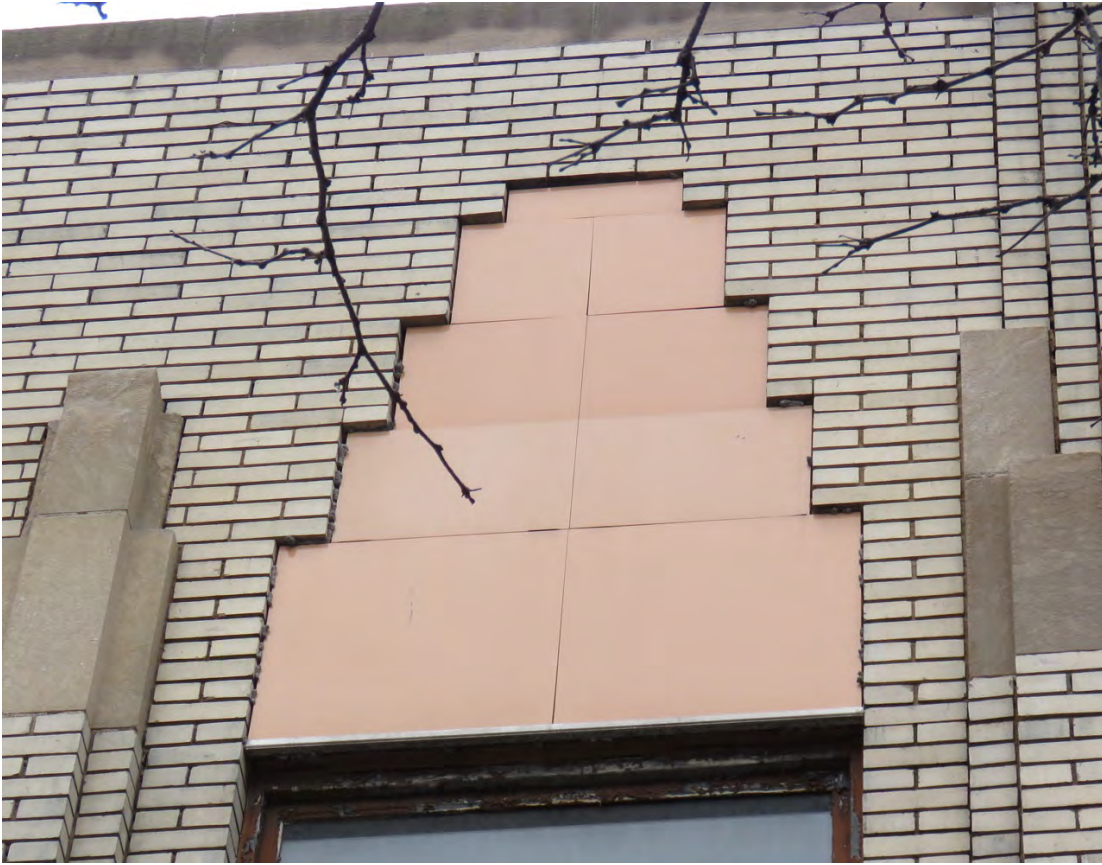
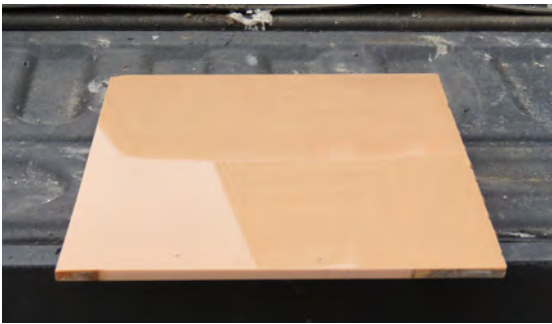
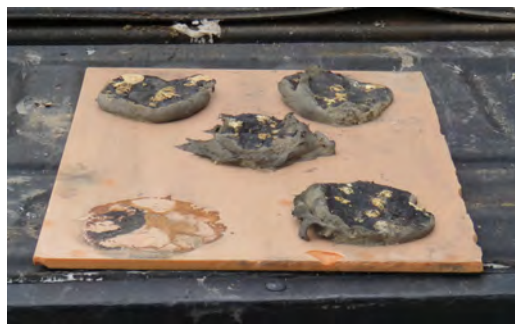
The surface behind the tile is stone and in one location clay speed tile was found. The surface of the stone is uneven and has been sealed with a bituminous waterproof

coating and there are daubs of black mastic glue adhered to the surface that were used to attach the vitrolite tiles.

Vitrolite tiles are affixed with black mastic.

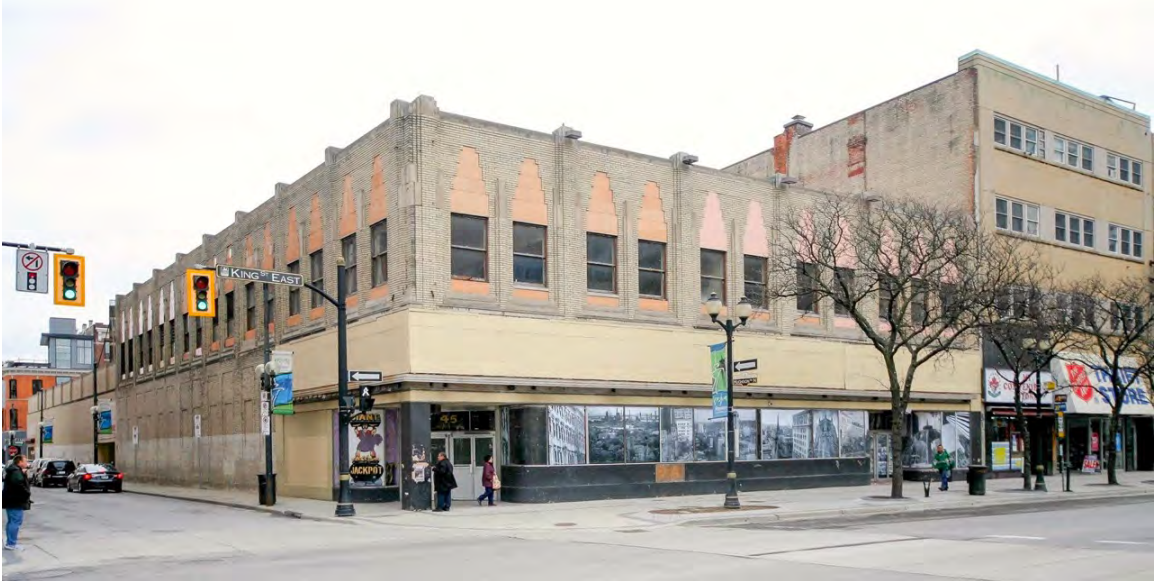
Vitrolite tiles in all 8 bays on the Hughson Street façade are intact and in good condition. Tiles on the King Street elevation have been removed and replaced with plywood in 3 of the 5 bays.

Vitrolite tiles	Fair to good. 100% intact on the Hughson Street façade. 20% intact on the King Street East façade.	<ul style="list-style-type: none"> • REMOVAL & RESTORATION OF MISSING ELEMENTS • Remove existing vitrolite tiles. • Restore Art Deco details based on physical and documentary evidence using similar materials. • Submit detailed drawings and materials and a full-scale mock-up for review prior to final approval.
Storefronts	Very poor	<ul style="list-style-type: none"> • REPLACEMENT • Replace existing storefronts with a new storefront design that is compatible with the historic building and will enhance both streetscapes. • Consider incorporating a recessed corner entrance with curved glazing into the new storefront design. • Submit detailed drawing of the new storefronts and materials for review prior to final approval.
2 nd floor windows	Very poor	<ul style="list-style-type: none"> • REPLACEMENT • Retain existing masonry openings. • Replace existing window sash with new window units with a similar configuration and similar material. • Submit detailed drawings and materials and a full-scale mock-up for review prior to final approval.

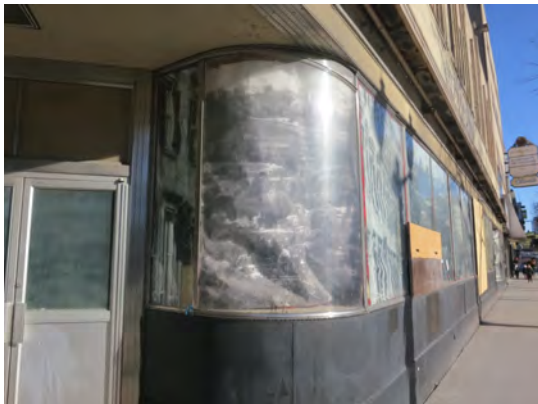
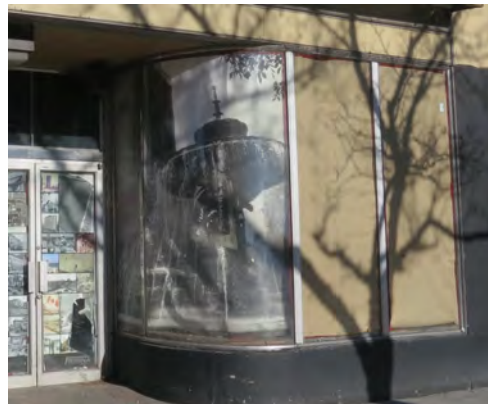
In general, the glazing units appear to have failed. Metal trim and seals have failed and most of the glass on the King Street elevation has been removed and replaced with plexi-glass and the size of the windows has been reduced.

Original doors and windows on the ground floor of the King Street East elevation have been altered or replaced.

The King Street storefront has been subject to extensive alterations including changes to the window openings, door and window replacements, and painting of cladding materials. The entrances on King William Street show less evidence of alteration but they are generally in poor condition.

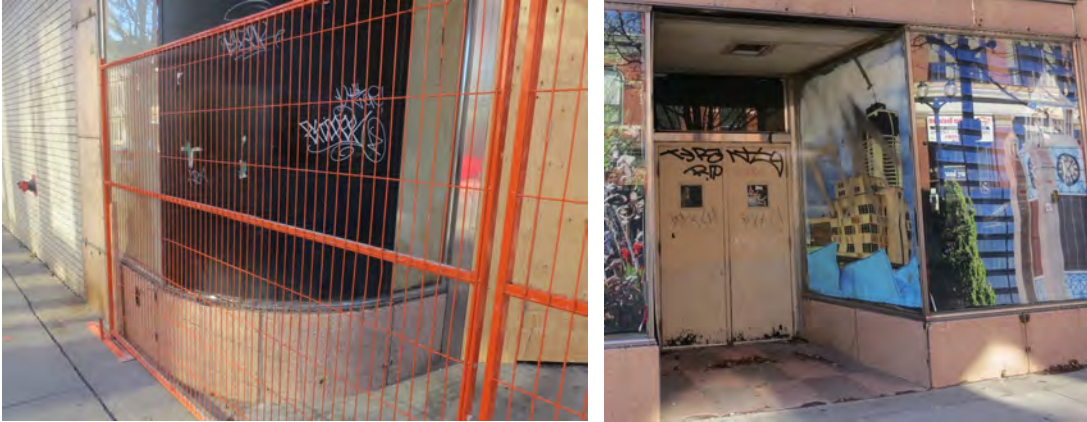
The entrances on King William Street retain some original features but are generally in poor condition.

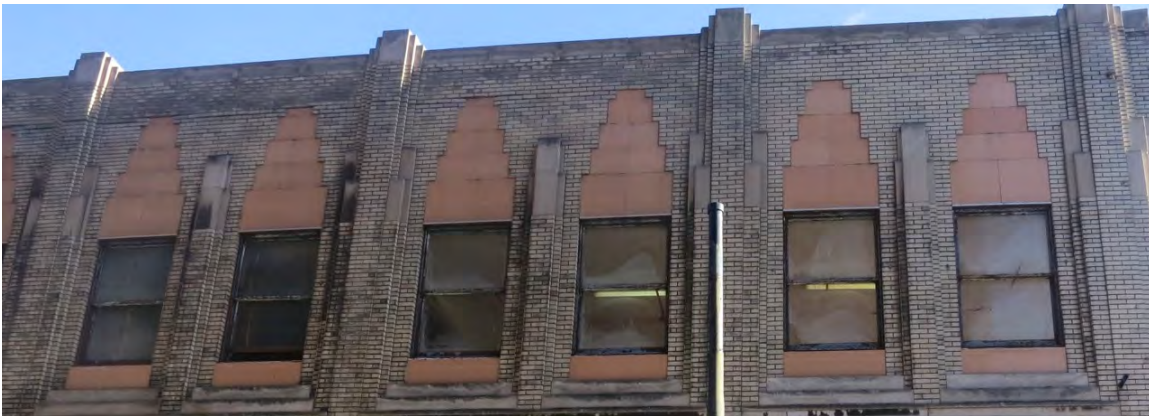
Windows on the second floor are steel framed sash windows that appear to be badly corroded. These windows do not appear to be operable. Some windows on the Hughson Street elevation have been removed and replaced with glass block.

Original steel sash windows on the 2nd floor are corroded and no longer operable.

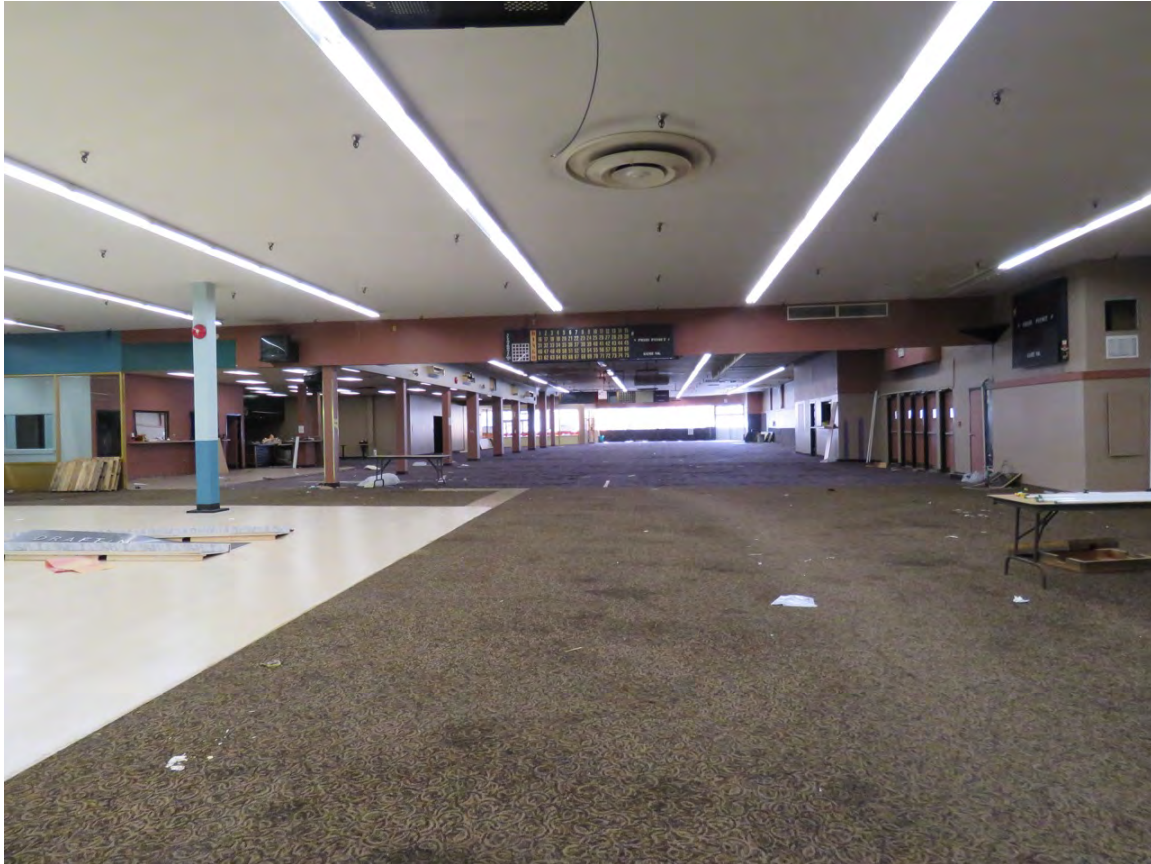
Condition of the ground floor interior just prior to removal of hazardous materials.

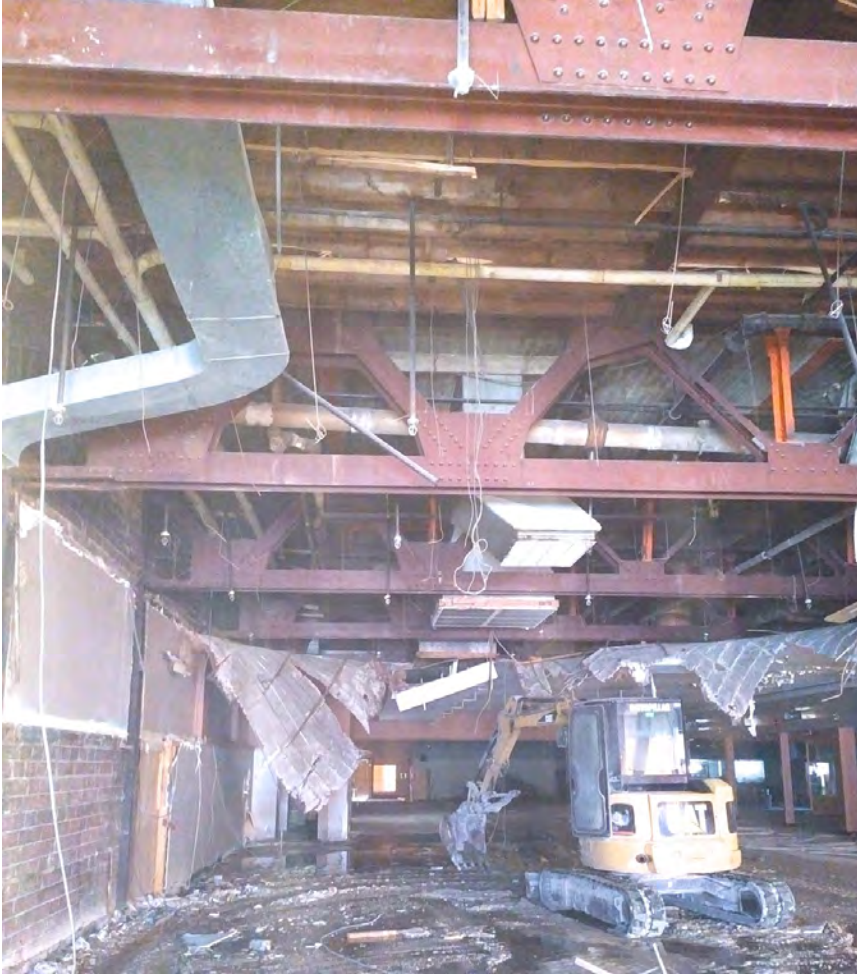
The subject property has been vacant since 2012. Materials containing asbestos are currently being removed from the interior and the structural components are now visible. Investigation of the structural components confirms that the building was built in two phases and has been subject to a number of structural and non-structural alterations over time.

Current condition of the interior.

There are no remaining interior features that have significance. Reconfiguration of the interior space with new interior finishes to suit the proposed use is therefore recommended.
