Reference # 13267.101.L1.Rev1_Shore hazard assessment

RE: 526 WINONA ROAD LiUNA GARDENS SHORELINE HAZARD ASSESSMENT AND SETBACK REQUIREMENTS

Executive Summary

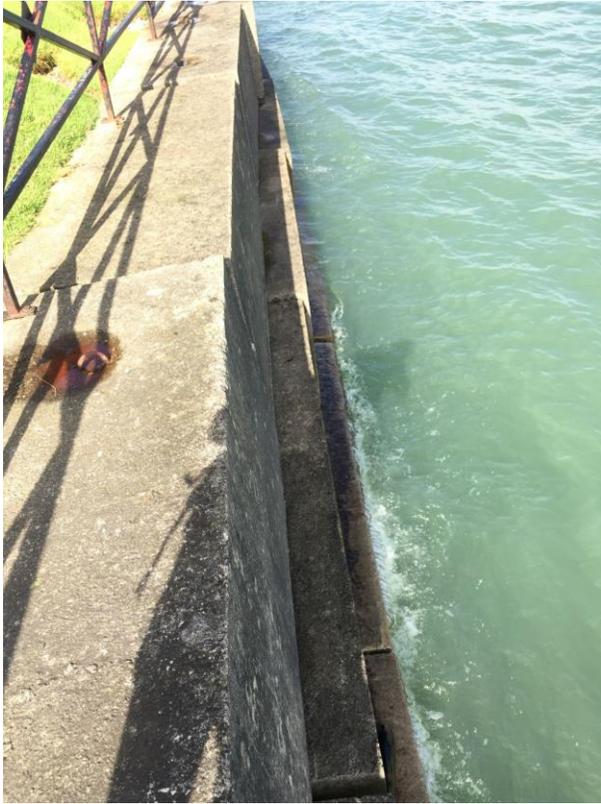
Figure 2: Existing stacked concrete block seawall

The existing seawall is comprised of precast concrete blocks stacked up vertically, with each block slightly setback from the block below it, creating a slight batter to the wall face (Figure 2). The concrete blocks are typically 3 m long by 1 m high by 1 m deep. The wall appears to be four blocks high above the lakebed. It is not known if there are more blocks buried further below the lakebed, but this is considered unlikely; the condition and elevation of the base of the seawall has not been confirmed. The westerly backshore area behind the seawall consists of grass turf and landscaped grounds (Figure 3); the backshore at the easterly part is mostly unimproved with rubble and gravel immediately behind the wall (Figure 4). Presently, the seawall is generally intact and in fair condition. There are irregularities and curves in the alongshore alignment of the seawall (Figure 5); it is not known if the overall alignment has shifted or changed since the original construction of the wall.

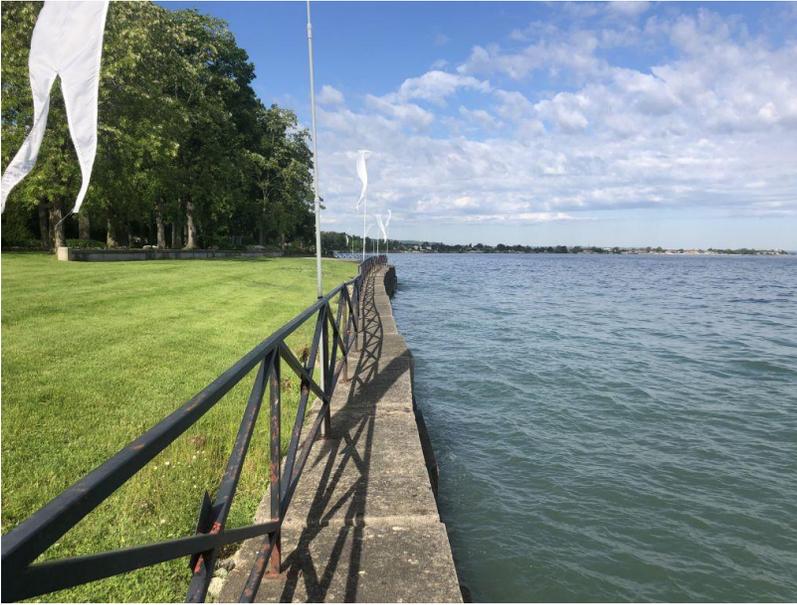
Figure 5: Wall alignment irregularities

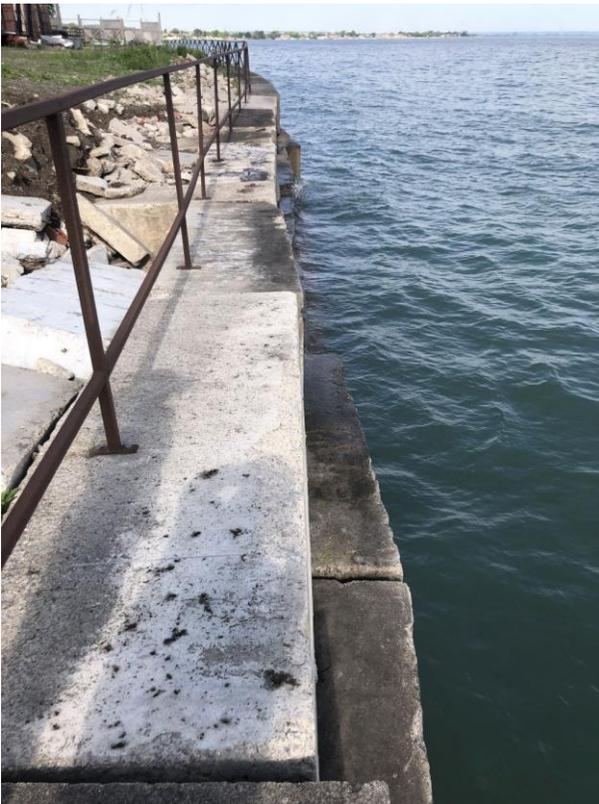
Figure 6: Immediate backshore at easterly part of site

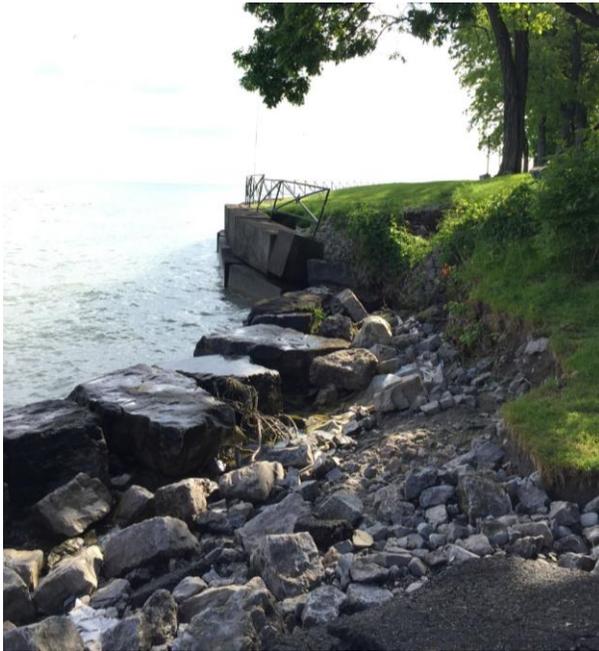
At the west end of the site, the concrete block seawall transitions to a row of armour stone, approximately 10 m long. At the crest of the armour stone are some gabion baskets, loose stone rubble and an upper retaining wall of small concrete blocks (Figure 7). There is evidence of wave overtopping damage in this area.

Figure 7: Transition from concrete block seawall to armour stone, gabion baskets, and stone rubble splash pad at west end of site

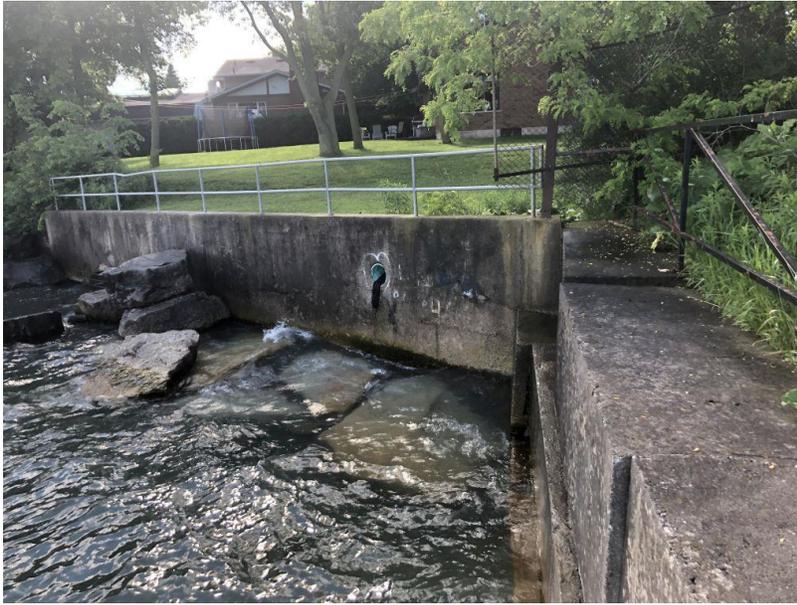
The site is bounded to the east by East Street. At the east end of the site, the concrete block seawall abuts against a concrete headwall at the shore end of East Street (Figure 10). Two drainpipes outlet through the concrete headwall. Armour stone has been placed along the base of the East Street headwall.

Figure 10: East end of concrete block seawall abutting concrete headwall at East Street

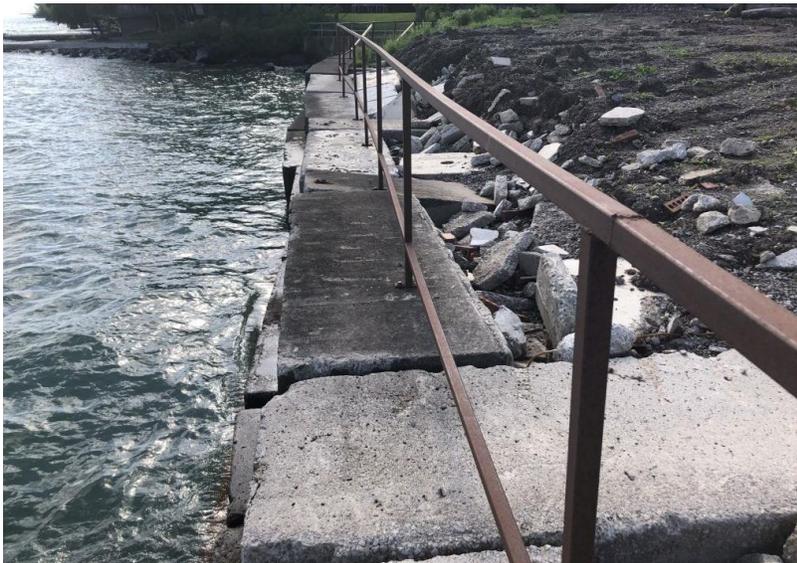
Along the length of the existing seawall at the site, several of the blocks were observed to have shifted and are now displaced various amounts towards the lake and some blocks have settled (Figure 11, Figure 12). Washed out areas behind the crest of the seawall, with loss of grass cover and backfill, were observed indicating damage due to wave overtopping (Figure 13 and Figure 14). The condition of the wall underwater was not observed.

Figure 11: Shifted and settled concrete blocks

It is recommended that a new sloping armour stone revetment, like the structure west of Millen Road (Figure 23), be implemented at the site. A double layer armour stone revetment concept is proposed and is shown in Figure 21. An allowance of 8 m has been provided for the new revetment structure, measured from a theoretical line extended downward from the position of the shoreside edge of the top concrete block of the existing seawall to the back of the new protection at elevation 75.0 m. A stone revetment structure provides a

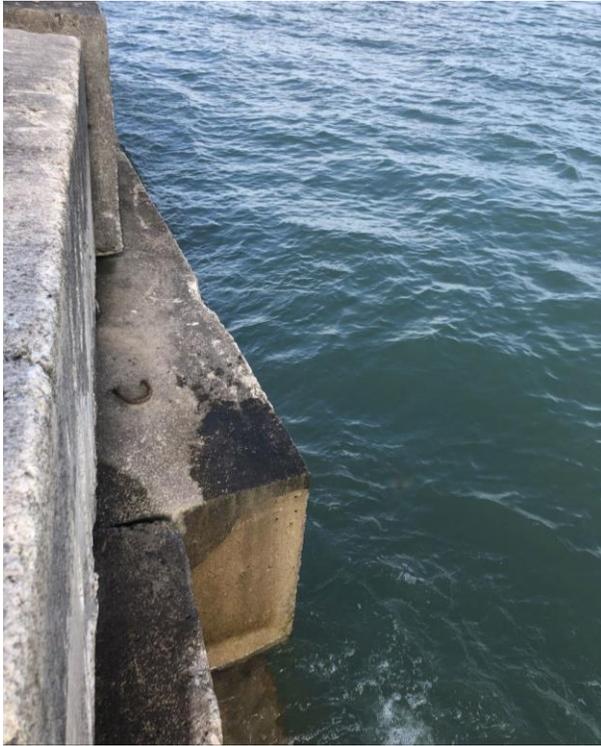
Figure 12: Displaced concrete block

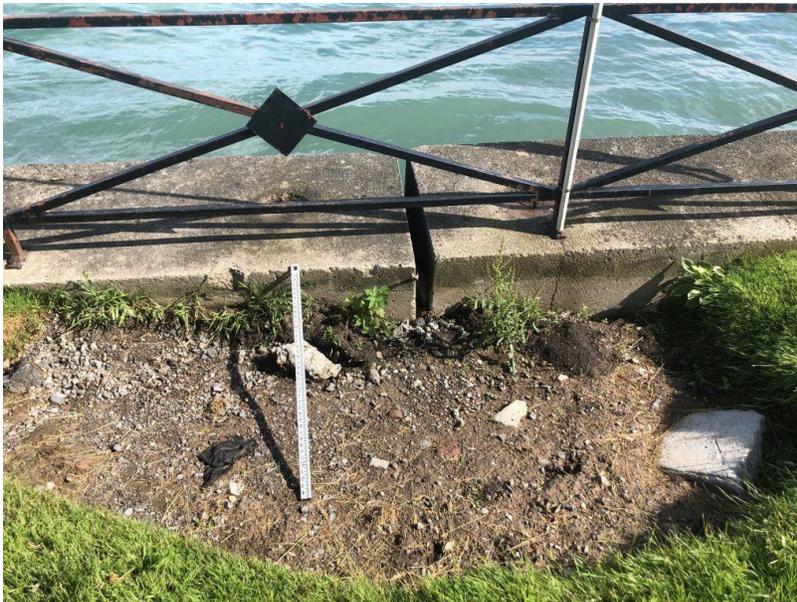
Figure 13: Evidence of wave overtopping

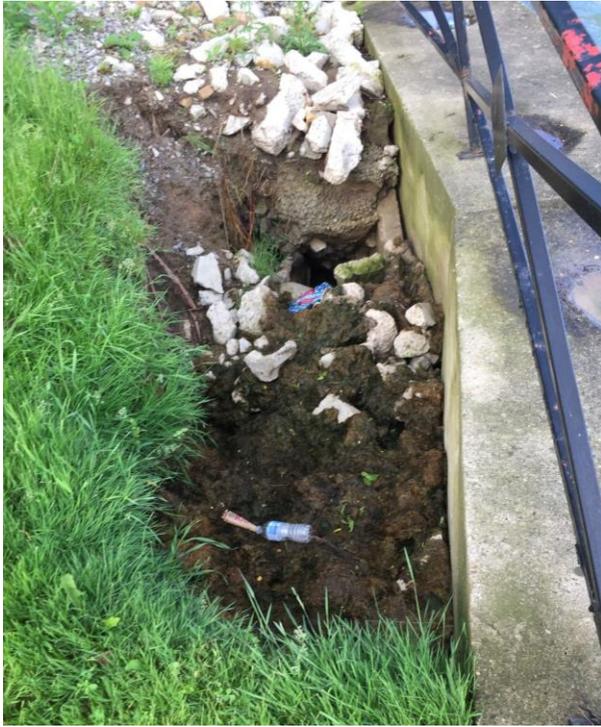
Figure 14: Example of washout and loss of backfill behind concrete block seawall
