3054 Homestead Drive Erosion Threshold Assessment

Hamilton, Ontario

January 26, 2023
PN22063

Report Prepared by: GEO Morphix Ltd.
36 Main Street North
PO Box 205
Campbellville, ON L0P 1B0

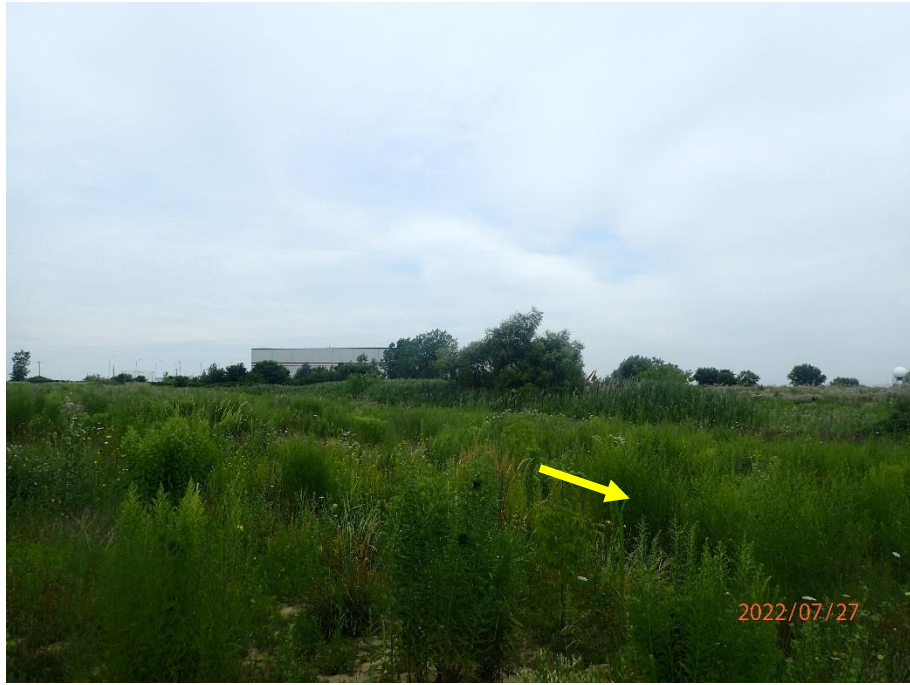
Photo 1
Reach **H1S1**

Reach **H1S1** is a high-order, headwater feature with limited channel definition. Yellow arrow denotes flow direction.

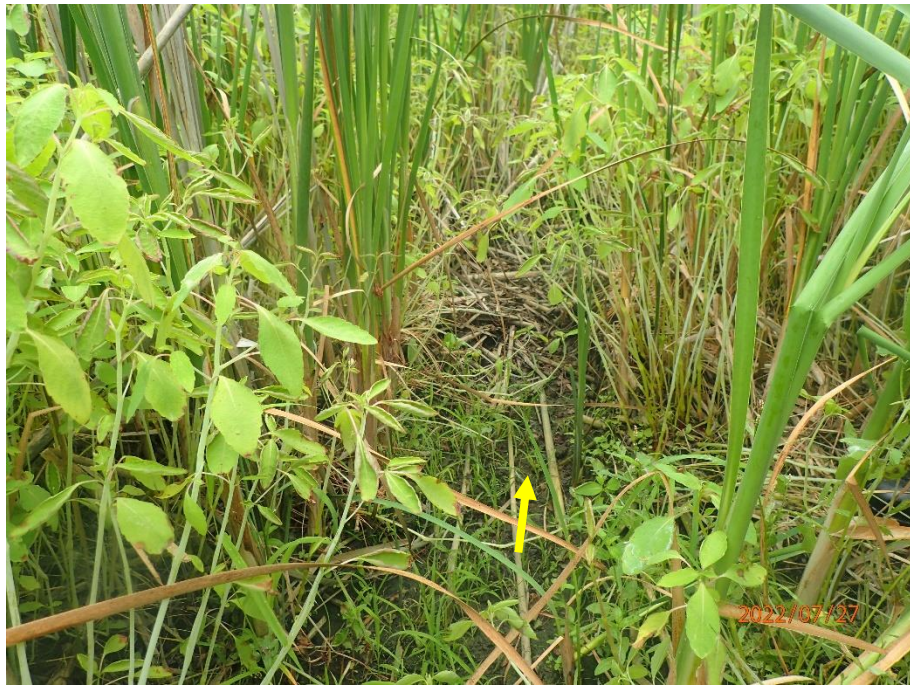
Photo 2
Reach **H1S1**

The channel is intermittently defined, but often exhibits multiple flow-paths. No flows were observed during the time of assessment.

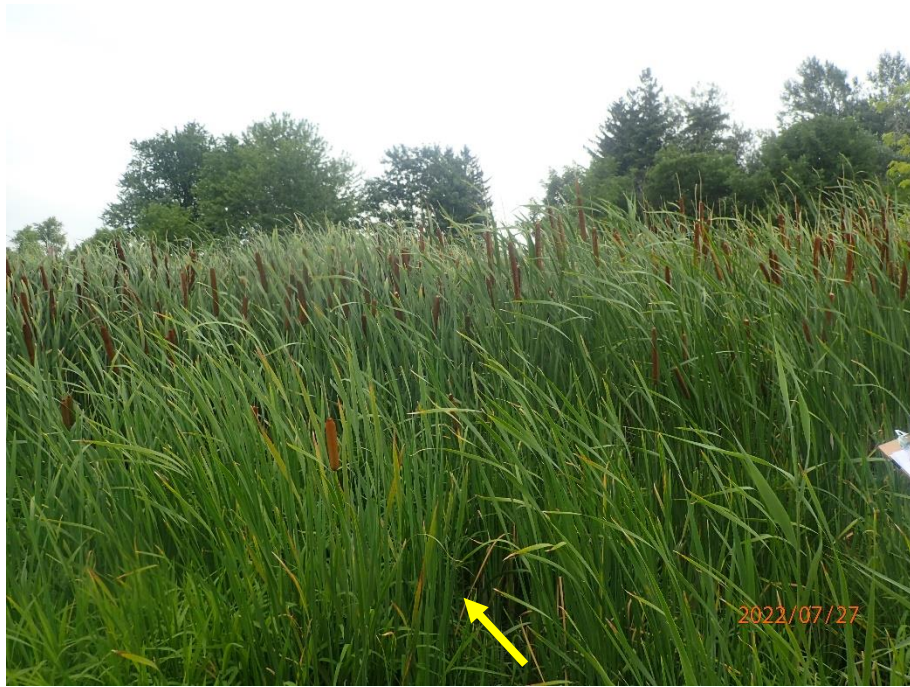
Photo 3
Reach **H1S1**

Riparian conditions are characterized by dense cattails and grasses with occasional mature trees.

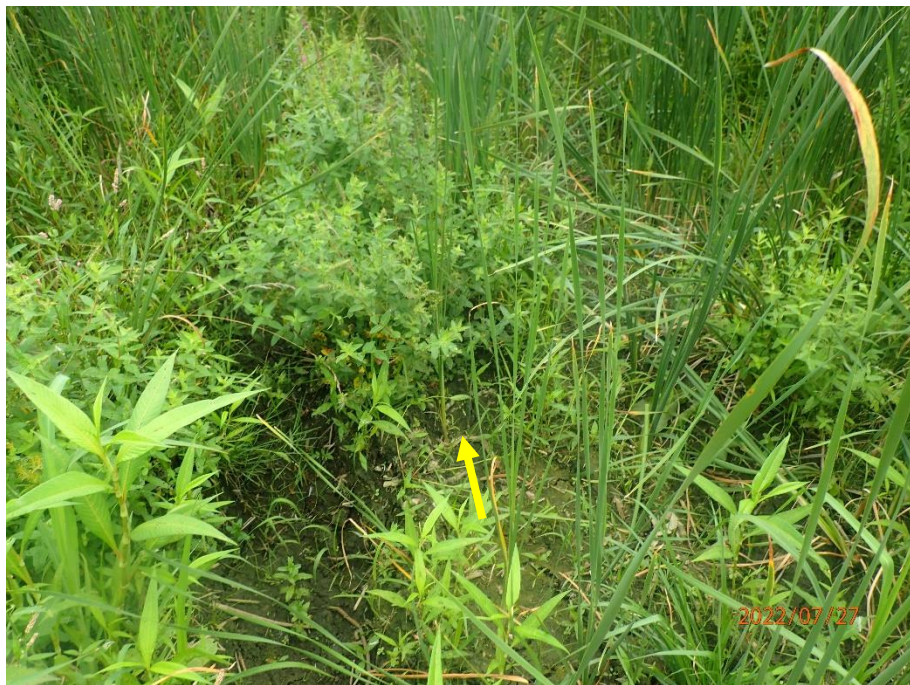
Photo 4
Reach **H1S1**

Vegetation encroachment onto the channel bed is common throughout the reach. Indicators of erosion are minimal.

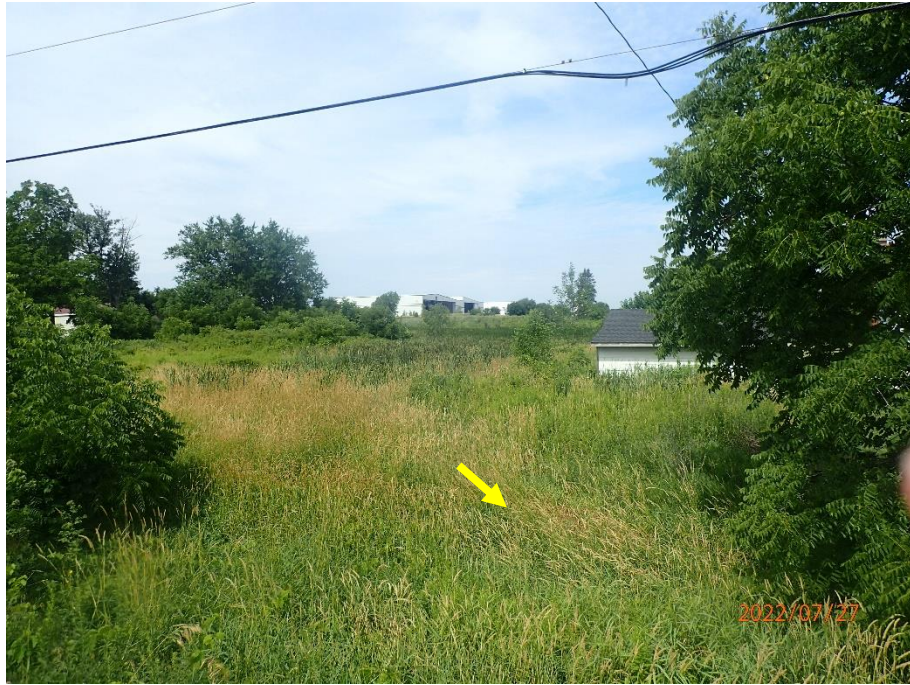
Photo 5
Reach **H1S1**

Flows travel through dense cattail marsh features towards Homestead Drive.

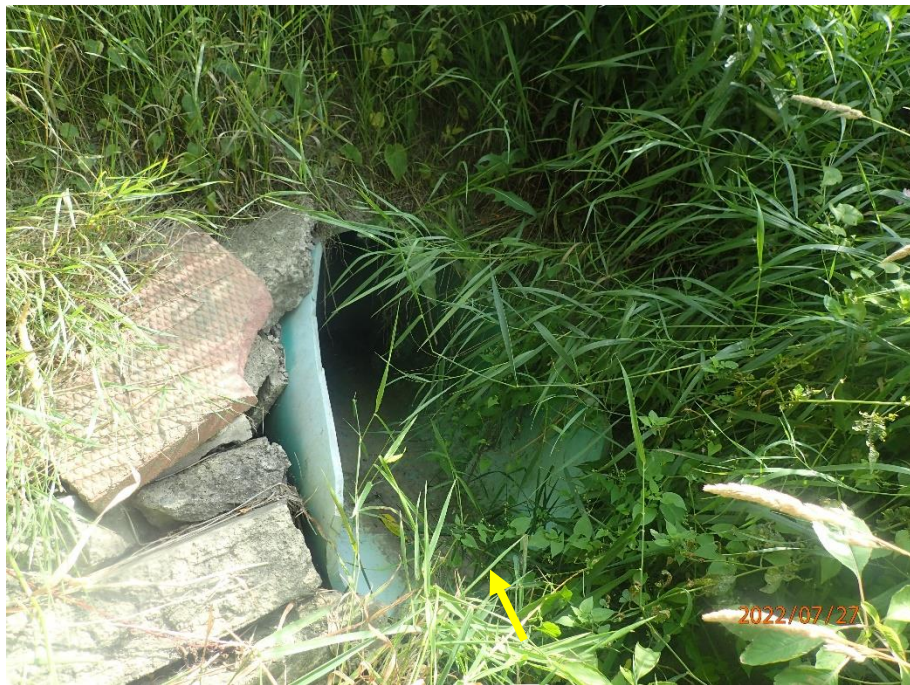
Photo 6
Reach **H1S1**

Flows exit the reach through a stable 0.90 m PVC pipe culvert passes beneath Homestead Drive and Upper James Street.

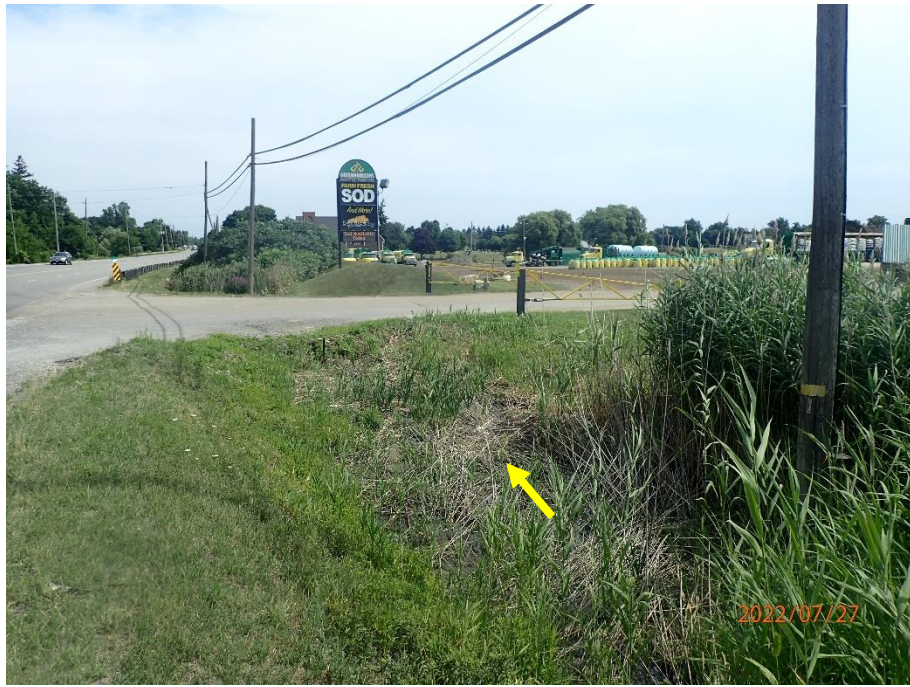
Photo 7
Reach **H1S2**

Reach **H1S2** flows northeast and adjacent to Upper James Street. The reach is best characterized as a straightened ditch.

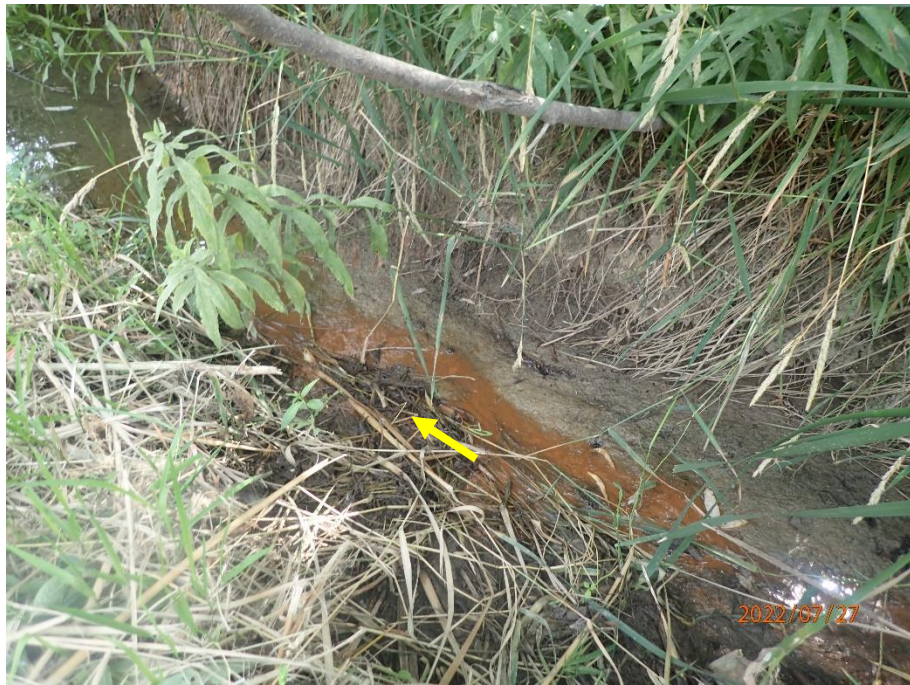
Photo 8
Reach **H1S2**

Groundwater inputs are evidenced by iron staining observed near the upstream extent of the reach.

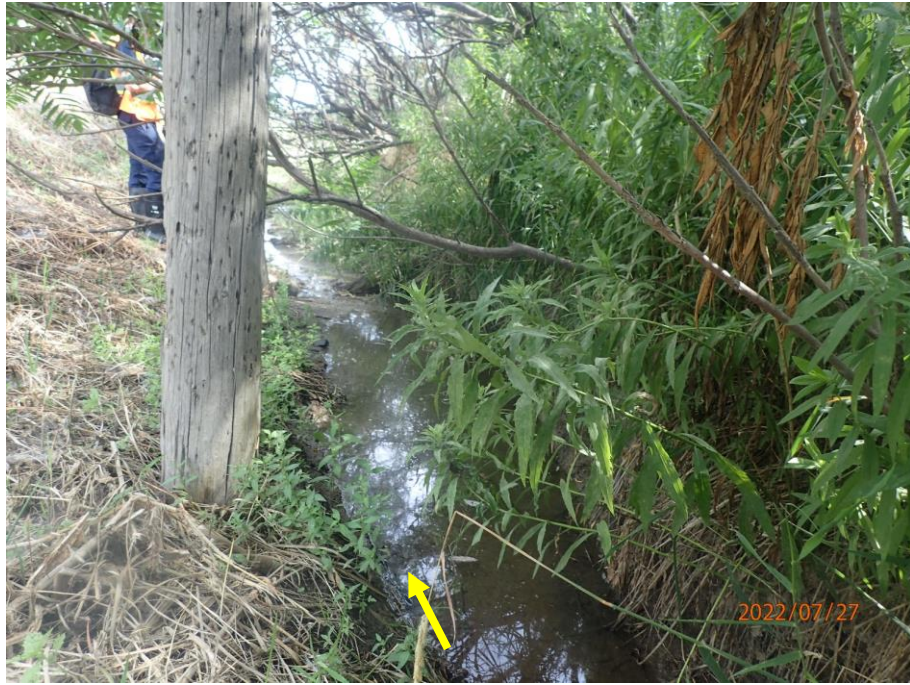
Photo 9
Reach **H1S2**

Reach **H1S2** held water during the assessment, but flow velocities were imperceptible. Signs of bank erosion were noted, but were not significant.

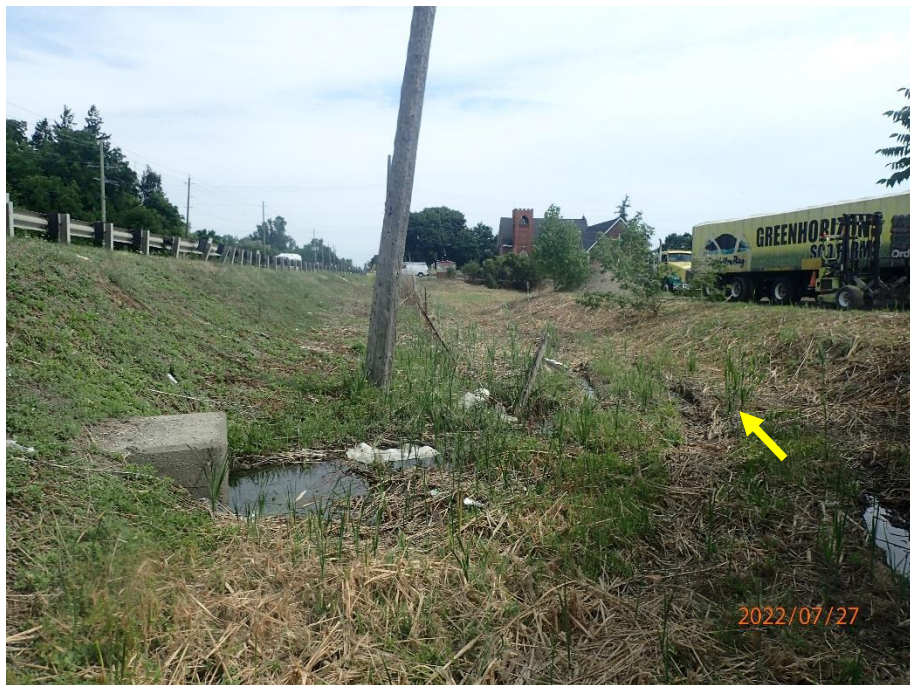
Photo 10
Reach **H1S2**

Sections of the reach exhibit multiple and poorly defined channels and flow-paths.

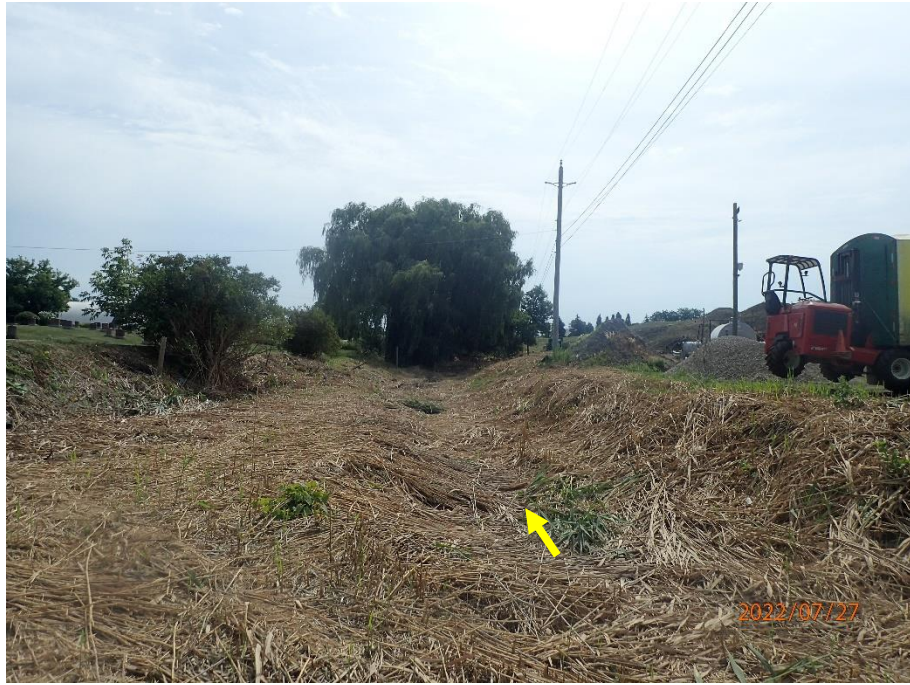
Photo 11
Reach **H1S2**

Cattail vegetation encroachment is significant throughout the downstream portions of the reach. The channel here is poorly defined.

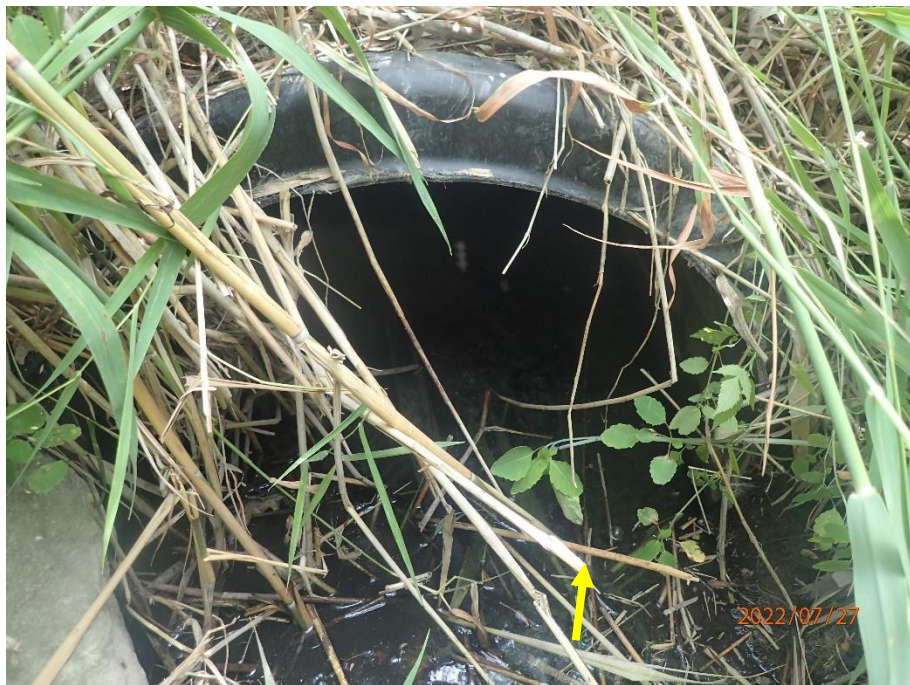
Photo 12
Reach **H1S2**

Flows exit reach H1S2 through a stable corrugated plastic pipe culvert that passes beneath a service road associated with the adjacent sod farm.

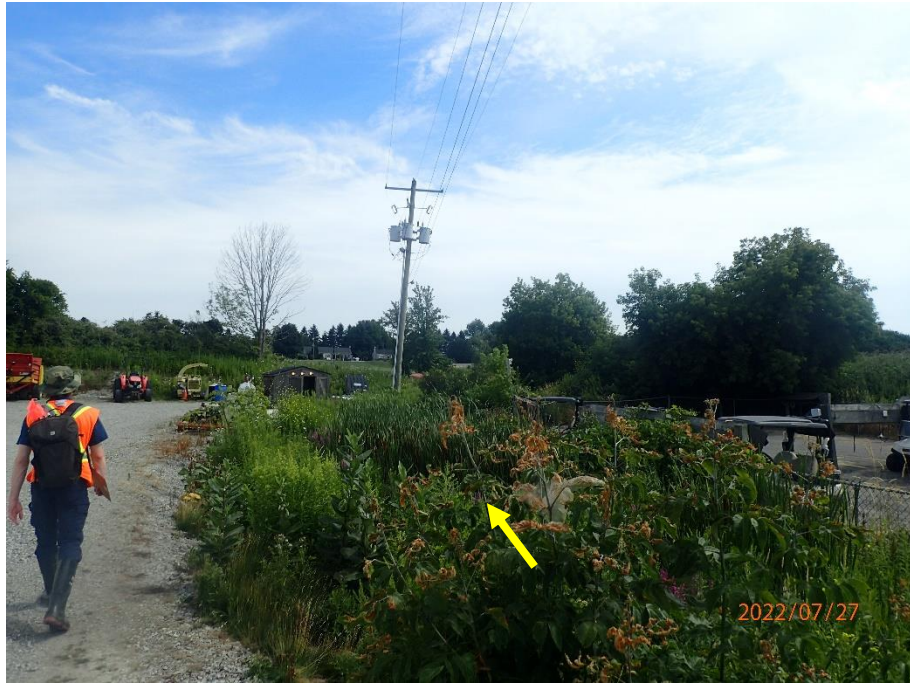
Photo 13
Reach **H1S3**

Reach **H1S3** flows through a constricted corridor between two paved lots.

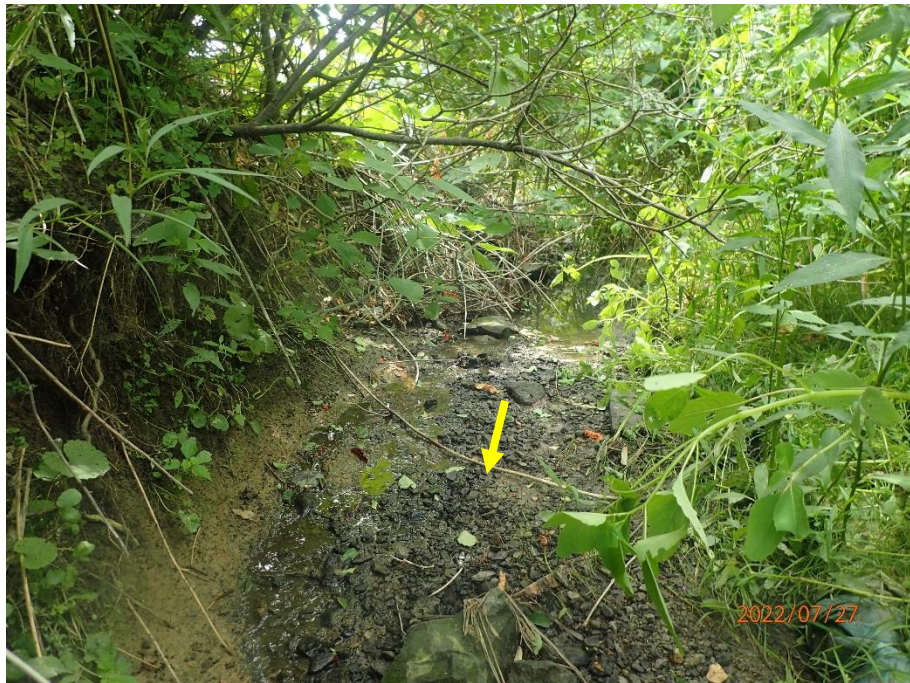
Photo 14
Reach **H1S3**

Bed material ranges from silty clays to medium sized gravels. Banks are comprised of a compact silty clay loam.

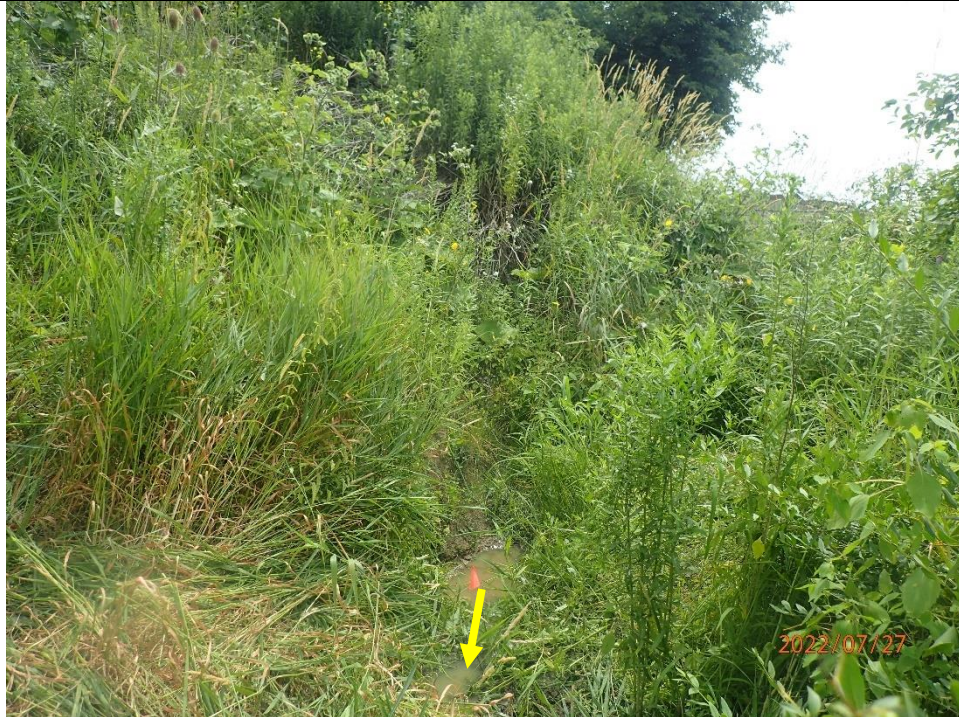
Photo 15
Reach **H1S3**

Riparian vegetation is mostly grasses and cattails, with occasional mature trees near the downstream extent of the reach.

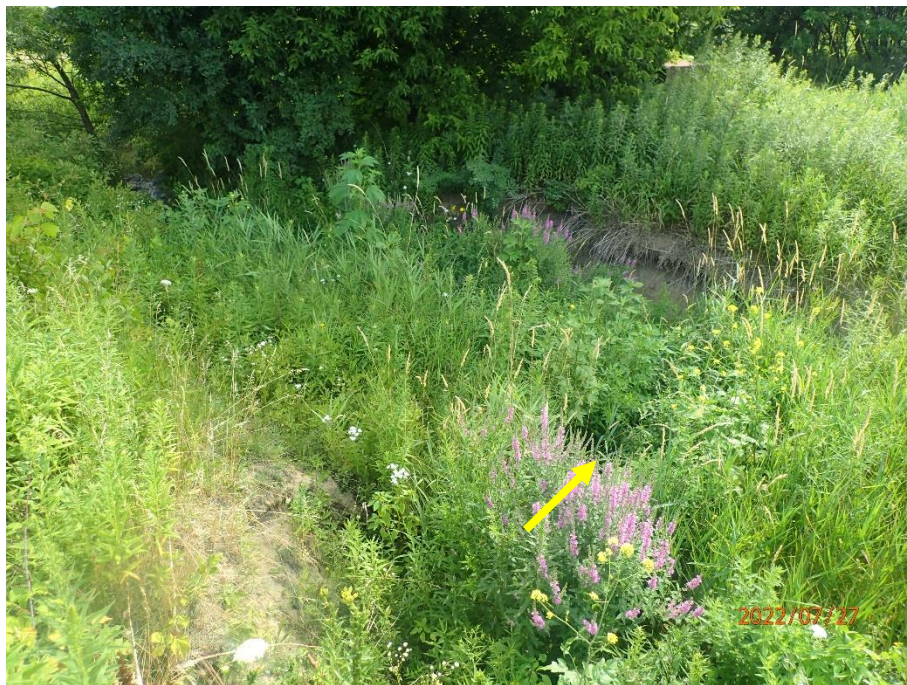
Photo 16
Reach **H1S3**

Reach **H1S3** scored 0.26 on the RGA, indicating a channel currently in transition or stress and consequently experiencing non-natural changes to its forms and processes. The dominant process was identified as aggradation, but evidence of channel widening and degradation was also present. The reach has a good level of stream habitat availability and channel stability, as the RSAT score was 25. Similar to reach **H1S2**, reach **H1S3** was classified as a recovering channel under the Downs (1995) model. The reach was classified as a mixed load meandering channel under the River Styles Framework (Brierley and Fryirs, 2005).

The channel exhibits a meandering planform within the constricted corridor. Bank exposure and erosion is common on the outer banks of meander bends.

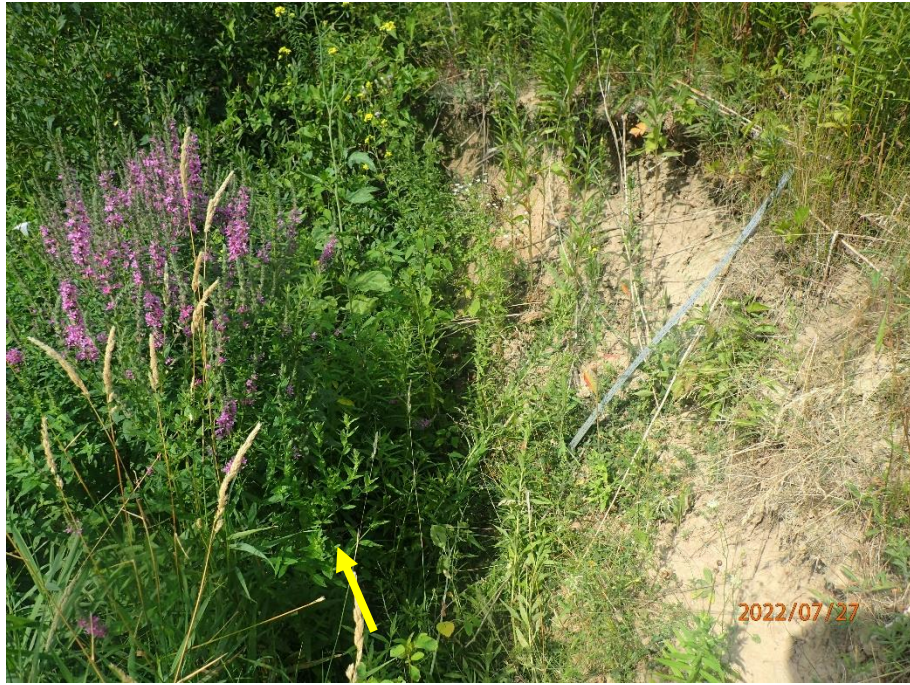
Photo 17
Reach **H1S3**

Bank erosion has caused several outer banks to become fully exposed and void of any significant vegetation establishment.

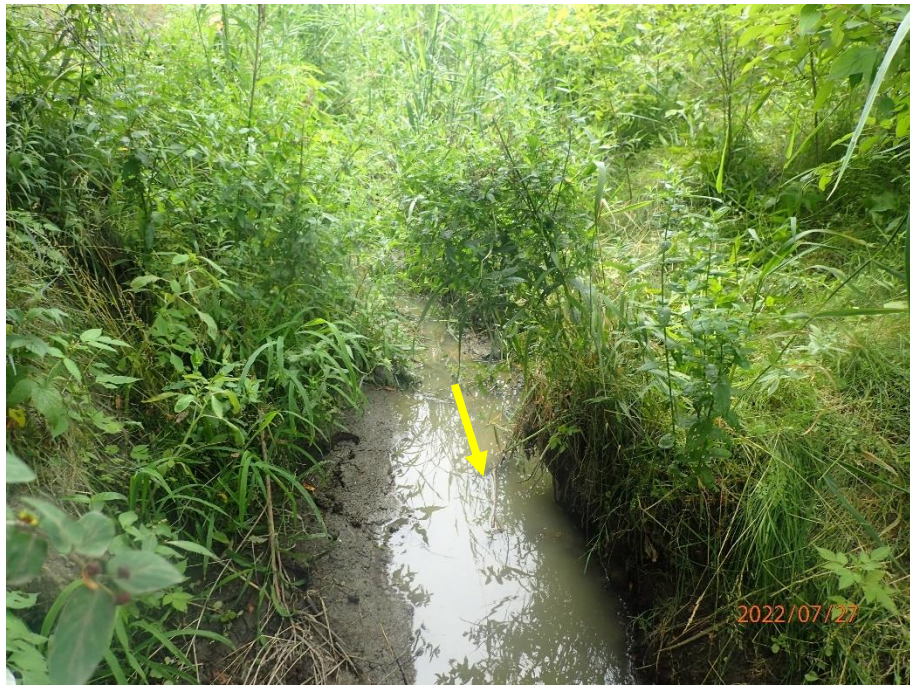
Photo 18
Reach **H1S3**

The channel bed was wetted, but flows were minimal and imperceptible during the time of assessment.

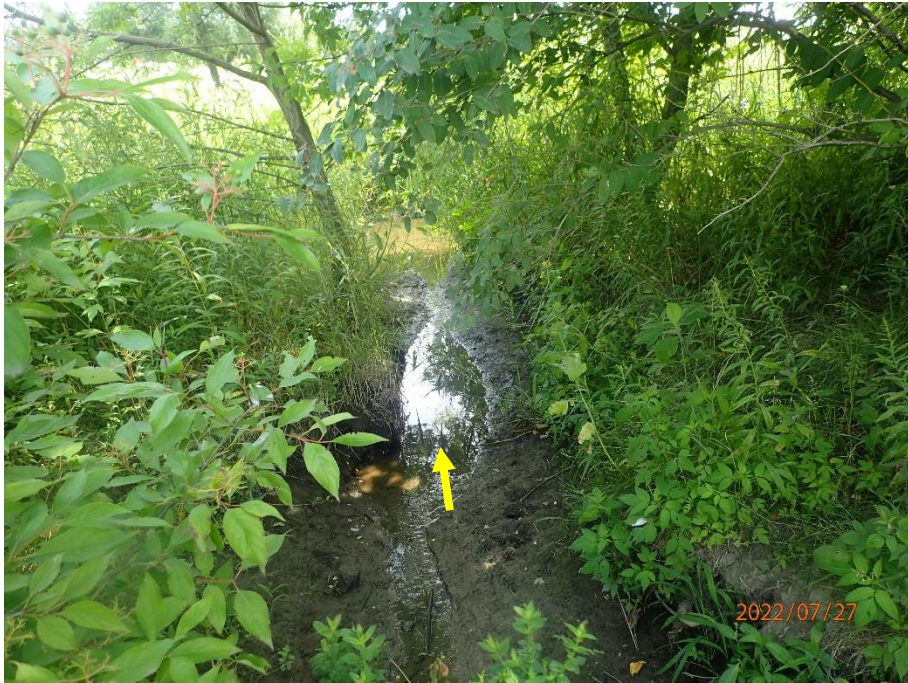
Photo 19
Reach **H1S3**

The channel typically exhibits a trapezoidal shape with bank angles generally ranging from 60-90 degrees.

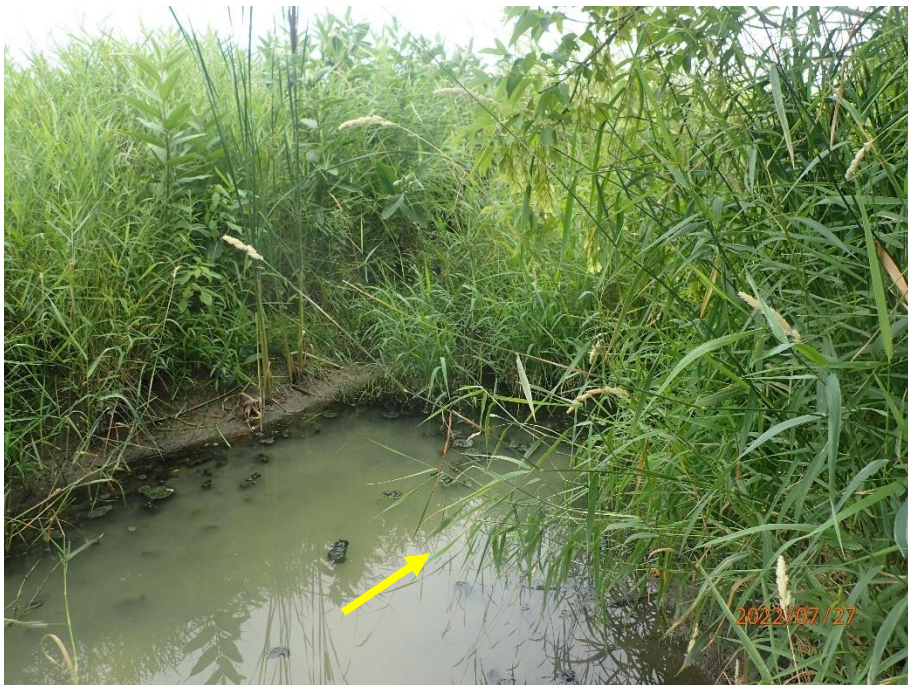
Photo 20
Reach **H1S3**

Flows exit the reach into an east-flowing tributary of Twenty Mile Creek.
