Arborist Report

Pre-Construction Assessment

559 Garner Rd E
Ancaster, ON
L9G 3K9

Updated February 10th, 2023

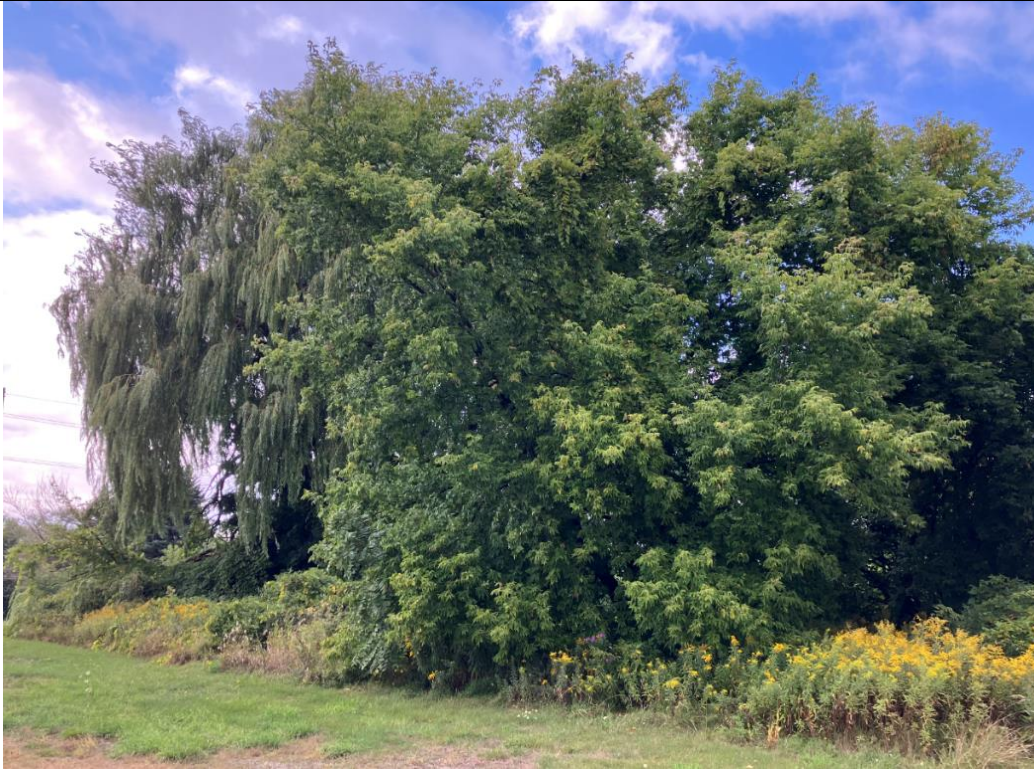
Figure 1: Trees #1-6 generally from right to left, viewed from Garner Rd.

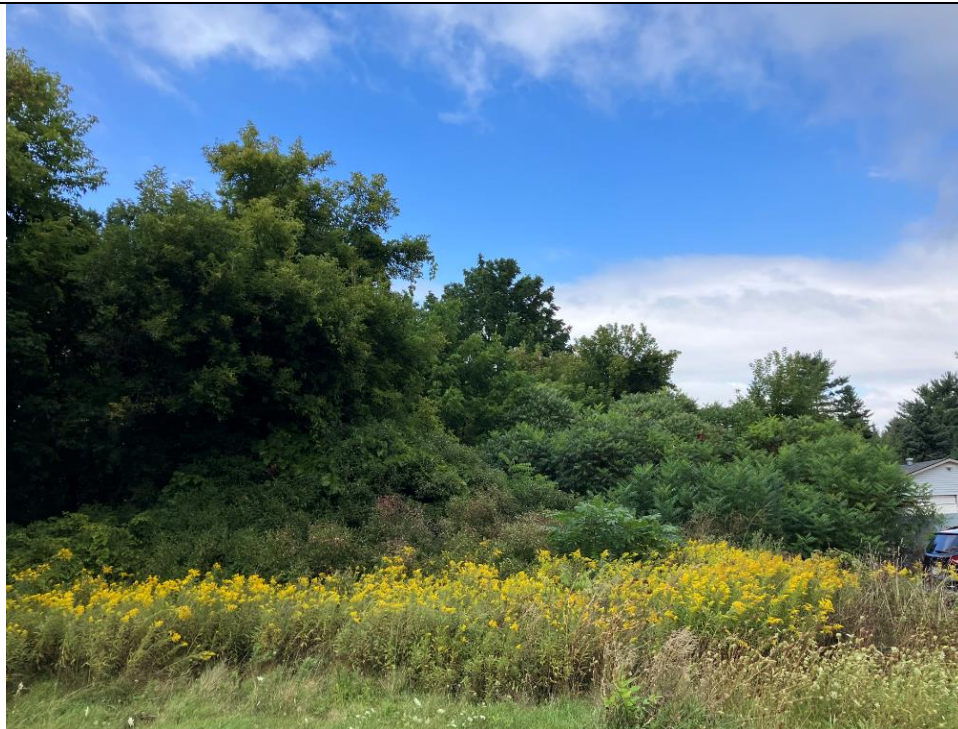
Figure 2: Shrubs and sumacs on the east side of 559 Garner Rd E.

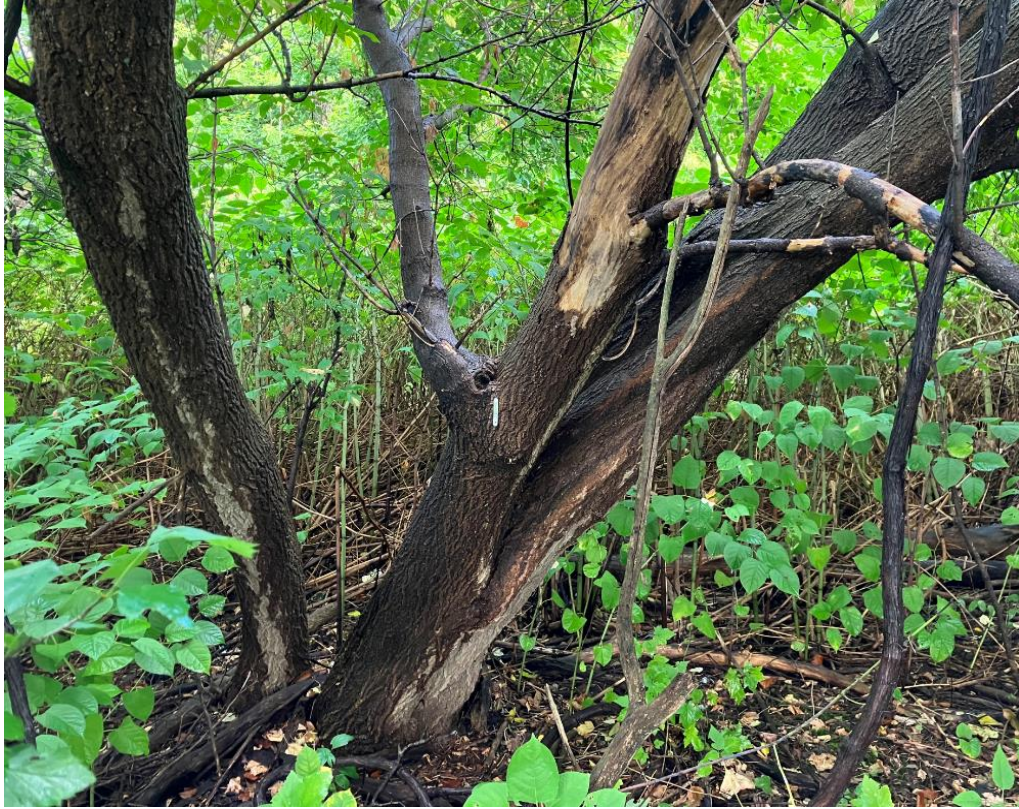
Figure 3: Base of Tree #1 showing overgrown invasive weeds (Japanese knotweed)

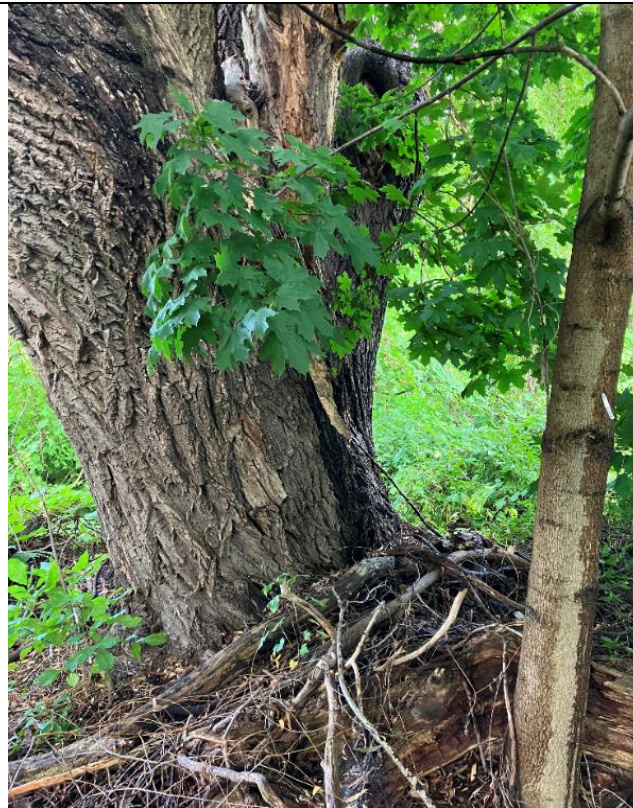
Figure 4: Base of Tree #5, with #4 in foreground

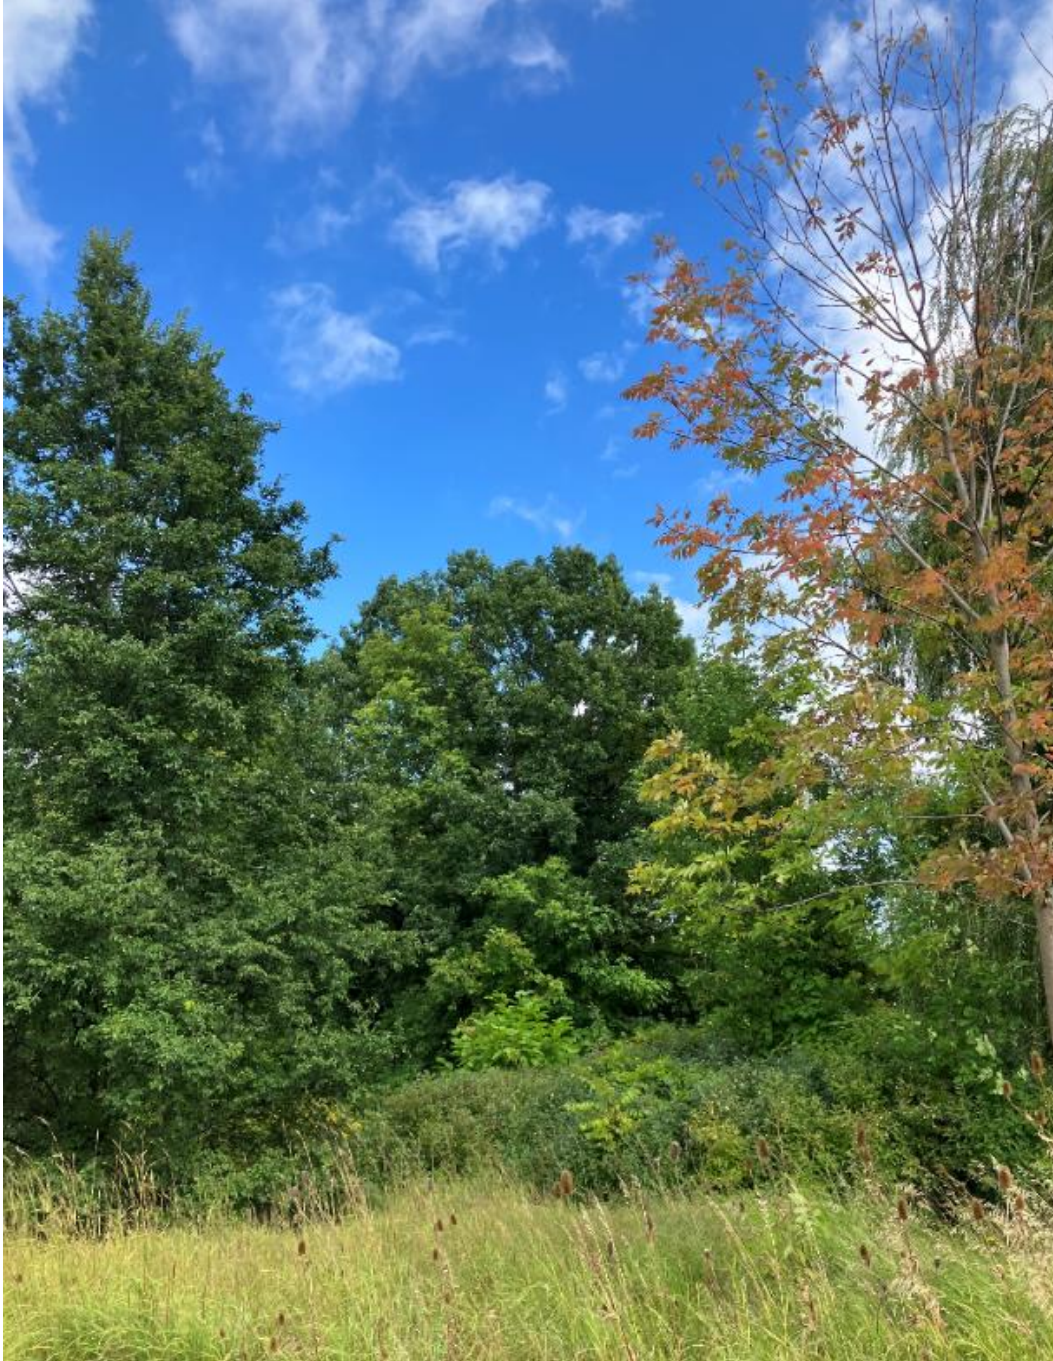
Figure 5: View looking east from Southcote Rd at trees #7-20 (generally right to left)

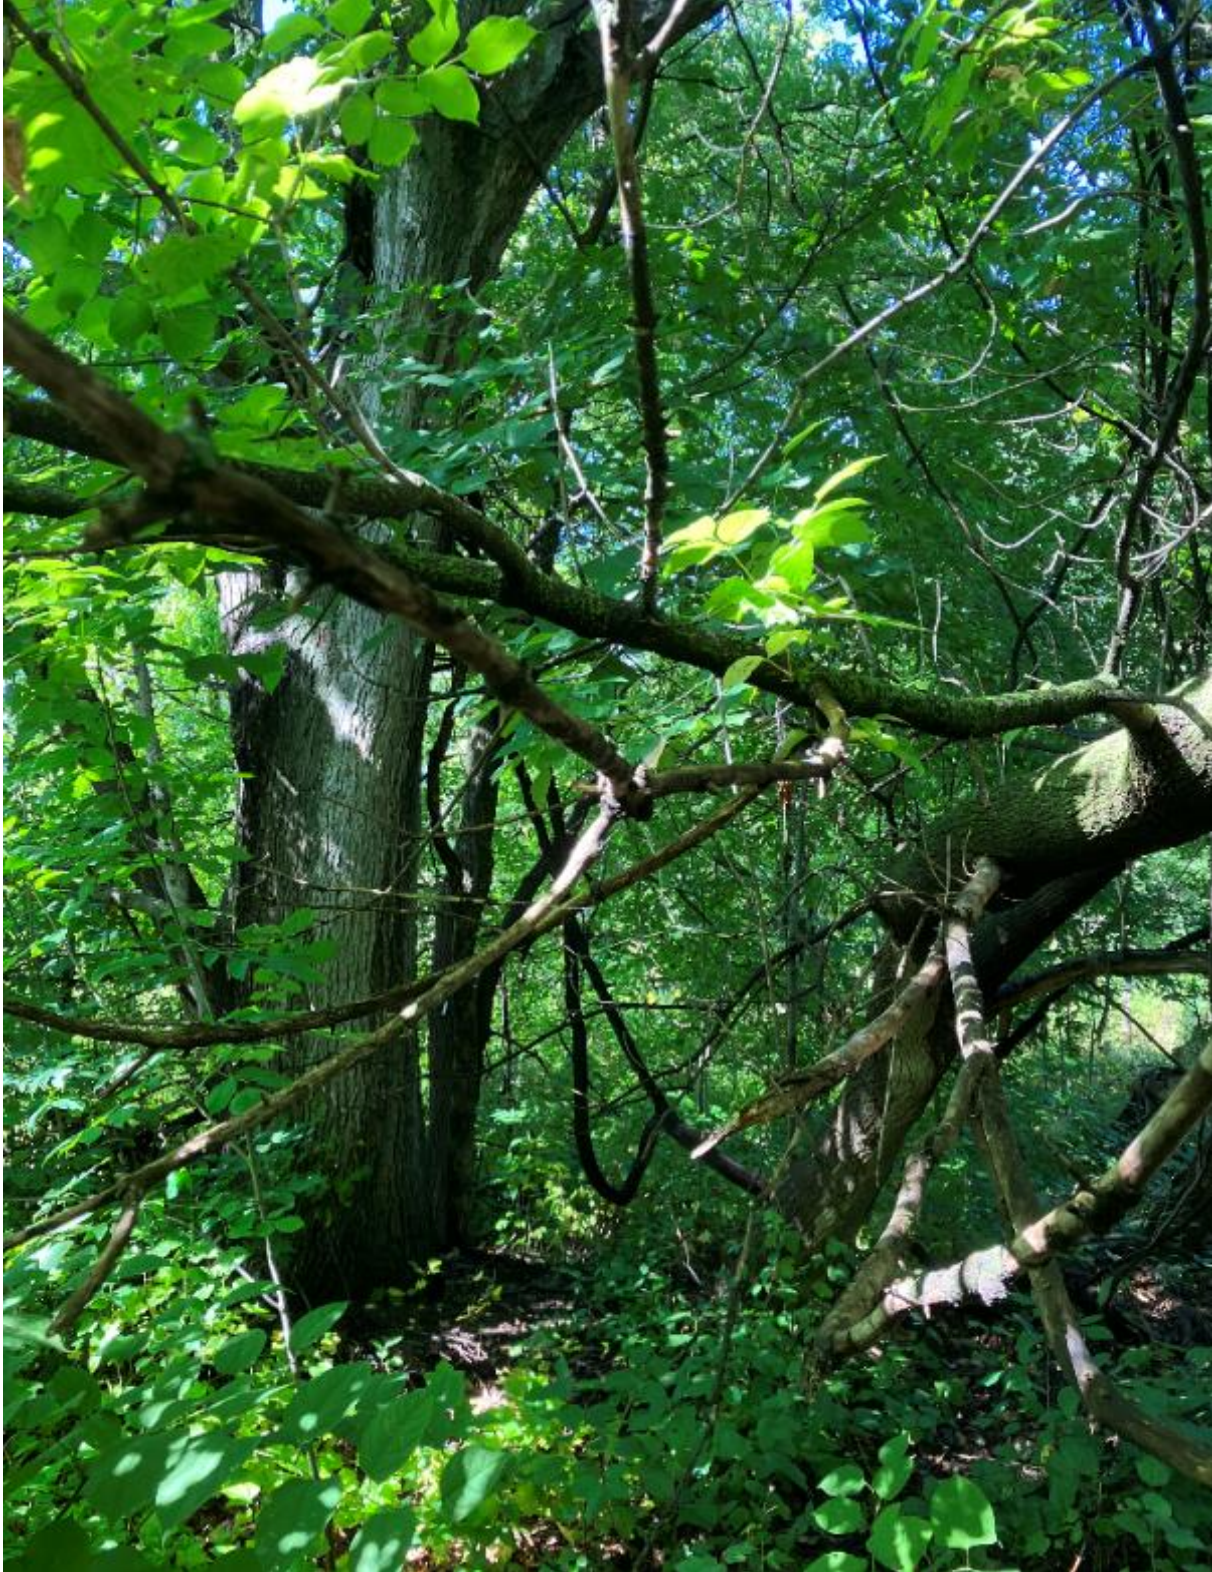
- Trees #15 and 40 are a large White Oak and Black Walnut within 559 Garner Rd E. These trees measure 84 and 64cm diameter and quality as Heritage Trees under Ancaster by-laws. Additional permission will be required for their removal. Replacement planting is planned to compensate for these trees.

Figure 6: View of the base of Tree #15 with Manitoba maple volunteers throughout

- Trees #15 and 40 qualify as “Heritage Trees” under Town of Ancaster by-laws and require additional permission for removal. These trees are located within the proposed construction and cannot be alternatively protected. It is recommended that the client request permission to remove these trees, and provide sufficient compensation for their removal.

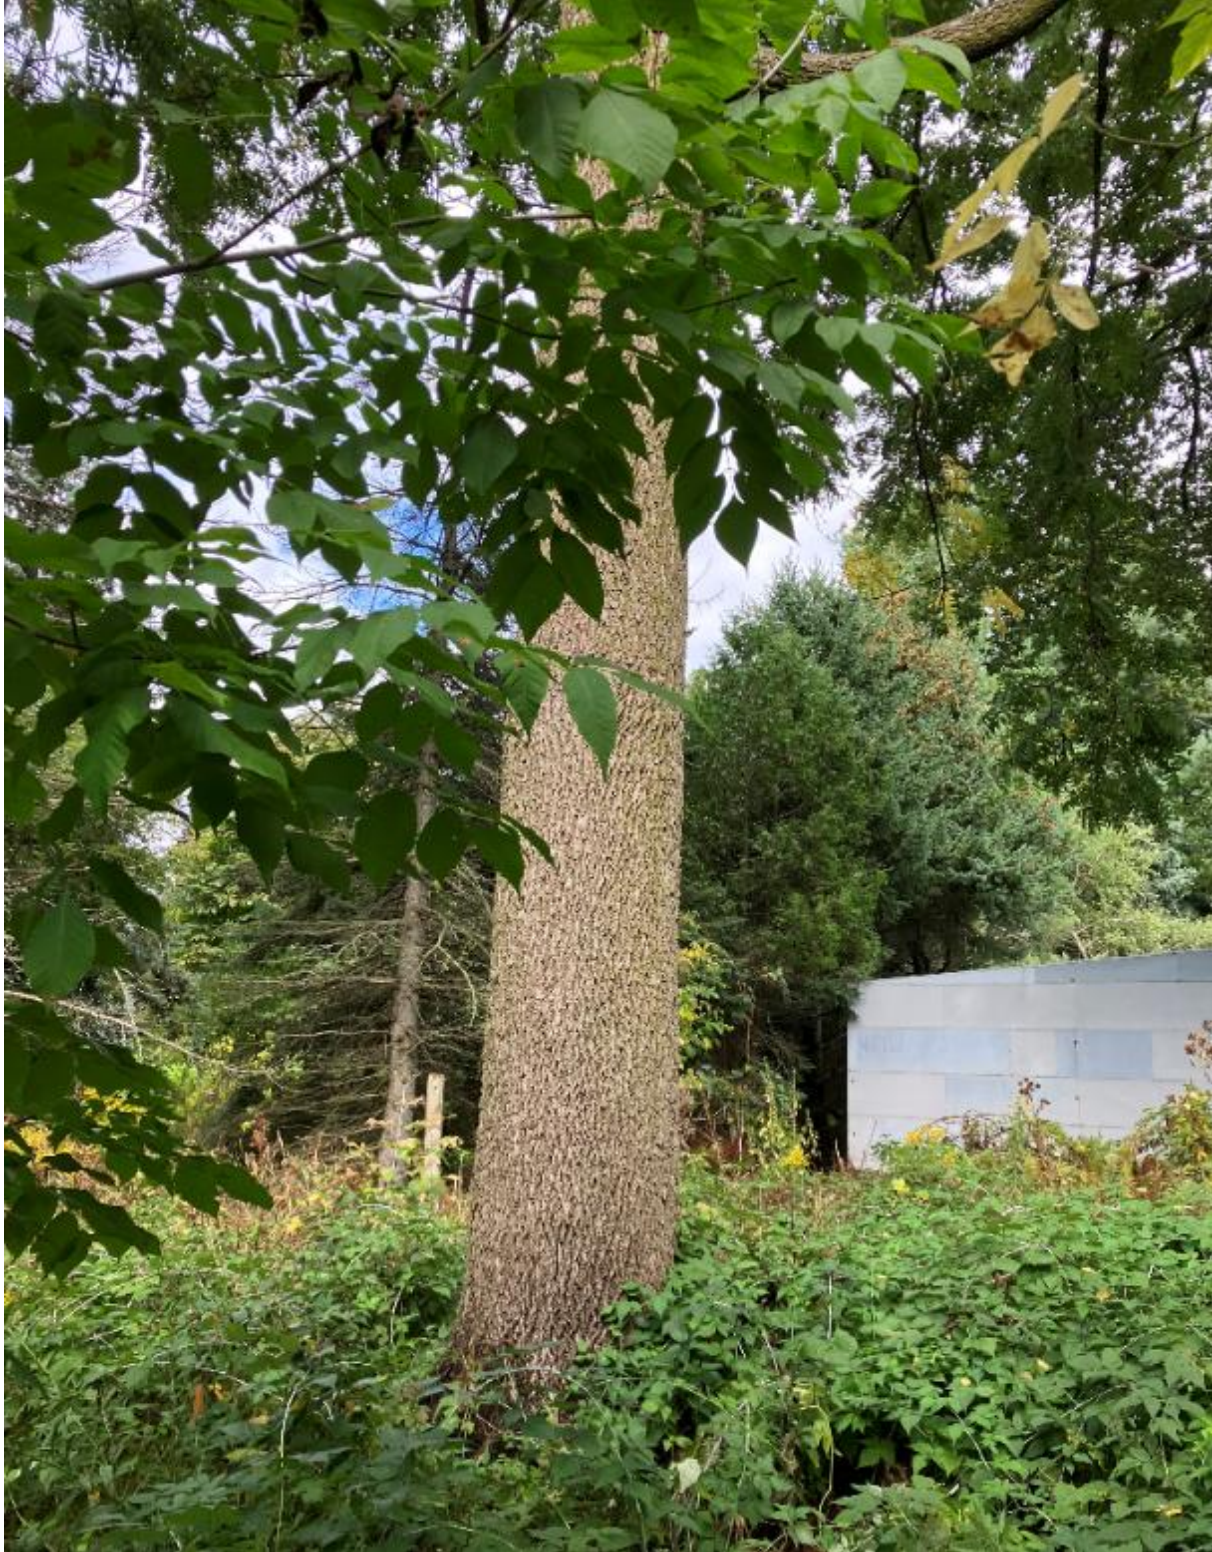
Figure 8: Base of Tree #40 with trees #45-50 from right to left in background.

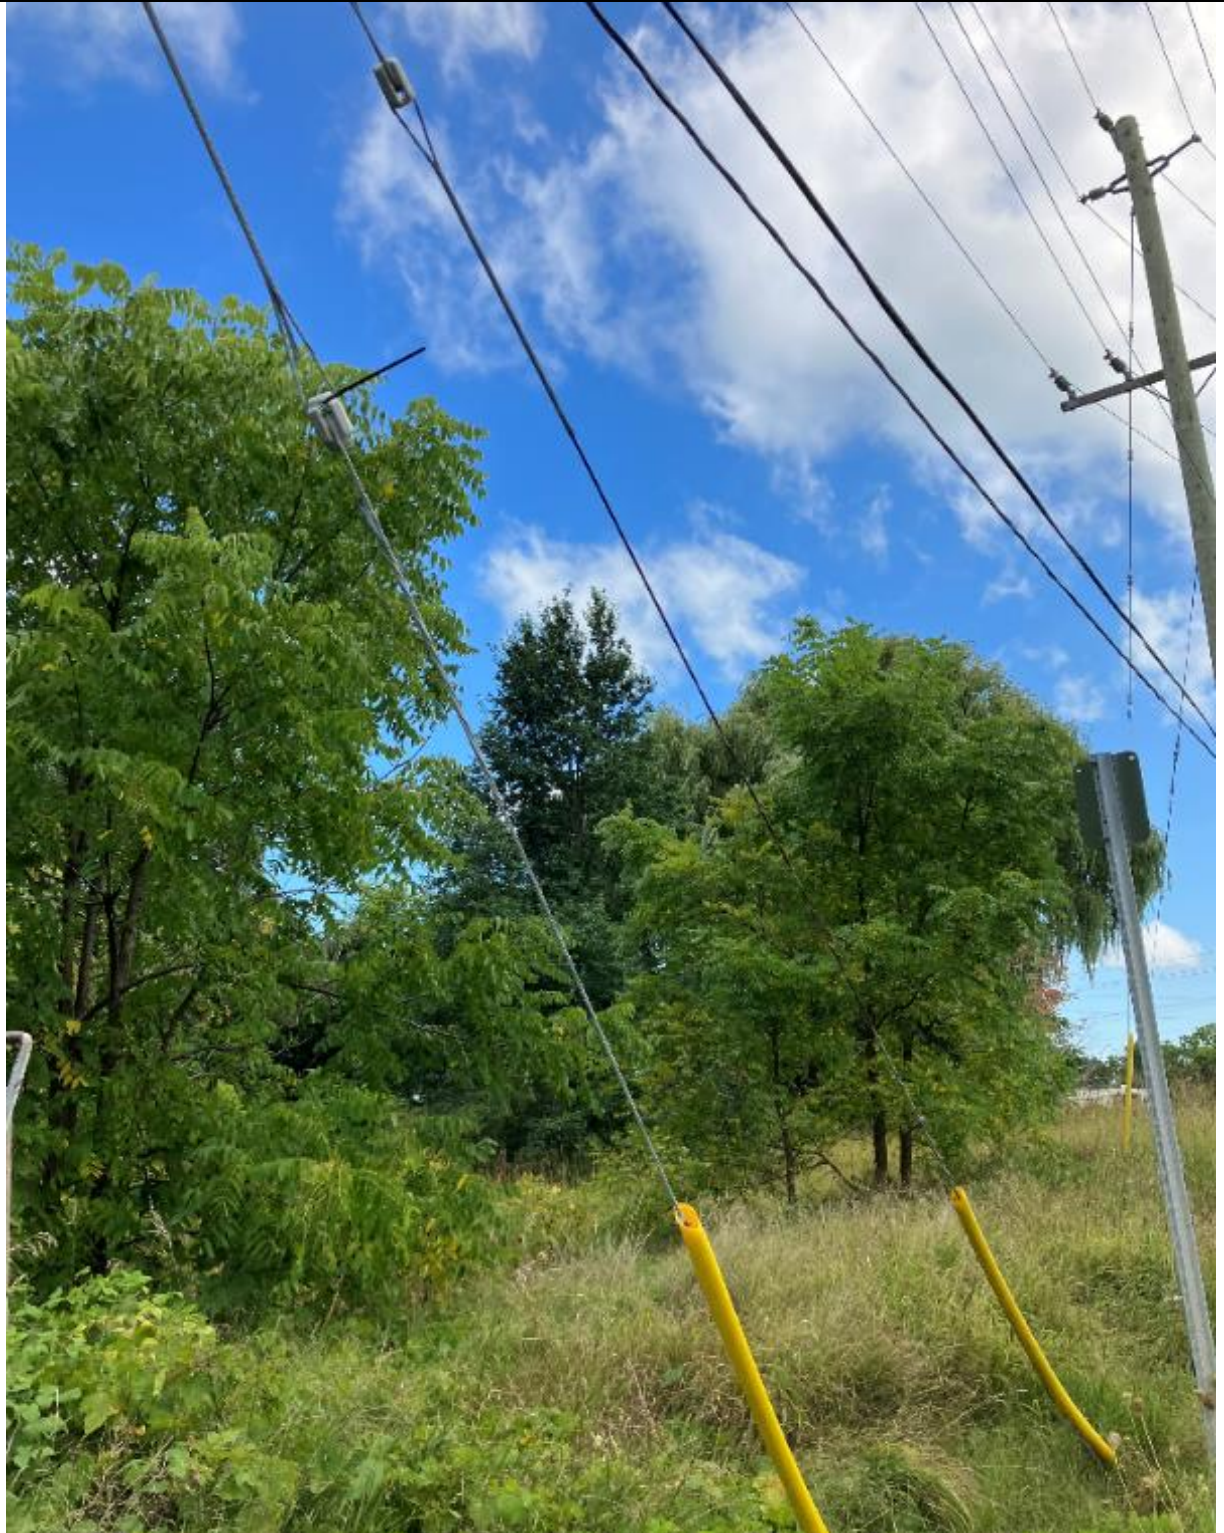
- Trees #44 and 45 are two Black Walnut trees along the roadway on Southcote Rd on the west side of the property. Both trees are growing as volunteers and are not maintained as street trees.

Figure 9: Trees #44 and 45 at right and left in boulevard along Southcote Rd, looking southeast.
