Arborist Report

Pre-Construction Assessment

559 Garner Rd E
Ancaster, ON
L9G 3K9

March 31, 2020

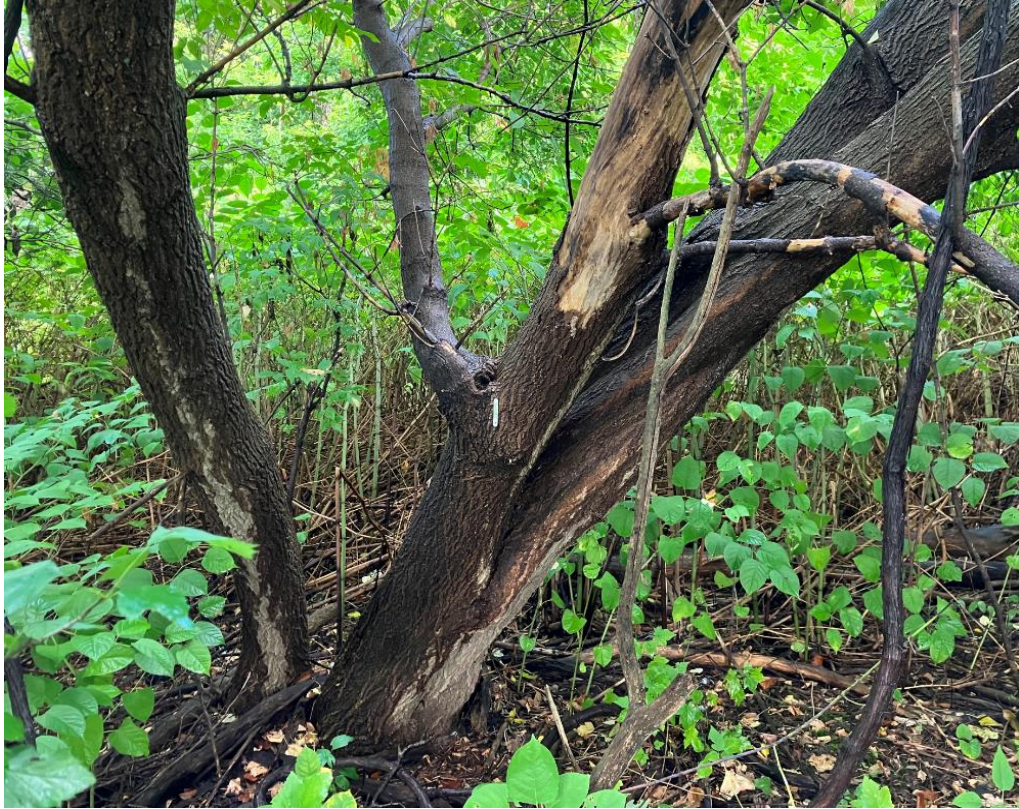
Figure 3: Base of Tree #1 showing overgrown invasive weeds (Japanese knotweed)

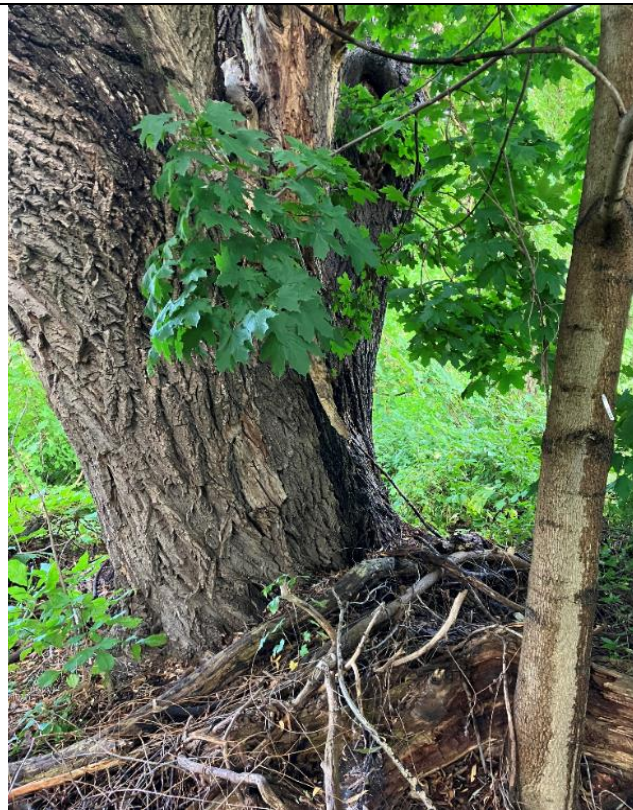
Figure 4: Base of Tree #5, with #4 in foreground

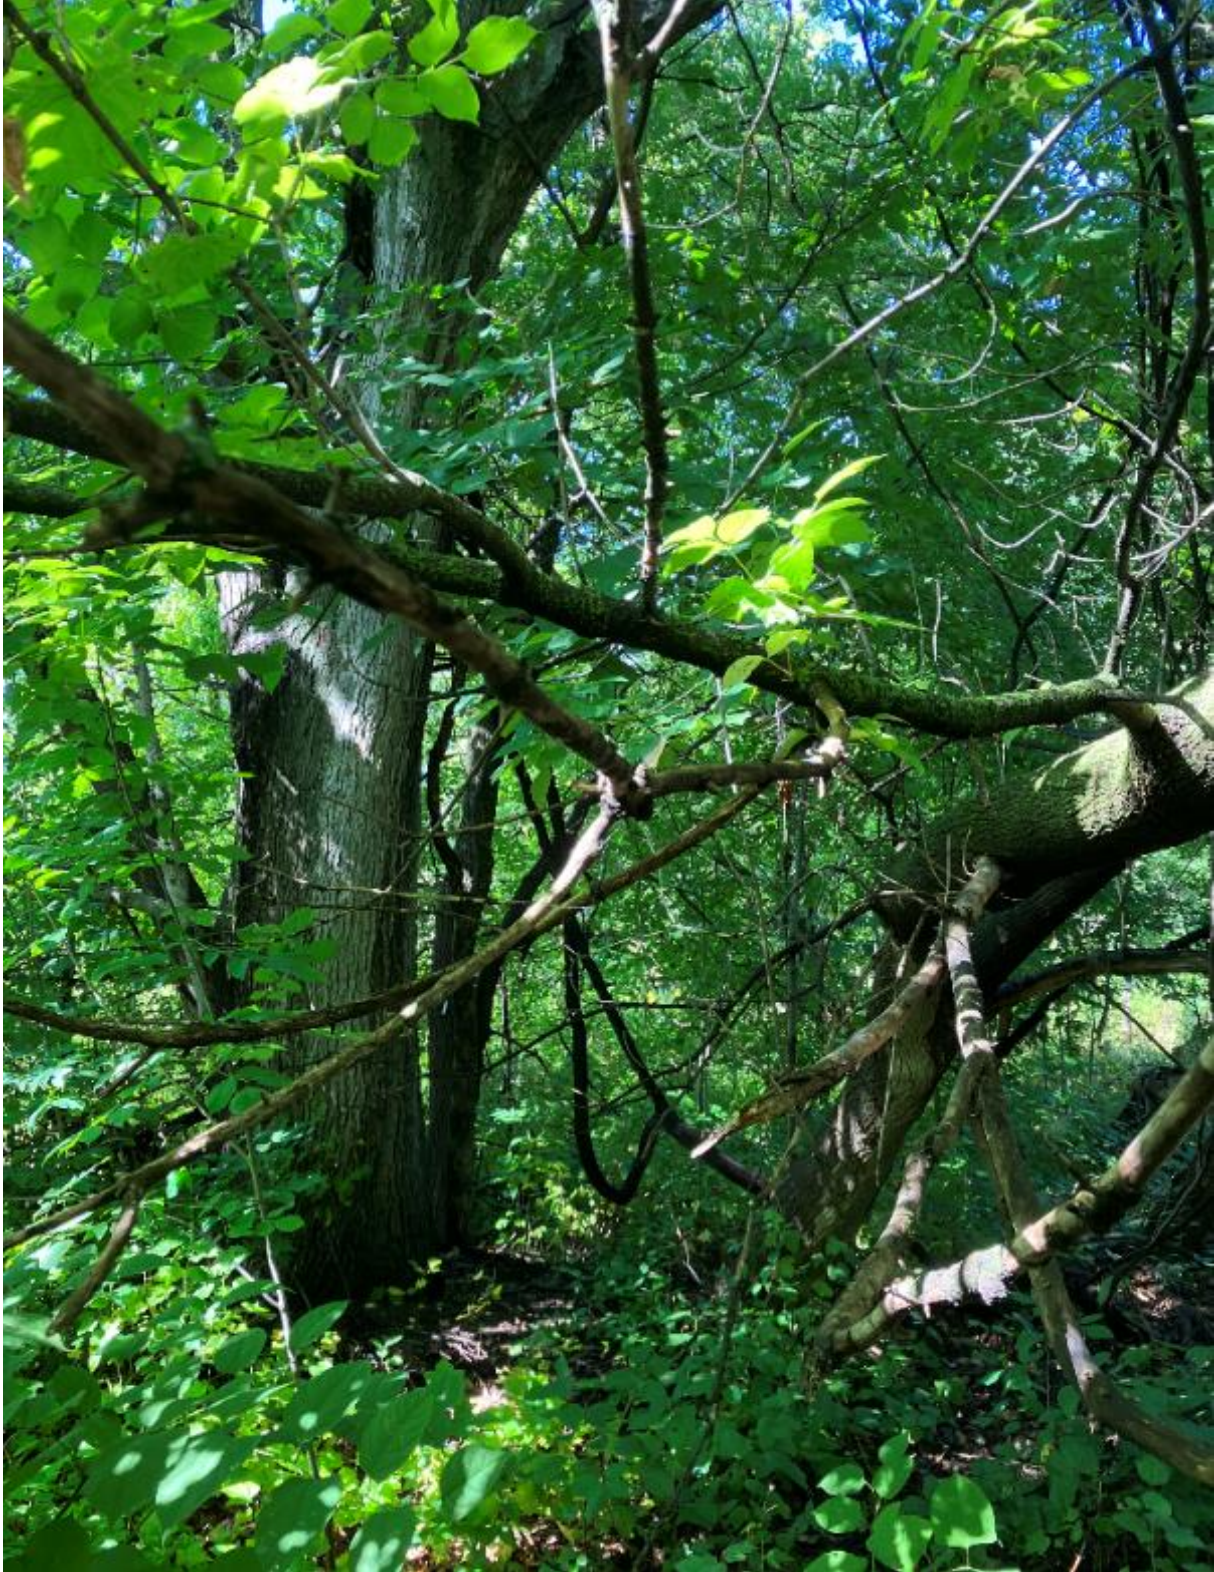
- Trees #15 and 40 are a large White Oak and Black Walnut within 559 Garner Rd E. These trees measure 84 and 64cm in diameter and quality as Heritage Trees under Ancaster by-laws. Additional permission will be required for their removal. Replacement planting is planned to compensate for these trees.

Figure 6: View of the base of Tree #15 with Manitoba maple volunteers throughout

- Trees #15 and 40 qualify as “Heritage Trees” under Town of Ancaster by-laws and require additional permission for removal. These trees are located within the proposed construction and cannot be alternatively protected. It is recommended that the client request permission to remove these trees and provide sufficient compensation for their removal.

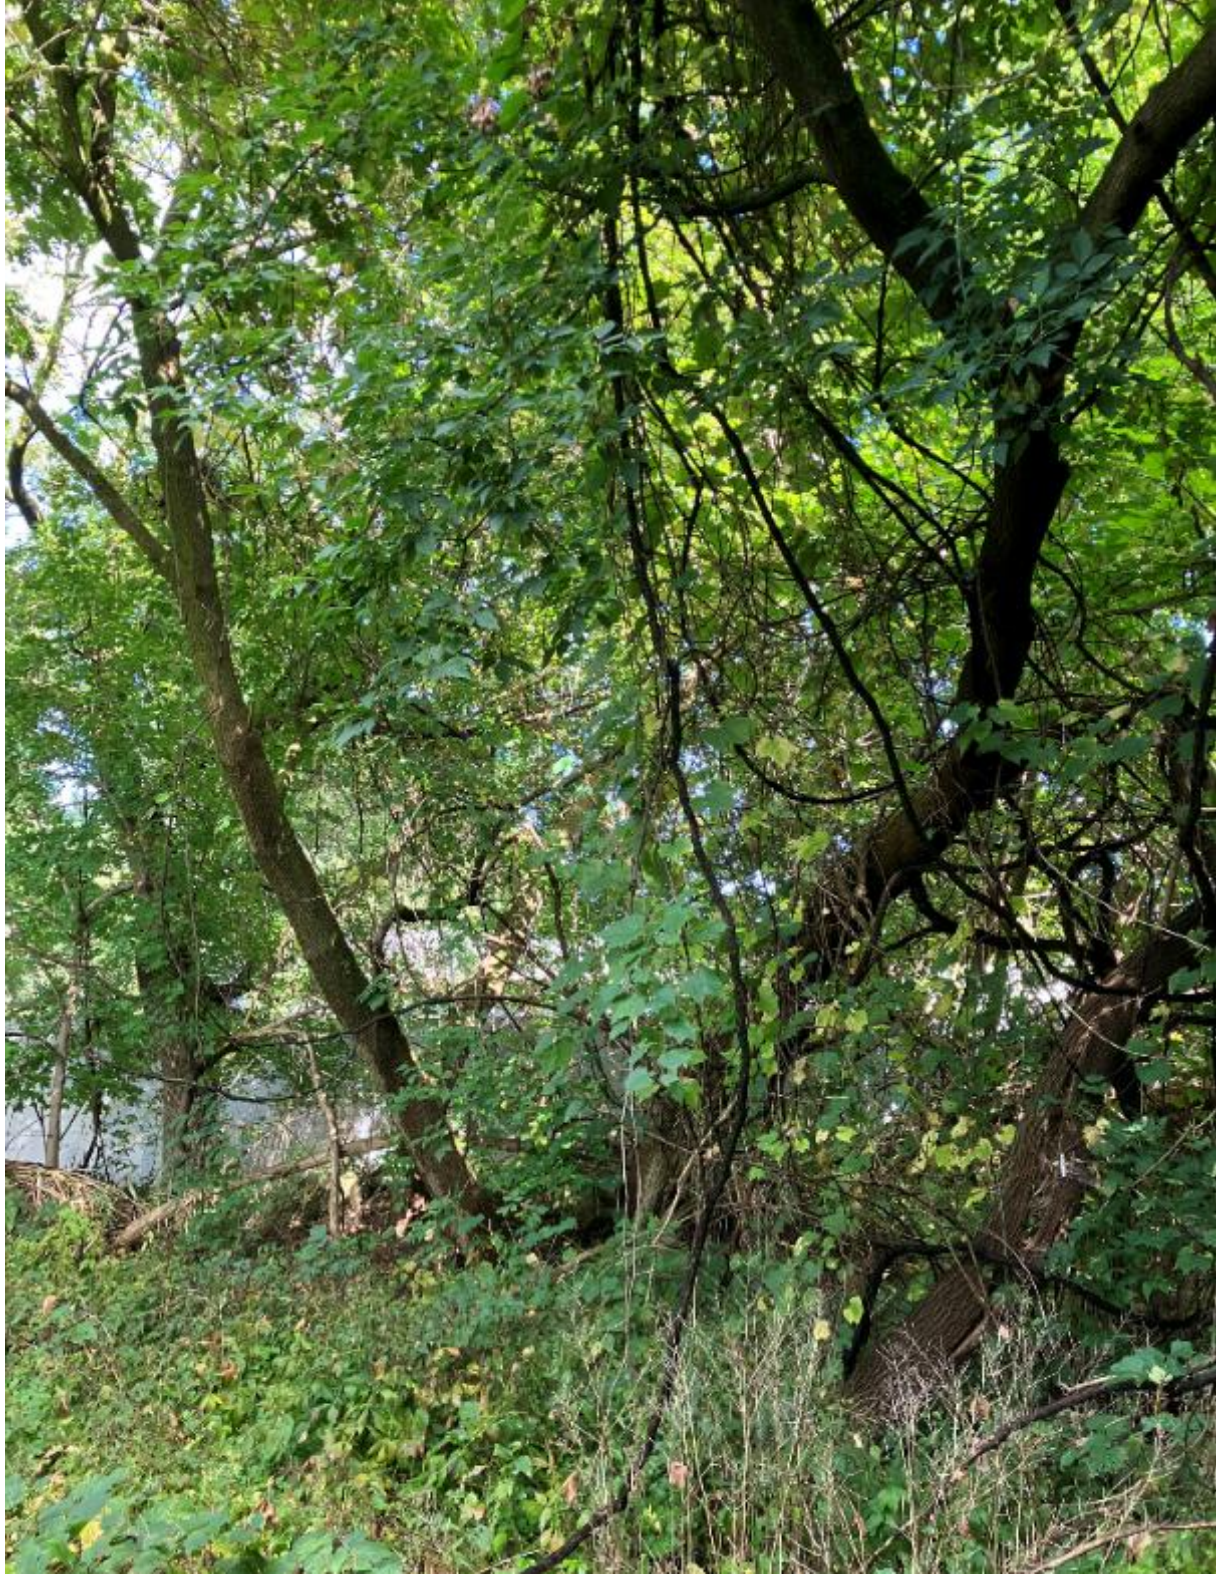
Figure 7: View of trees #24-30 growing from rubble pile in northeast end of property.

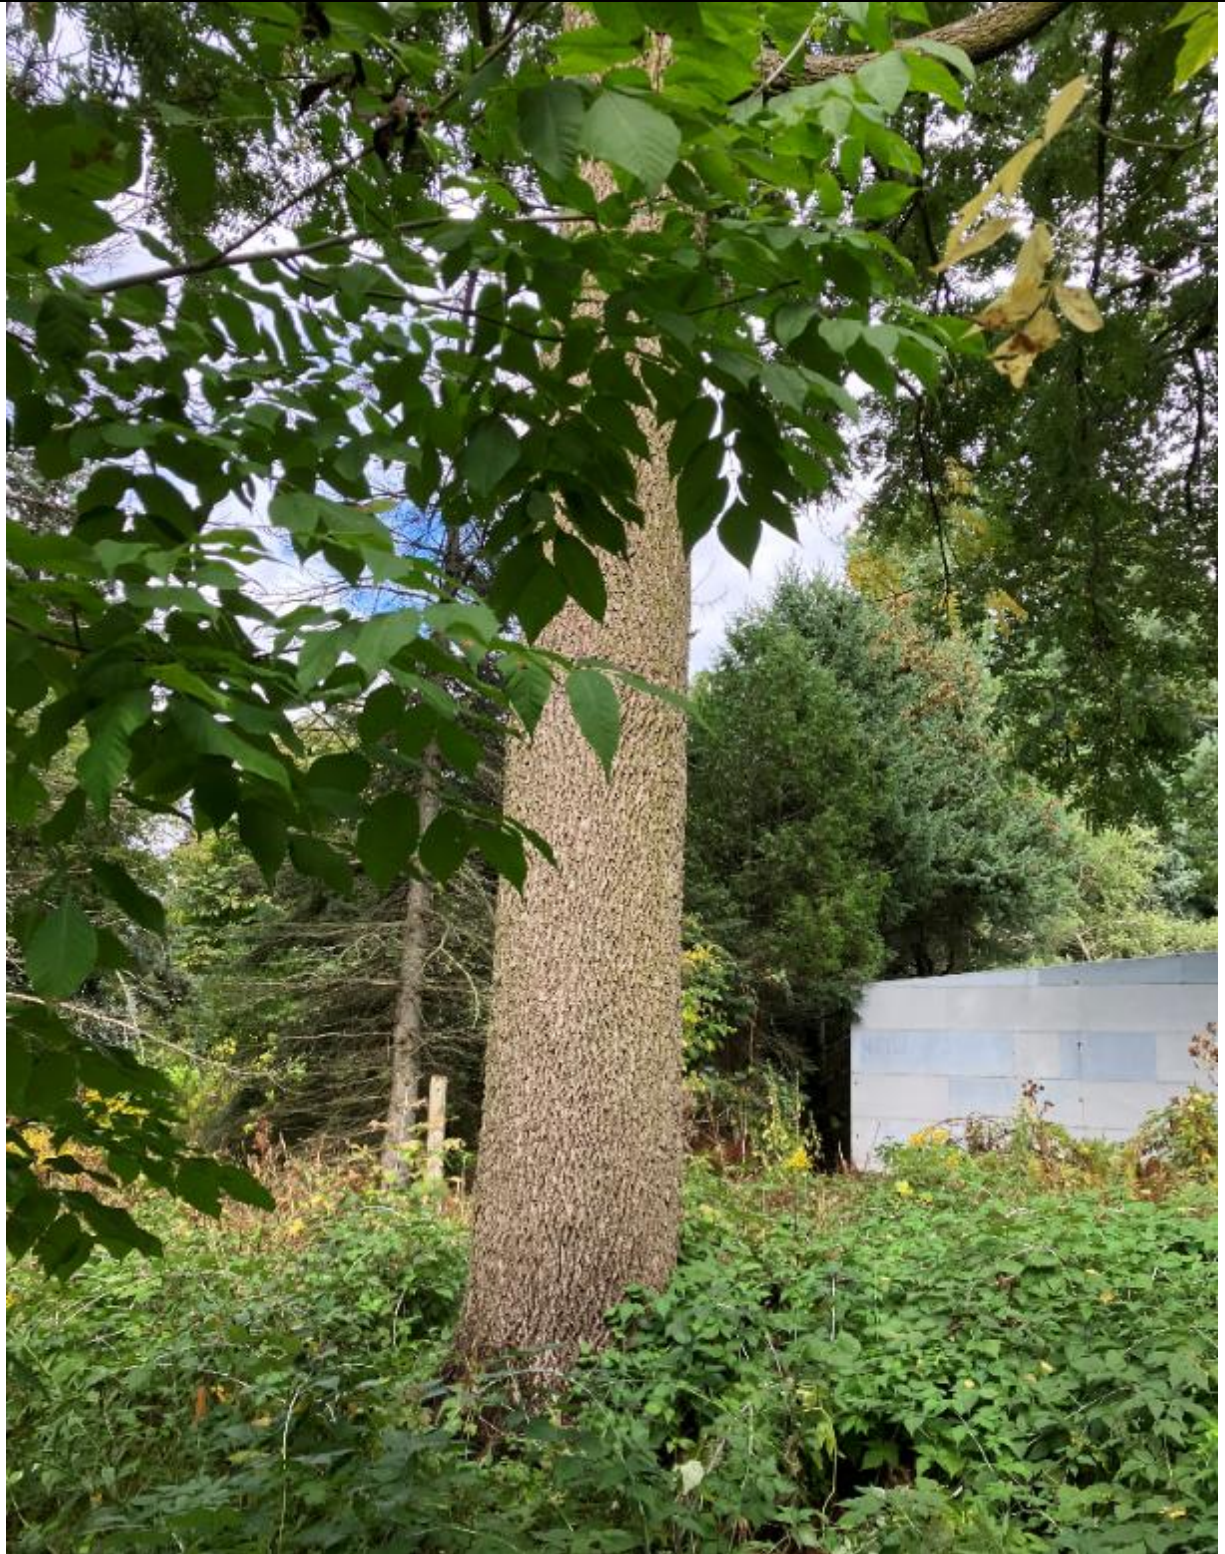
Figure 8: Base of Tree #40 with trees #45-50 from right to left in background.

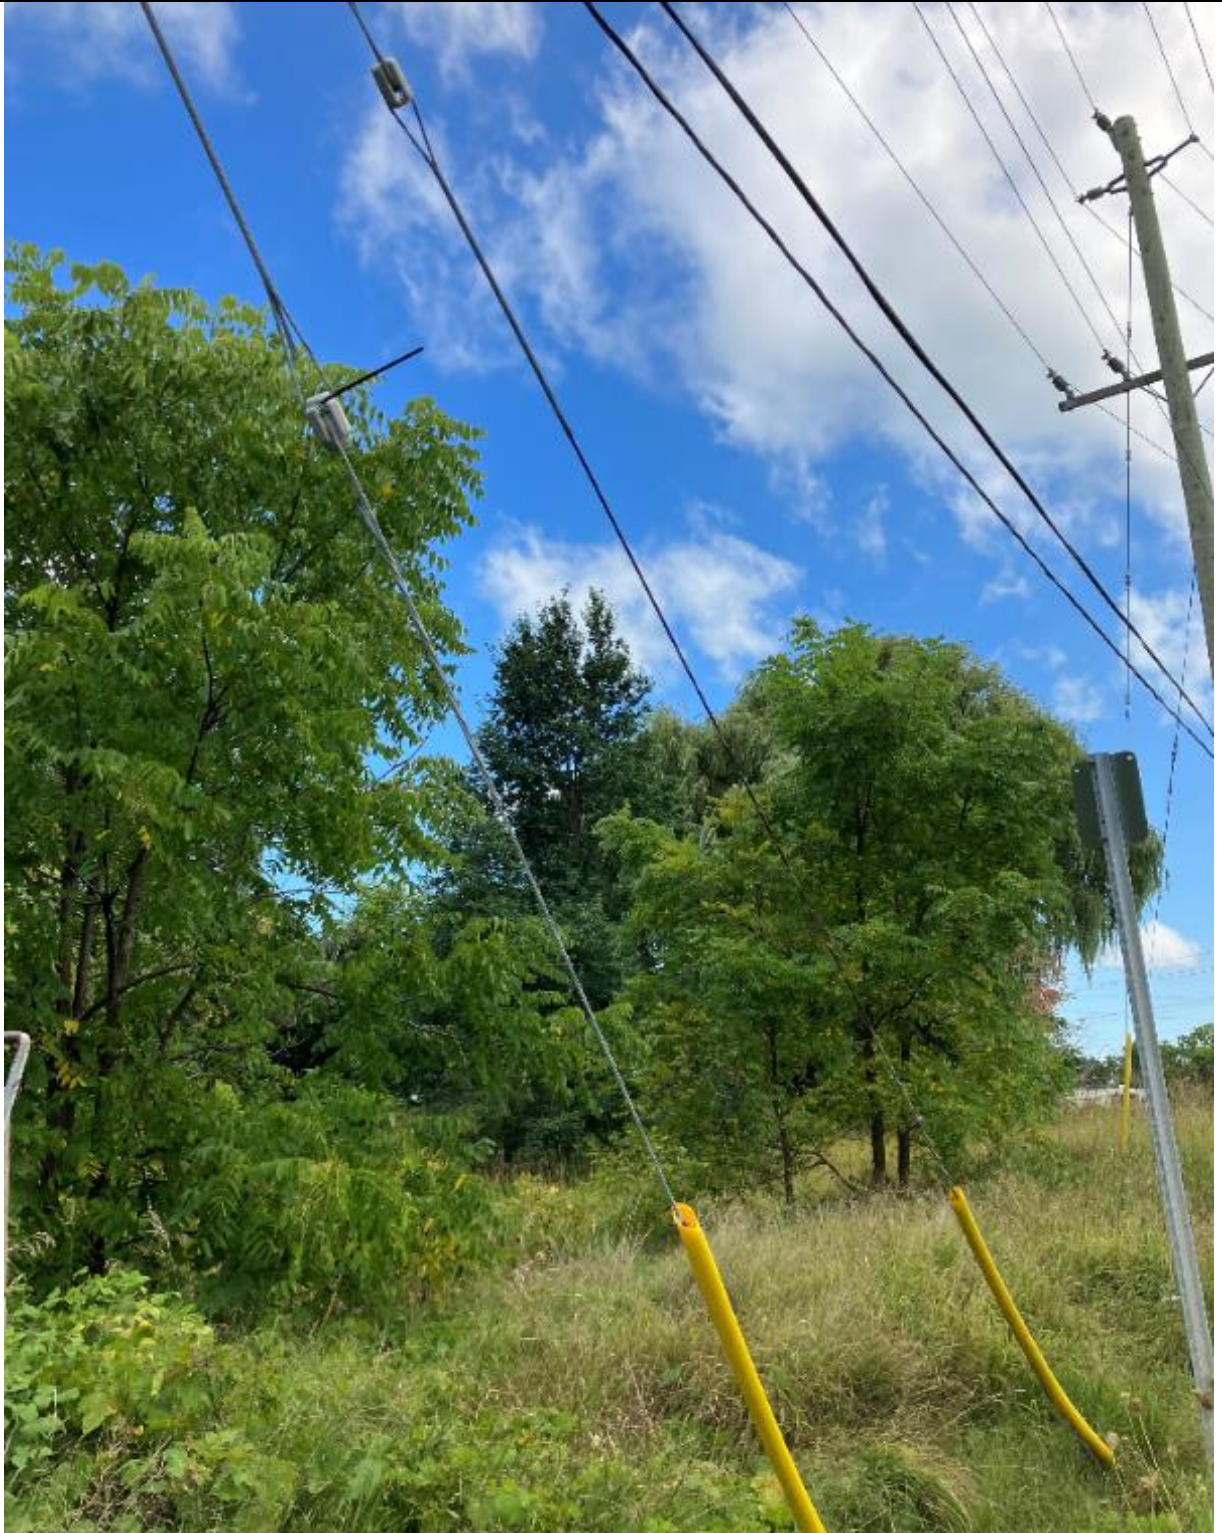
- Trees #44 and 45 are two Black Walnut trees along the roadway on Southcote Rd on the west side of the property. Both trees are growing as volunteers and are not maintained as street trees.

Figure 9: Trees #44 and 45 at right and left in boulevard along Southcote Rd, looking southeast.

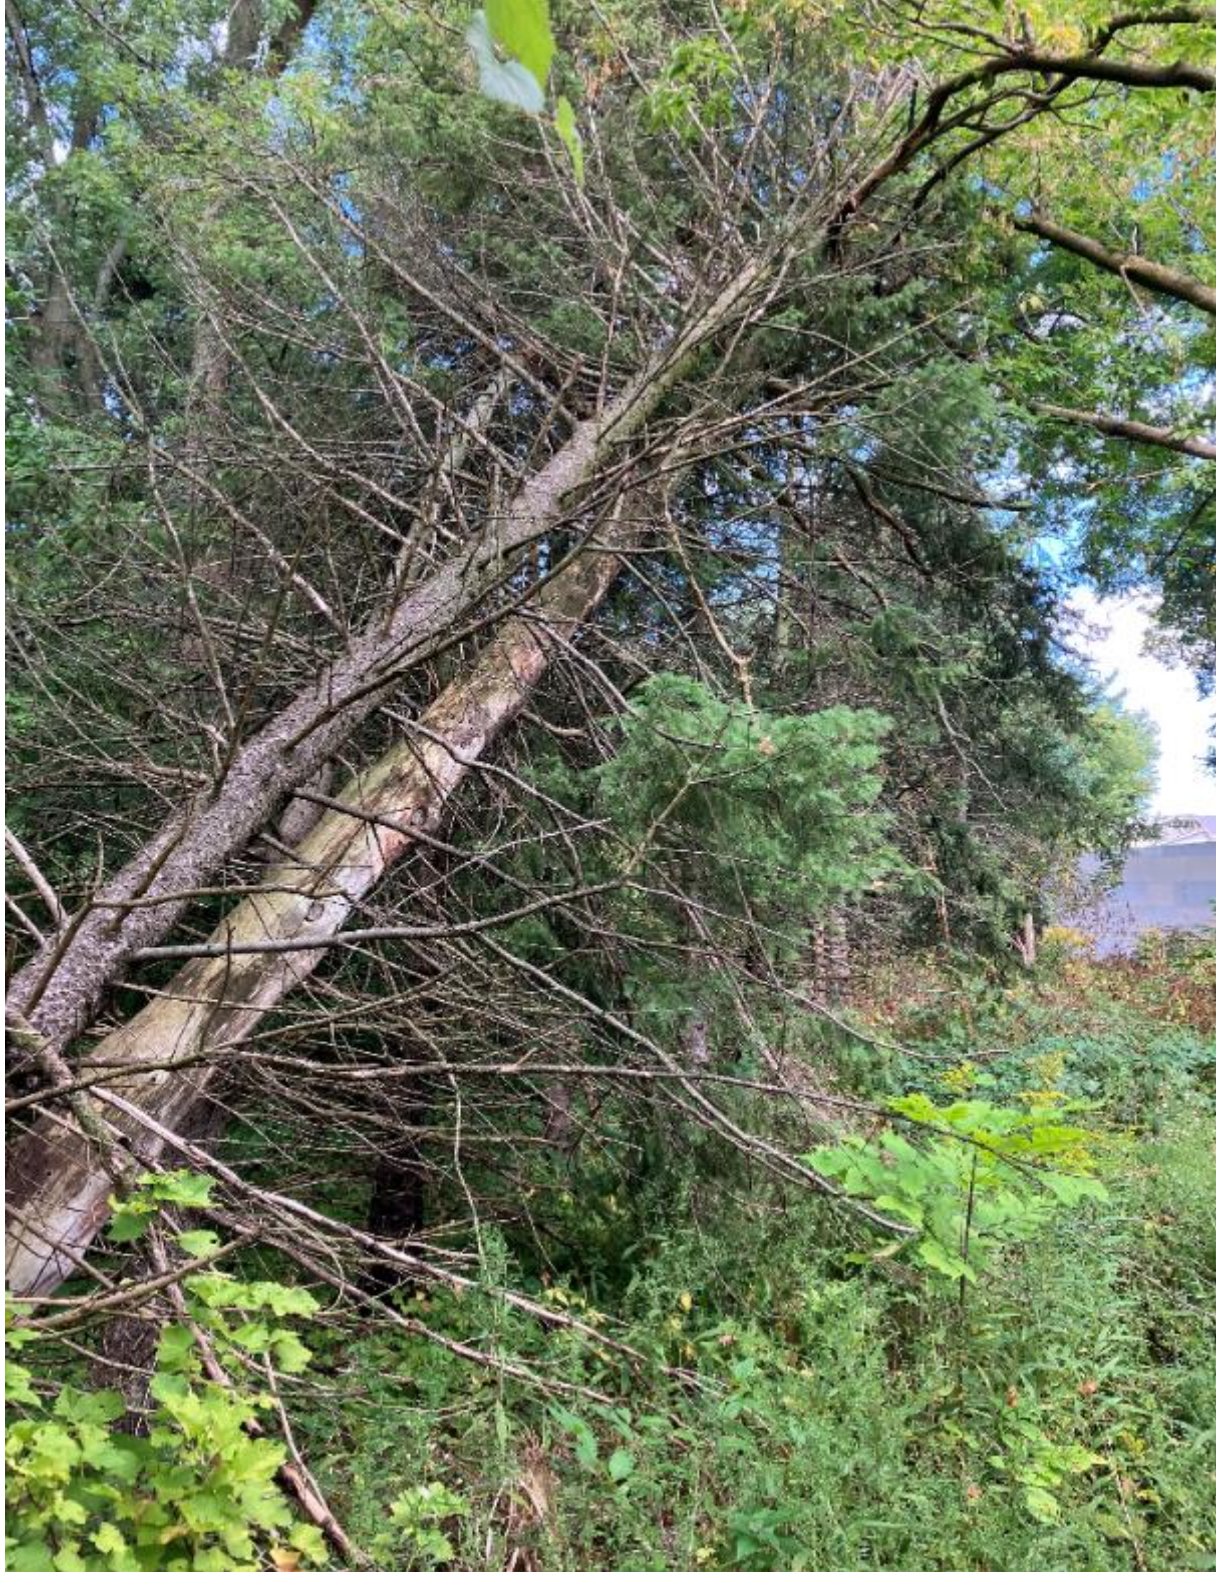
- Trees #48, 49, 56, 66, and 70 are within 509 Southcote Rd and far enough away from the proposed construction to be retained with minor root loss. Low-impact root excavation by means of Hydro-Vac at 500psi or lower is recommended to expose roots for pruning prior to deep excavation for the underground parking garage. Permission of the neighbours will be required. Trees #56 and 66 qualify as Heritage Trees under Ancaster tree preservation by-laws, and additional permits will be required.

Figure 10: Trees #51-65 from right to left along north property boundary. Most trees are in poor or dead condition and recommended for removal. Trees #56 and 66 in background to be preserved with minor injury during excavation.

- For Trees #48, 49, 56, 66, and 70, we recommend root excavation by low-pressure hydro vac supervised by a Certified Arborist to minimize the damage to the health and structure of the trees. Once roots are excavated, root pruning required is to be conducted by a Certified Arborist in order to minimize severance of anchor roots, which provide upright support for the tree. An Arborist should be present on site at all times when work is within the TPZ.

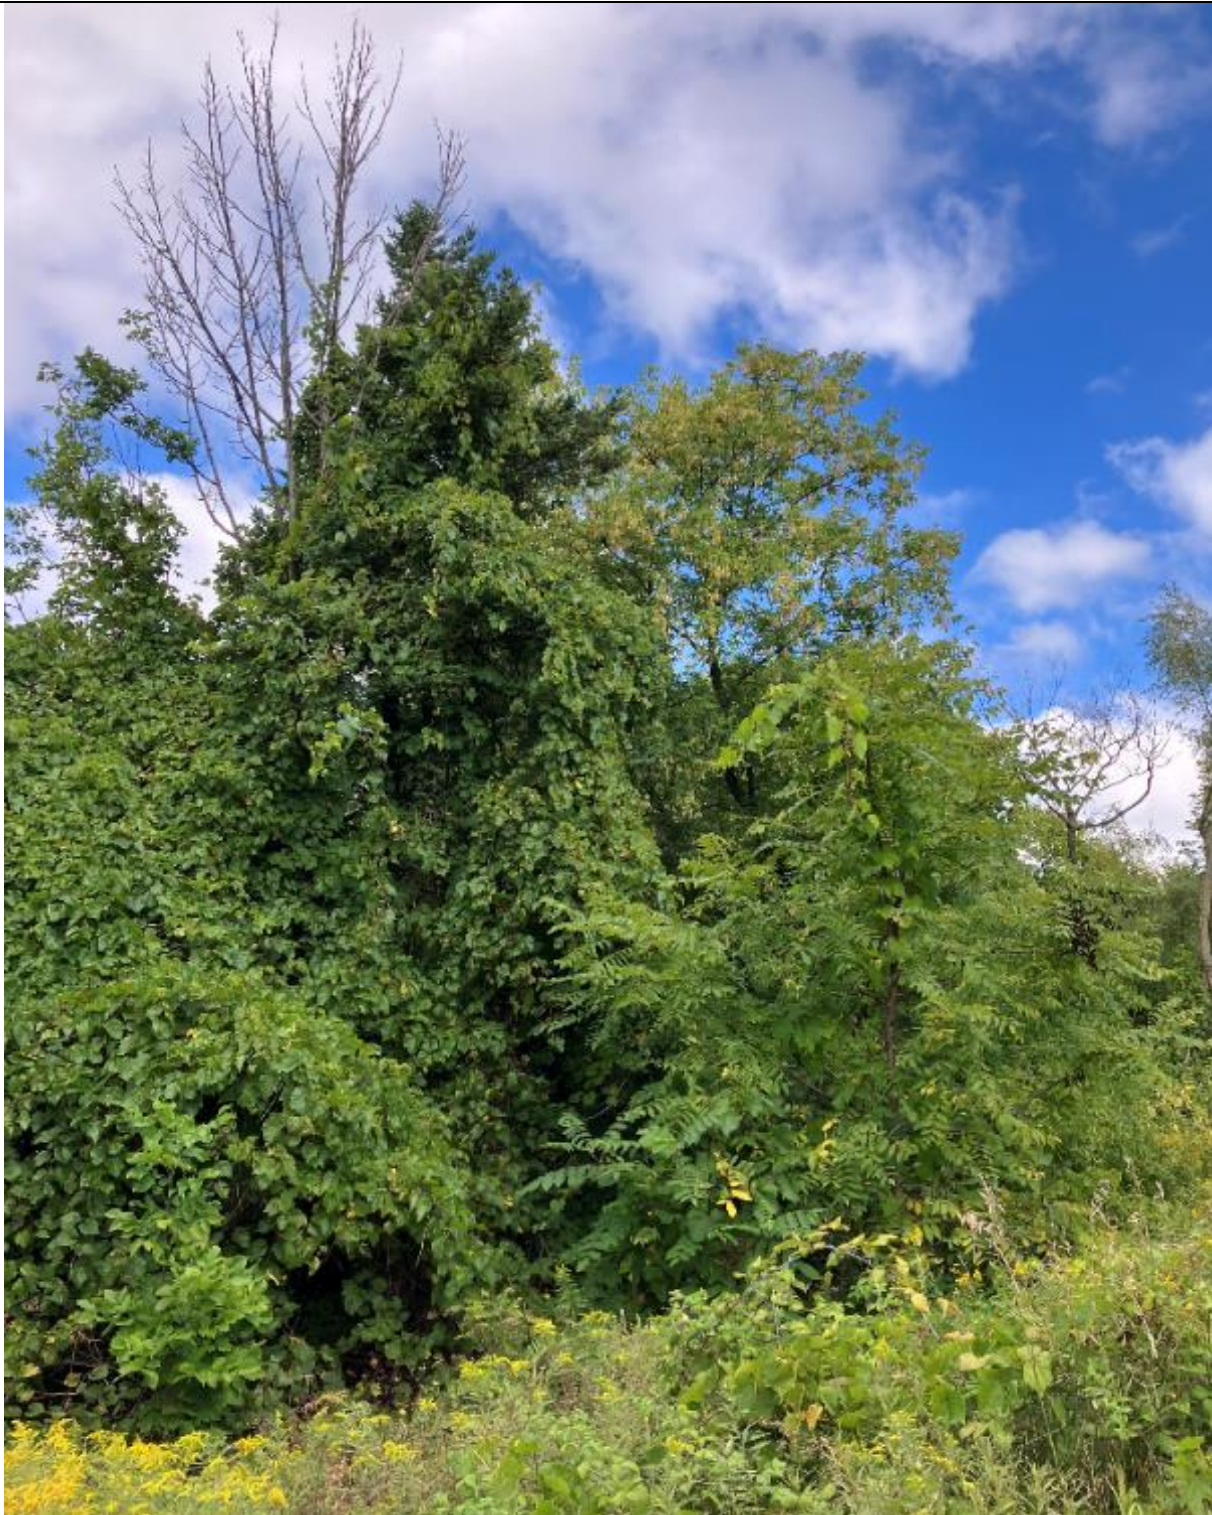
Figure 11: Trees #68-71 in inaccessible thicket overgrown with vines at northwest corner of property.
