Arborist Report

Pre-Construction Assessment

559 Garner Rd E
Ancaster, ON
L9G 3K9

September 20th, 2022
Updated September 23rd, 2024

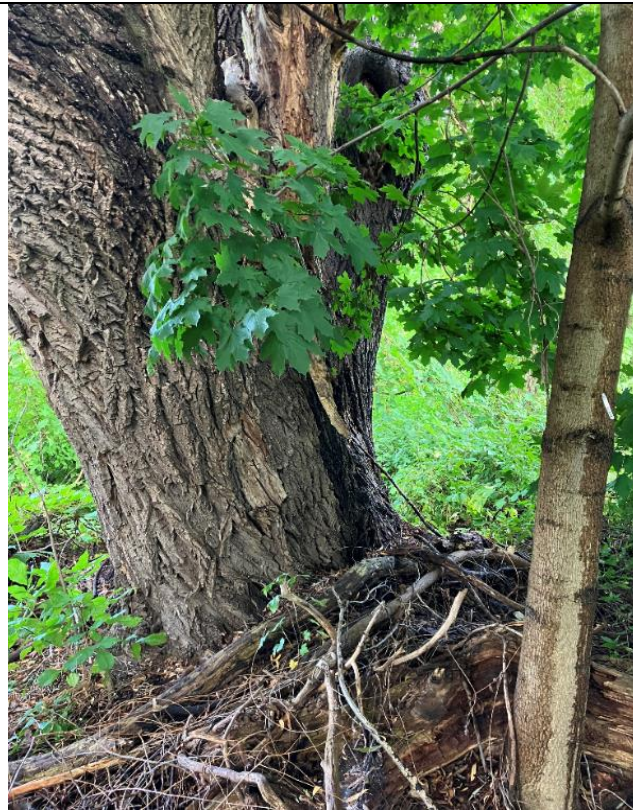
Figure 4: Base of Tree #5, with #4 in foreground

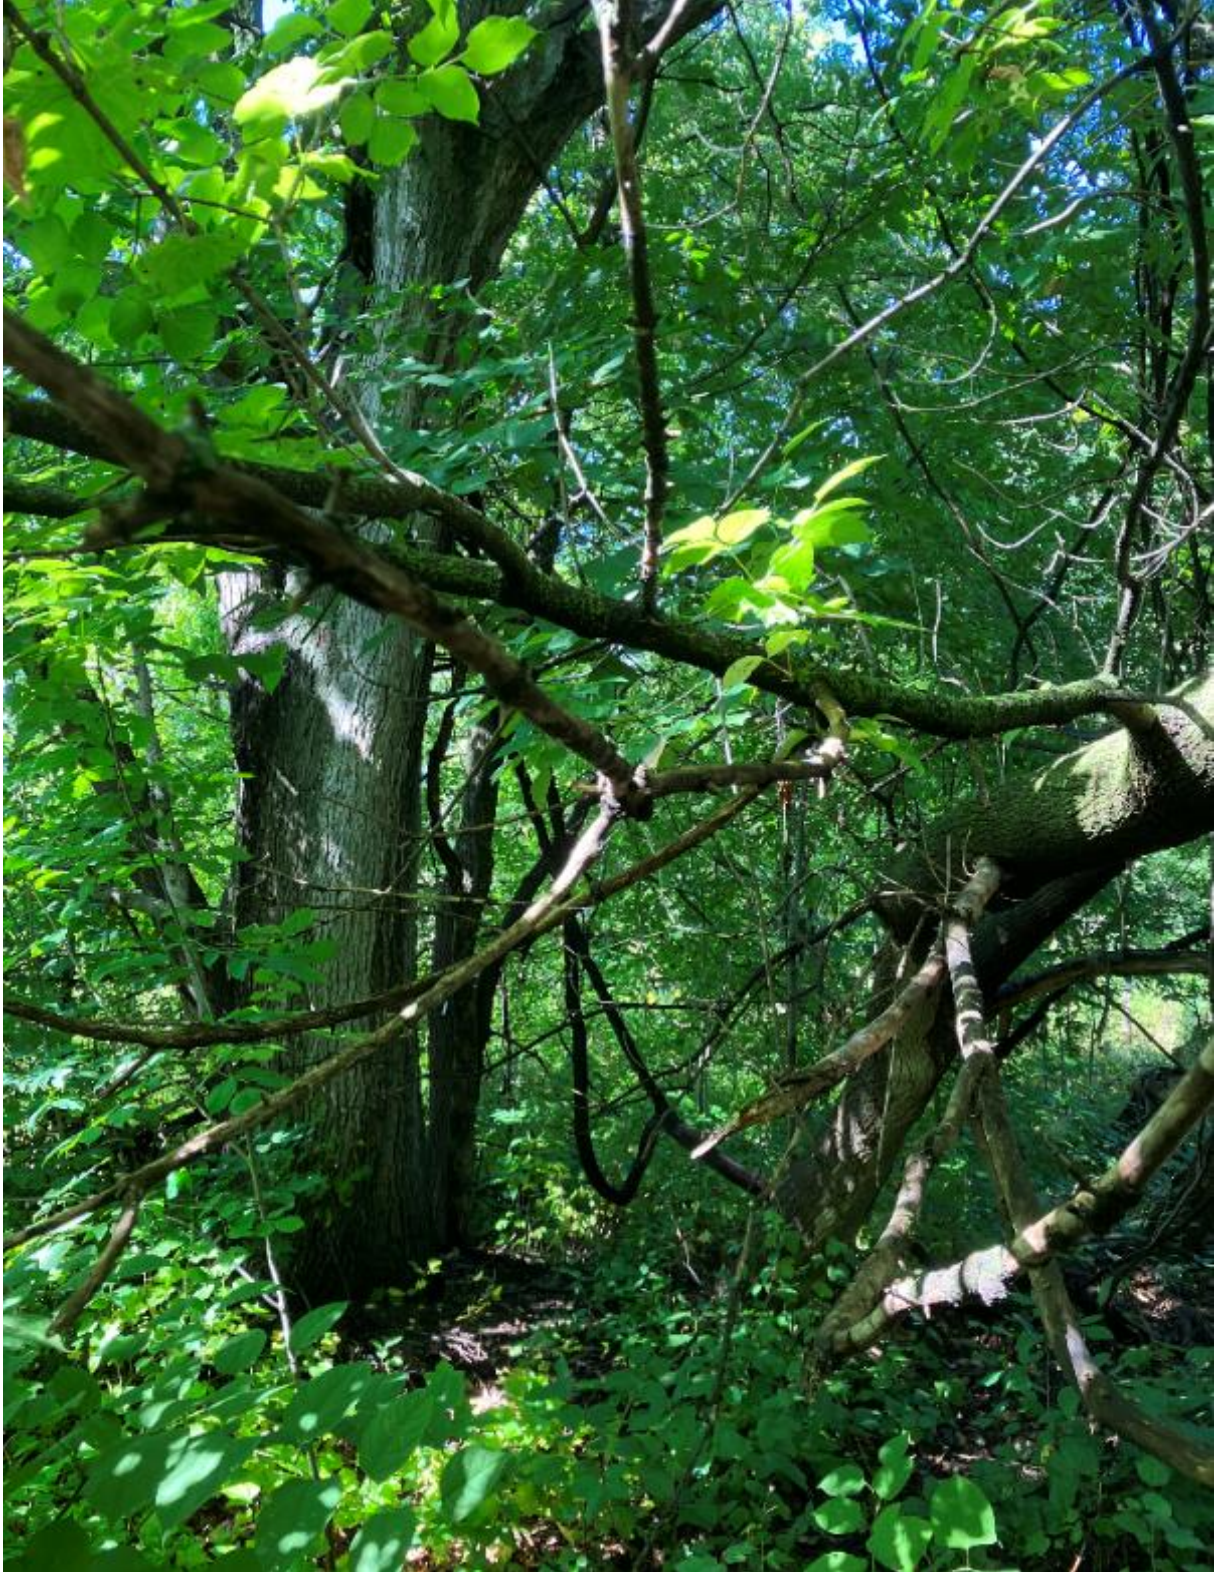
- Trees #15 and 40 are a large White Oak and Black Walnut within 559 Garner Rd E. These trees measure 84 and 64cm diameter and quality as Heritage Trees under Ancaster by-laws. Additional permission will be required for their removal. Replacement planting is planned to compensate for these trees.

Figure 6: View of the base of Tree #15 with Manitoba maple volunteers throughout

- Trees #15 and 40 qualify as “Heritage Trees” under Town of Ancaster by-laws and require additional permission for removal. These trees are located within the proposed construction and cannot be alternatively protected. It is recommended that the client request permission to remove these trees, and provide sufficient compensation for their removal.

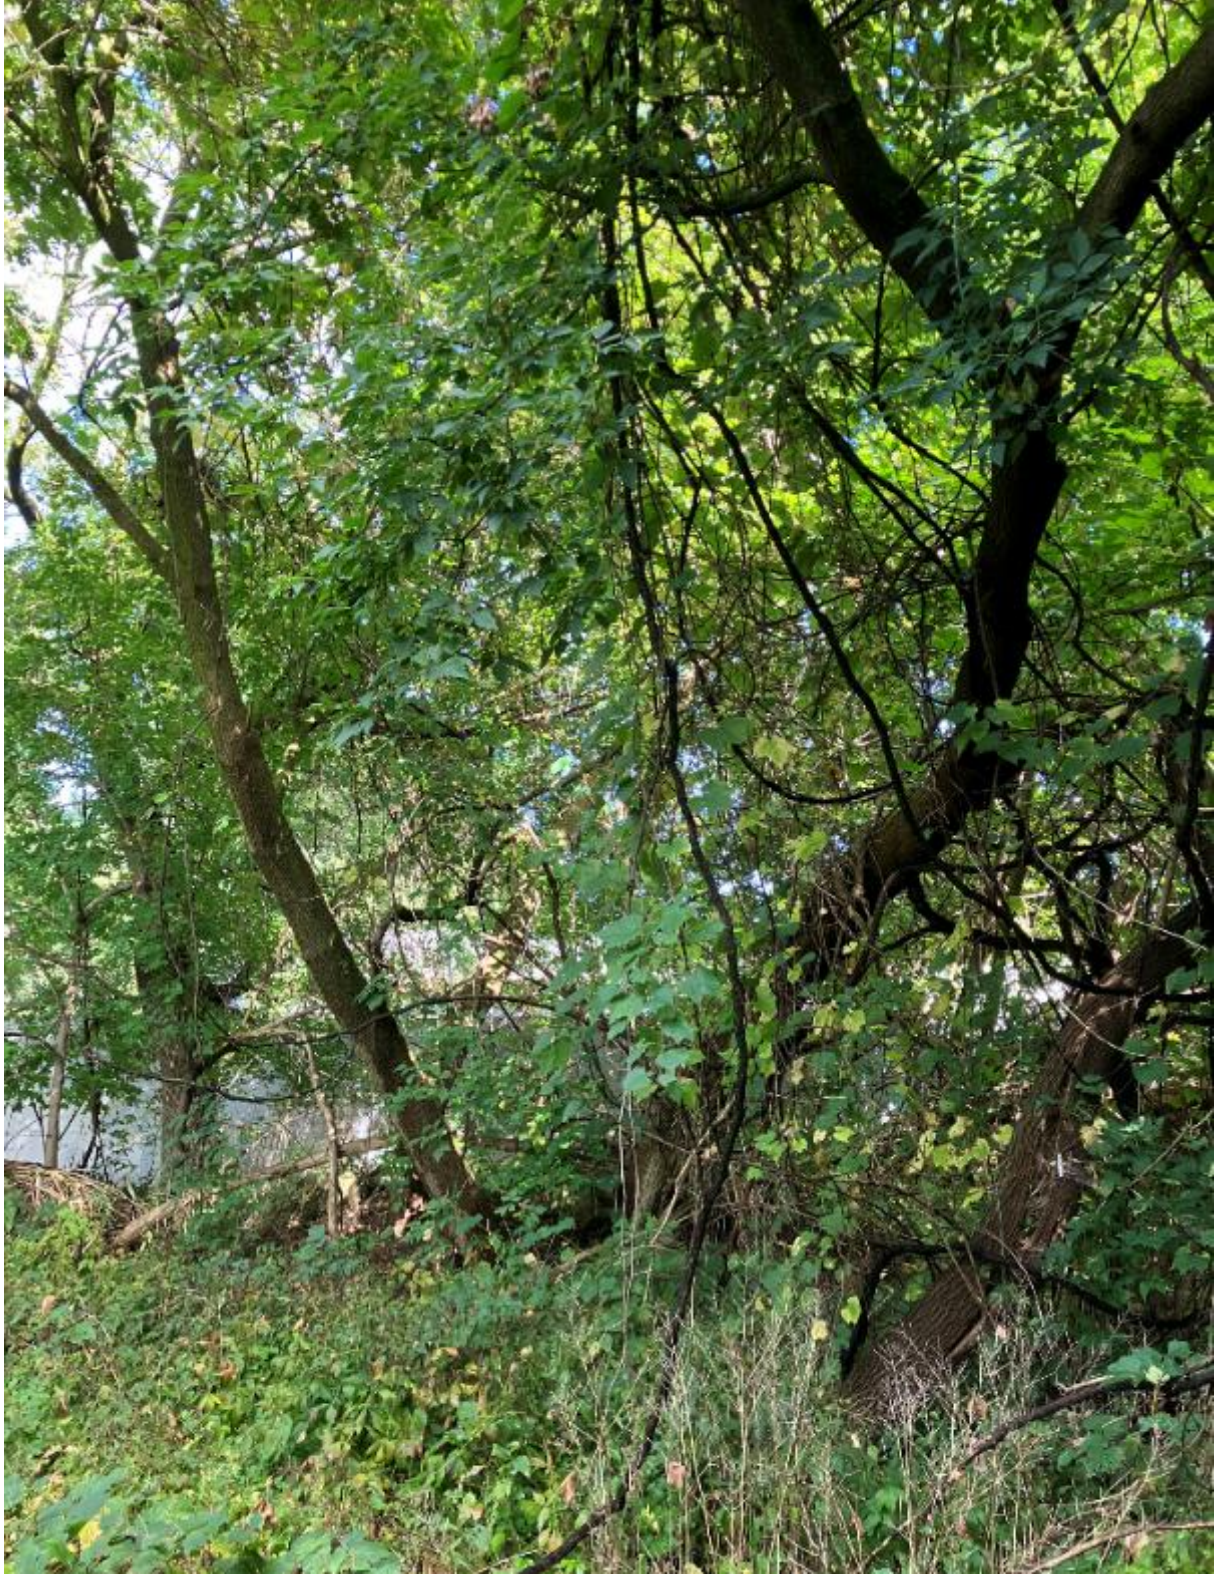
Figure 7: View of trees #24-30 growing from rubble pile in northeast end of property.

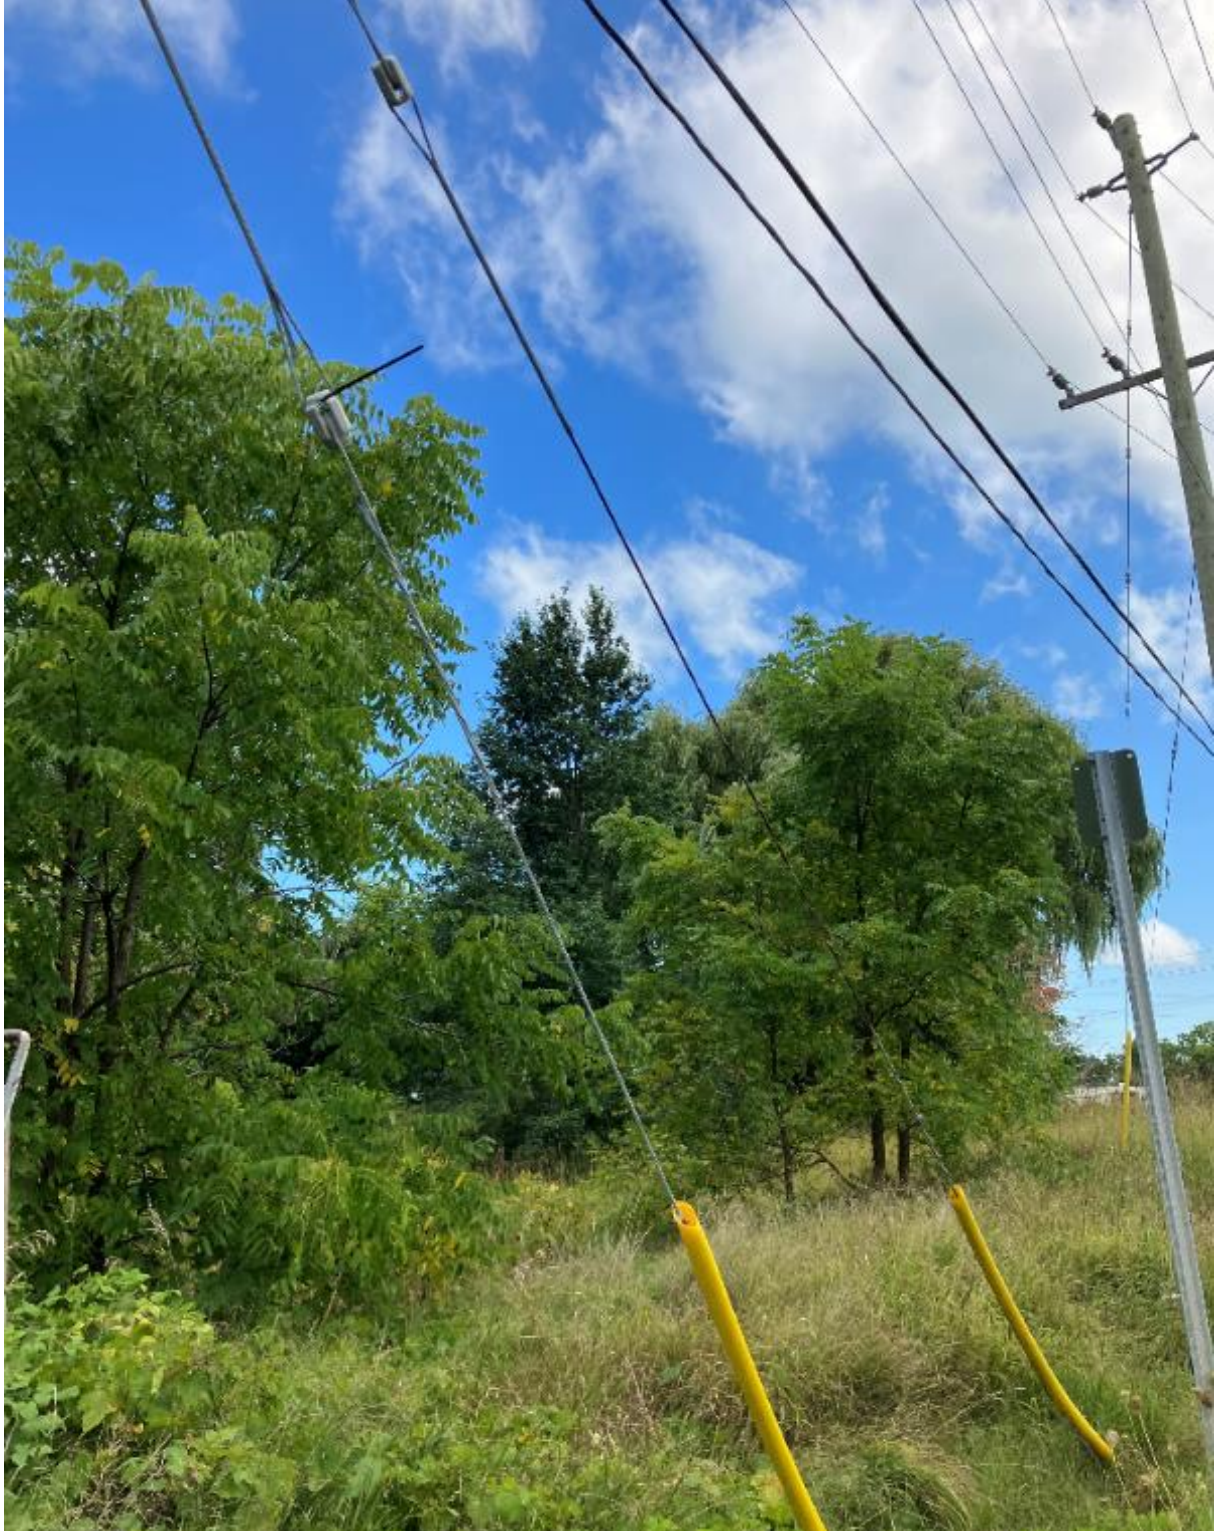
- Trees #44 and 45 are two Black Walnut trees along the roadway on Southcote Rd on the west side of the property. Both trees are growing as volunteers and are not maintained as street trees.

Figure 9: Trees #44 and 45 at right and left in boulevard along Southcote Rd, looking southeast.

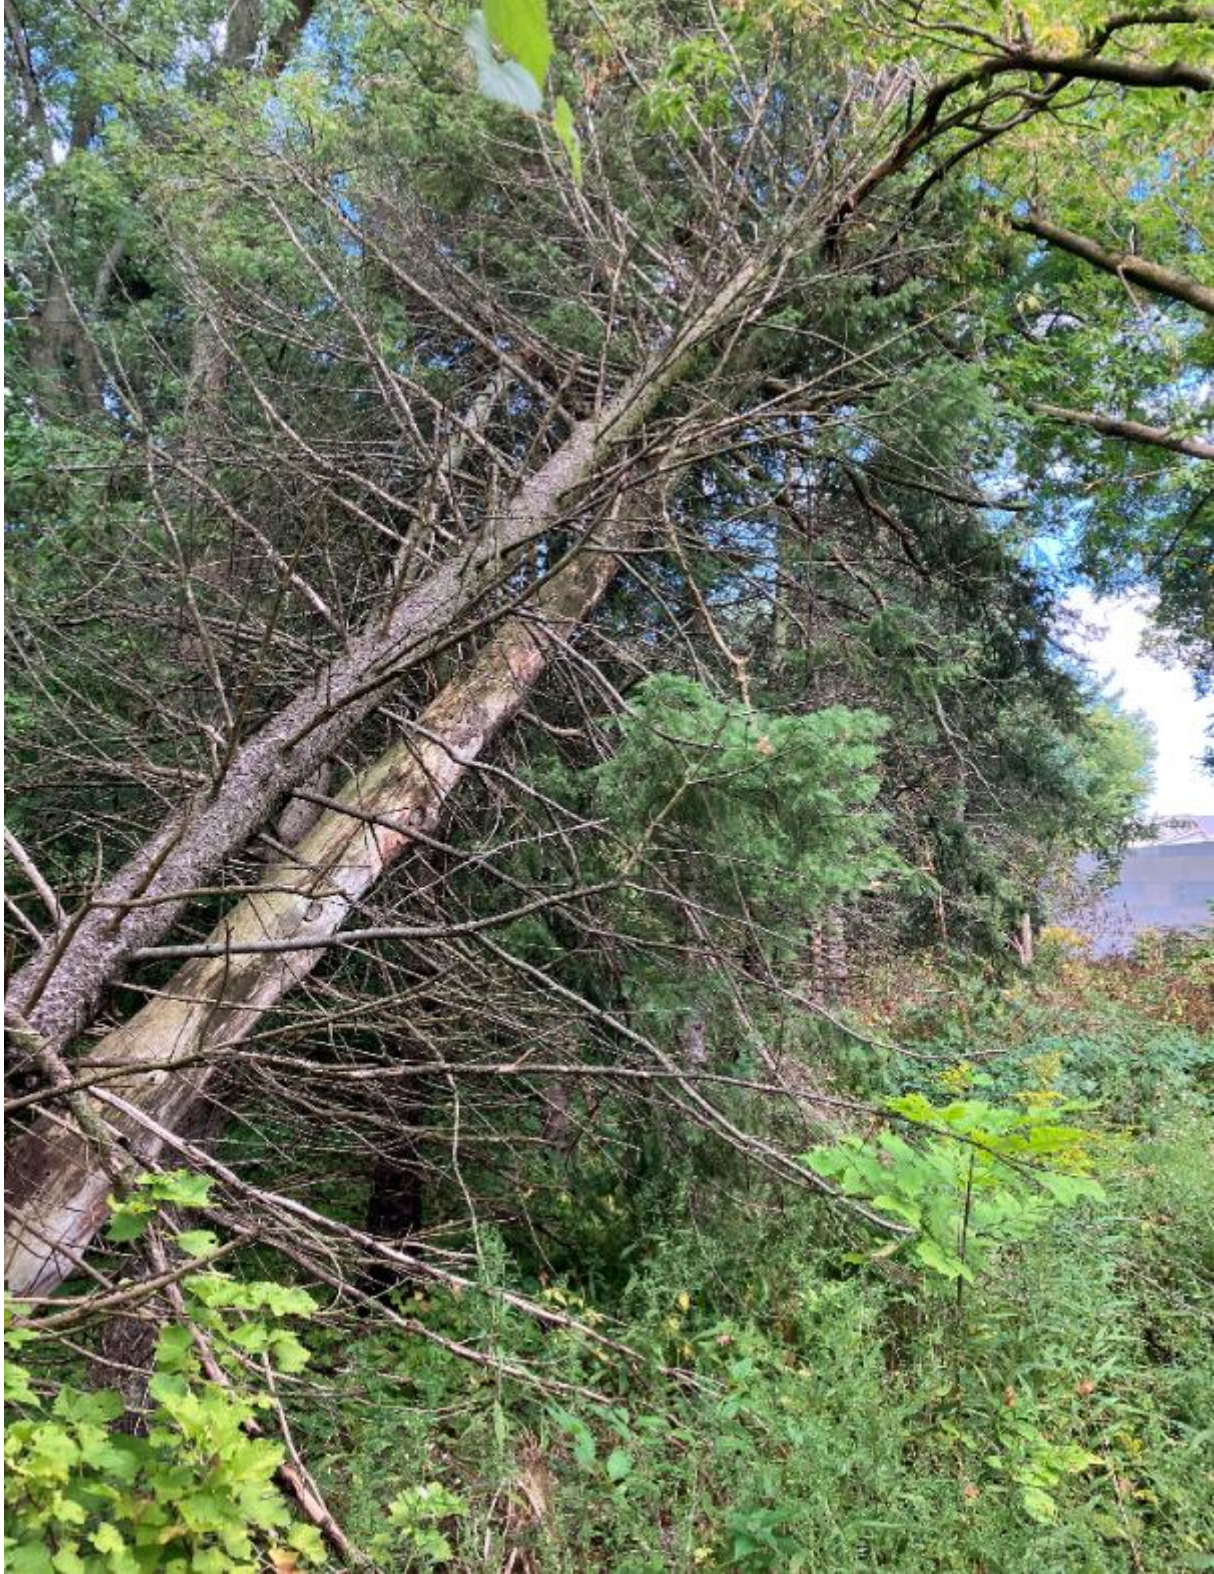
- Trees #48, 49, 56, 66, and 70 are within 509 Southcote Rd and far enough away from the proposed construction to be retained with minor root loss. Low-impact root excavation by means of Hydro-Vac at 500psi or lower is recommended to expose roots for pruning prior to deep excavation for the underground parking garage. Permission of the neighbours will be required. Trees #56 and 66 qualify as Heritage Trees under Ancaster tree preservation by-laws, and additional permits will be required.

Figure 10: Trees #51-65 from right to left along north property boundary. Most trees in poor or dead condition and recommended for removal. Trees #56 and 66 in background to be preserved with minor injury during excavation.

- For Trees #48, 49, 56, 66, and 70, we recommend root excavation by low-pressure hydro vac supervised by a Certified Arborist to minimize the damage to the health and structure of the trees. Once roots are excavated, root pruning required is to be conducted by a Certified Arborist in order to minimize severance of anchor roots, which provide upright support for the tree. An Arborist should be present on site at all times when work is within the TPZ.

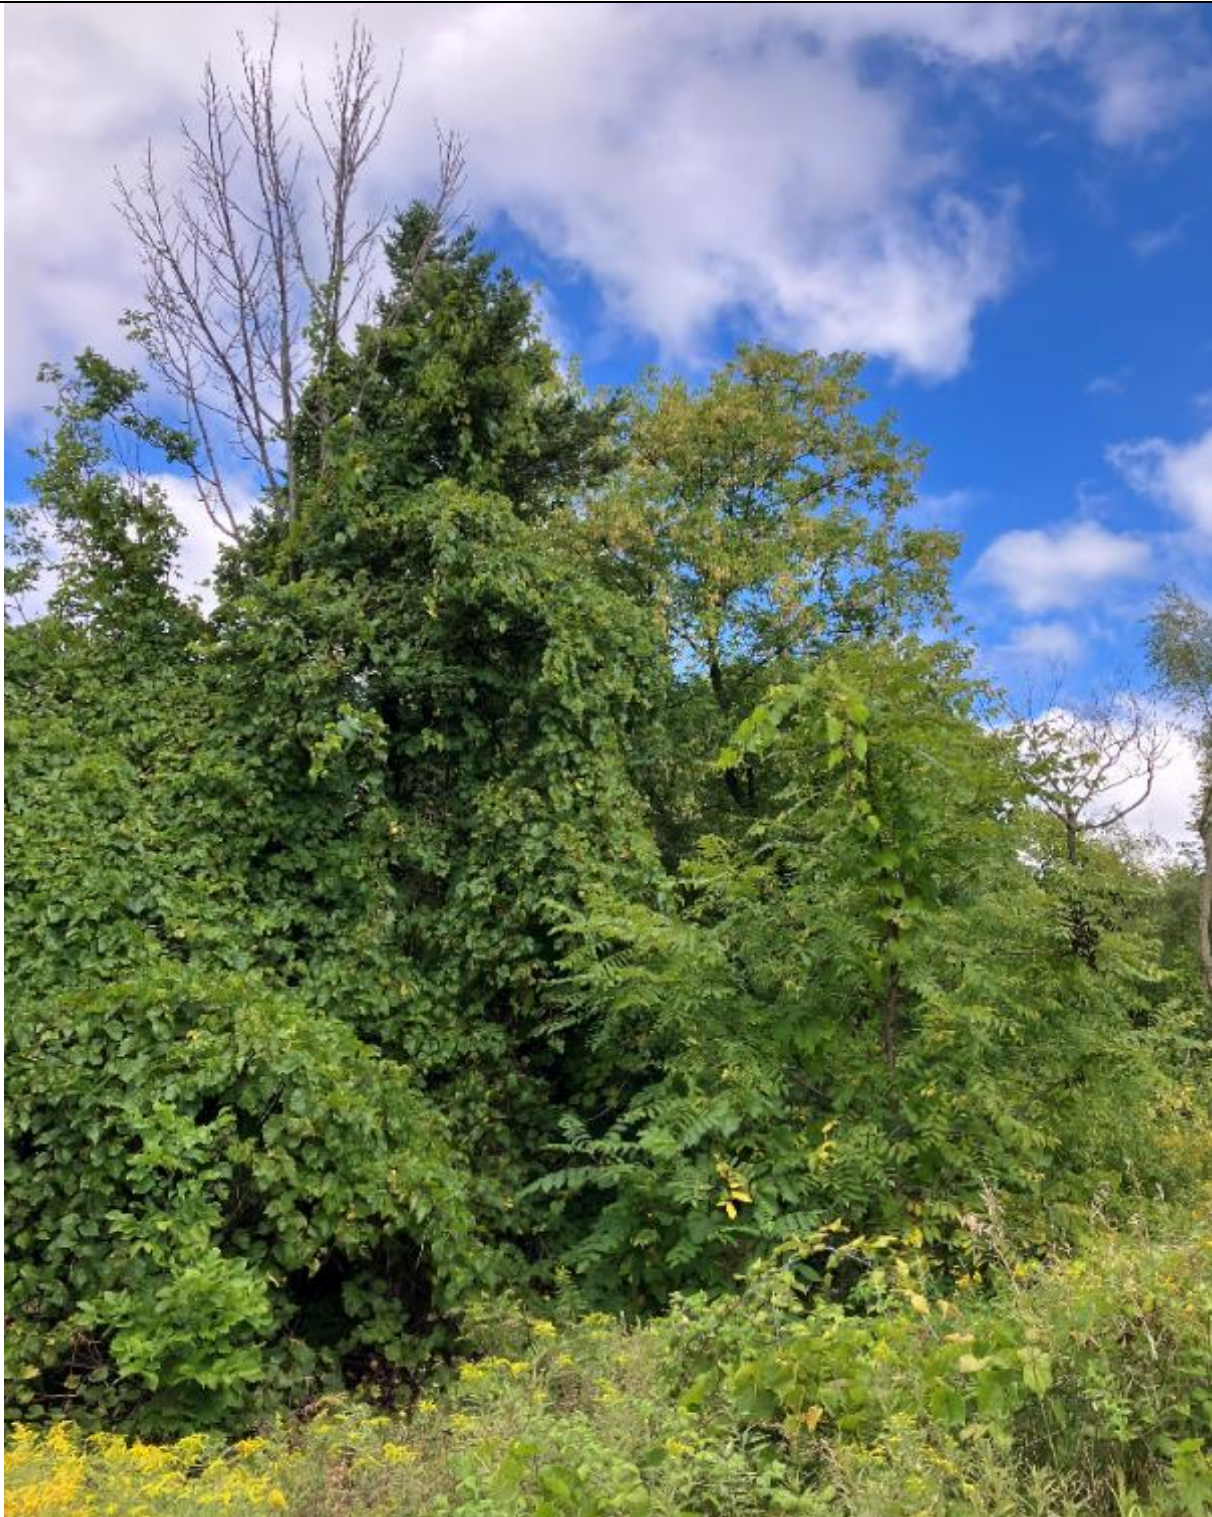
Figure 11: Trees #68-71 in inaccessible thicket overgrown with vines at northwest corner of property.
