Technical Design Brief: Tributary of Chedoke Creek Realignment

City of Hamilton, Ontario

Report Title: Technical Design Brief: Tributary of Chedoke Creek
Realignment, City of Hamilton

Project Number: PN19110
Status: Final
Version: 1.0
First Submission Date: July 24, 2020
Revision Date: --

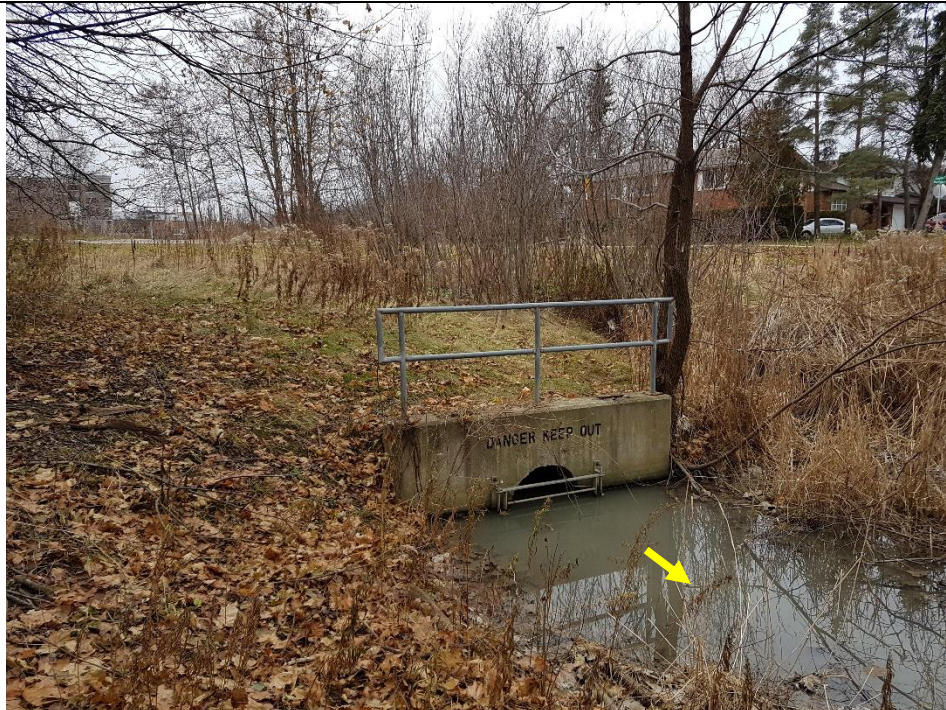
Photo 1
Tributary of Chedoke Creek, Hamilton, Ontario

Looking upstream at the furthest upstream extent assessed. The single channel flows through predominantly residential lands and exits a culvert downstream of Scenic Drive. Yellow arrow denotes flow direction.

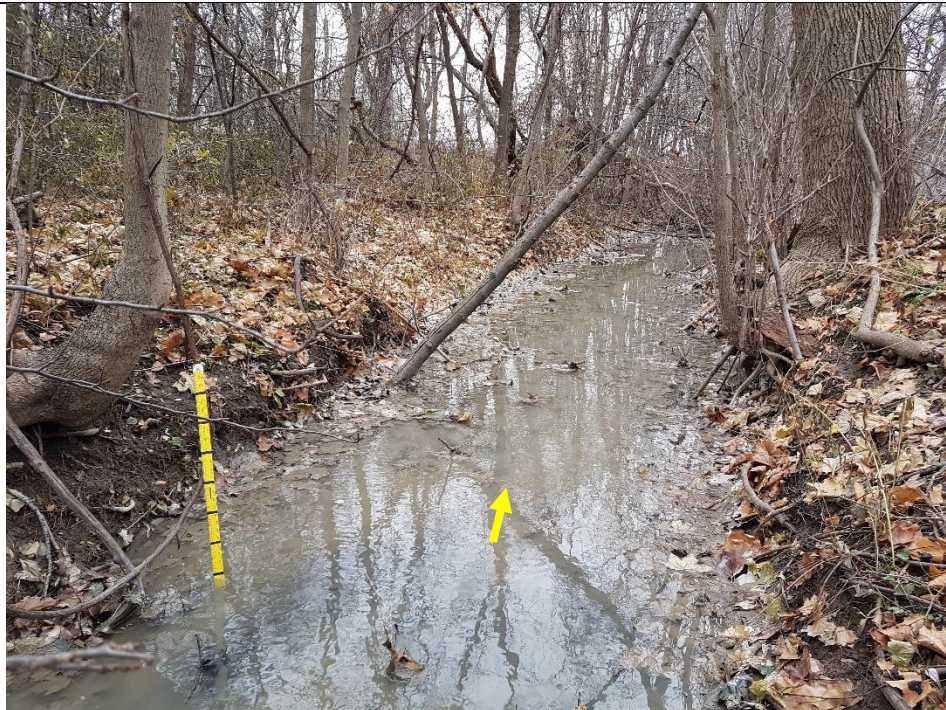
Photo 2
Tributary of Chedoke Creek, Hamilton, Ontario

Downstream view of the channel. Leaning and fallen trees, as well as exposed tree roots, were frequently noted through the extent of the reach and provided evidence of channel widening.

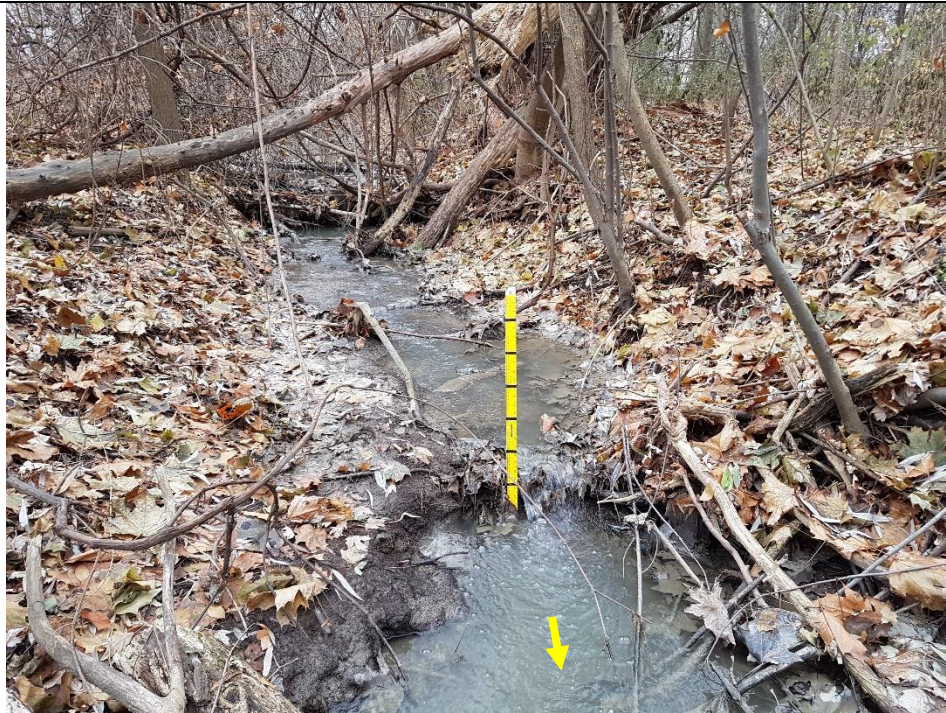
Photo 3
Tributary of Chedoke Creek, Hamilton, Ontario

Upstream view of the channel. A rooted knickpoint was observed with apparent head-cutting due to knickpoint migration upstream.

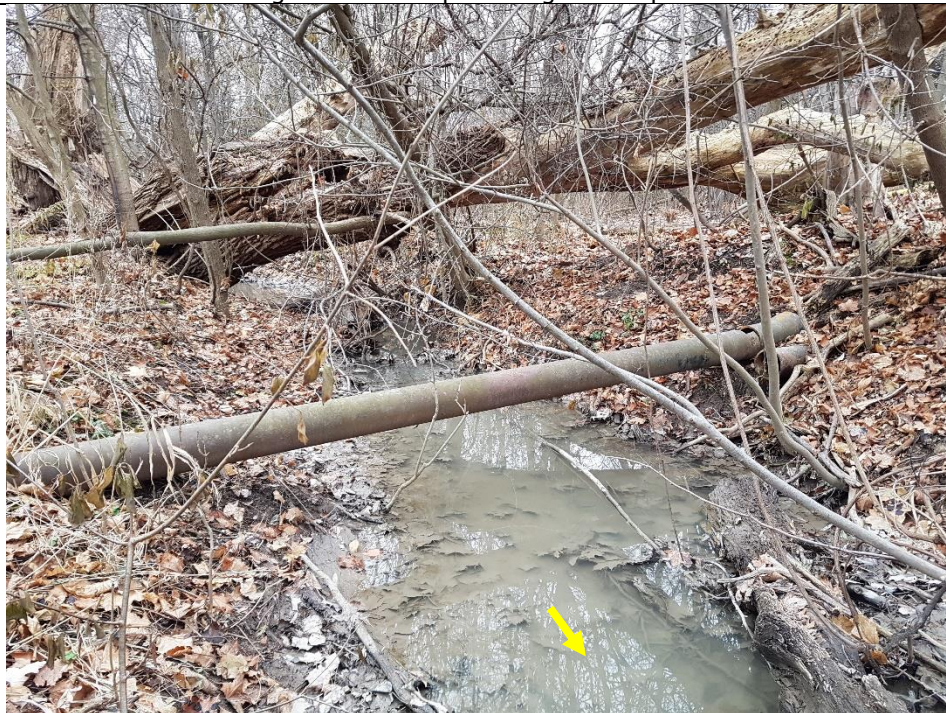
Photo 4
Tributary of Chedoke Creek, Hamilton, Ontario

An exposed length of previously buried pipe was observed. Occurrence of large organic debris and substrate fouling was common.

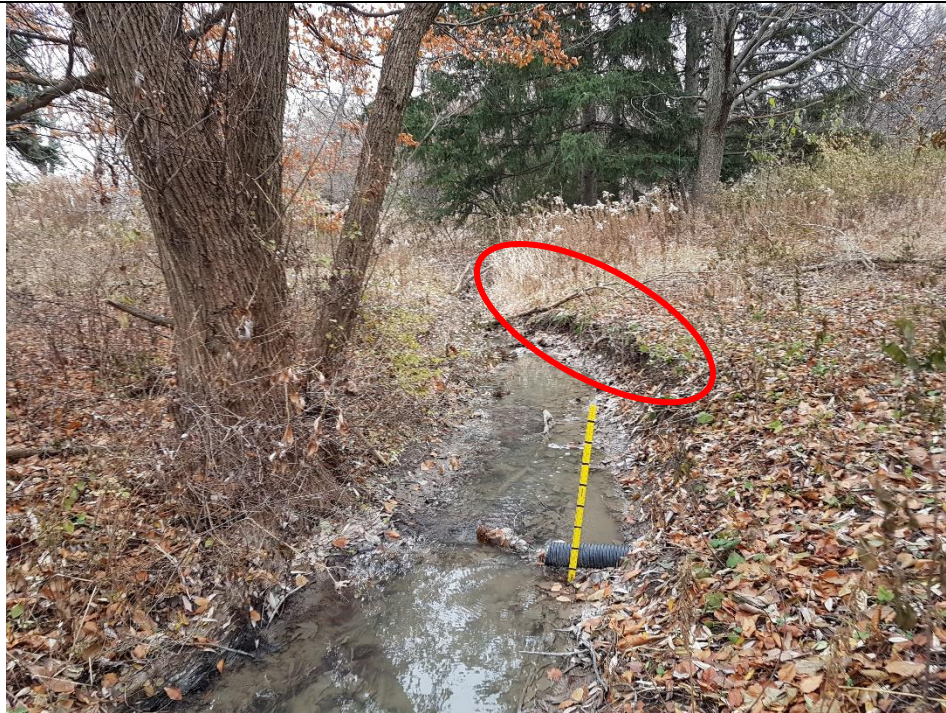
Photo 5
Tributary of Chedoke Creek, Hamilton, Ontario

Downstream view of the channel. Bank erosion was present through 60 to 100% of the subject reach and was observed through scouring of the channel banks (circled) and undercutting.

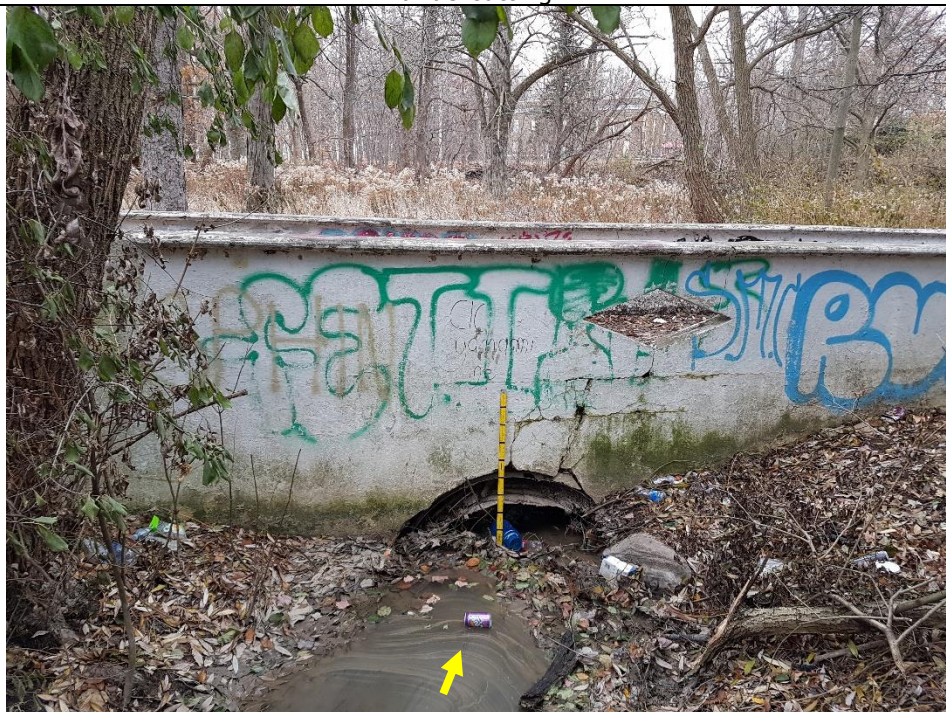
Photo 6
Tributary of Chedoke Creek, Hamilton, Ontario

The channel flows through a corrugated steel pipe (CSP) at a pedestrian crossing mid-reach. Upstream was dominated by runs indicating poor physical instream habitat.

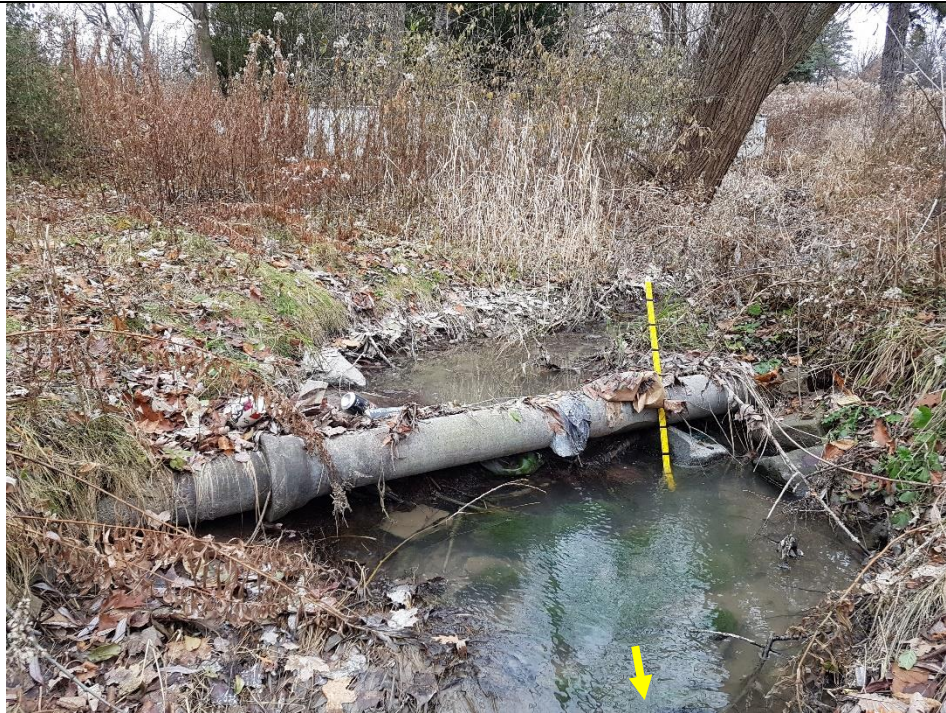
Photo 7
Tributary of Chedoke Creek, Hamilton, Ontario

An additional length of exposed sanitary/storm sewer/pipeline was observed downstream of the pedestrian crossing providing further evidence of degradation.

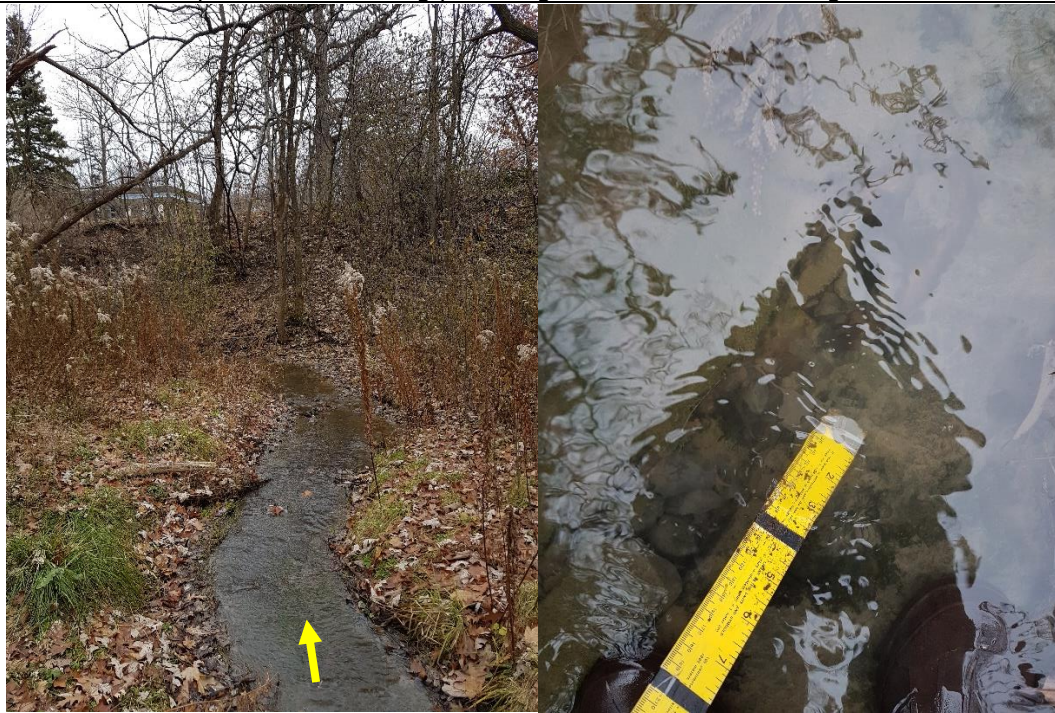
Photo 8
Tributary of Chedoke Creek, Hamilton, Ontario

At the downstream extent of the reach, the valley was partially confined and valley wall contact was observed. The channel was worn into bedrock (pictured on right).

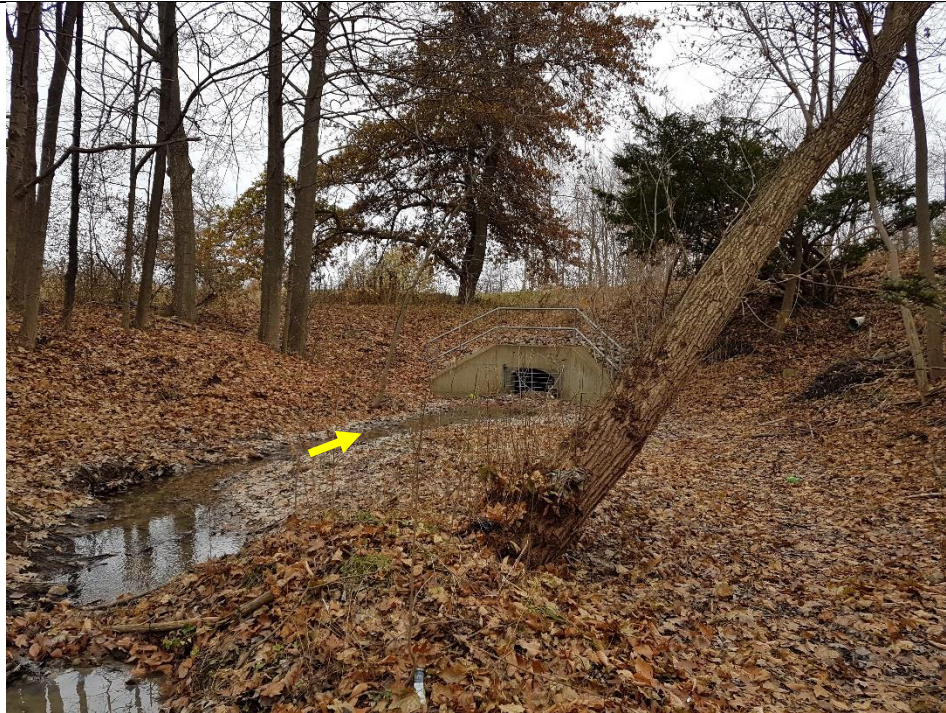
Photo 9
Tributary of Chedoke Creek, Hamilton, Ontario

At the downstream extent of the reach, the channel entered a culvert at Sanitorium Road. Evidence of widening and degradation were the key geomorphic indicators of channel stability through the reach.

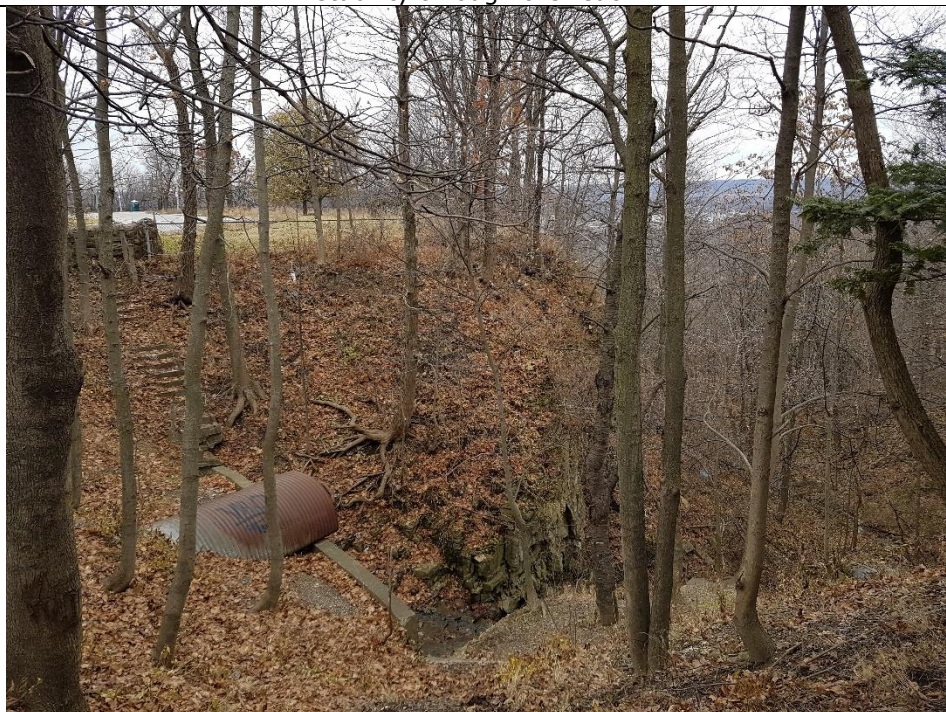
Photo 10
Tributary of Chedoke Creek, Hamilton, Ontario

Downstream of Sanitorium Road, a rapid change in gradient was observed. The valley was confined beyond the study limits.
