NOTE:
 Vegetation inventory undertaken by Carleigh Pope, ISA Certified Arborist (ON-2578A) on 2021-11-24.

PROJECT
 1177-1187 West 5th Street

SHEET
 Tree Protection Plan **L-1**

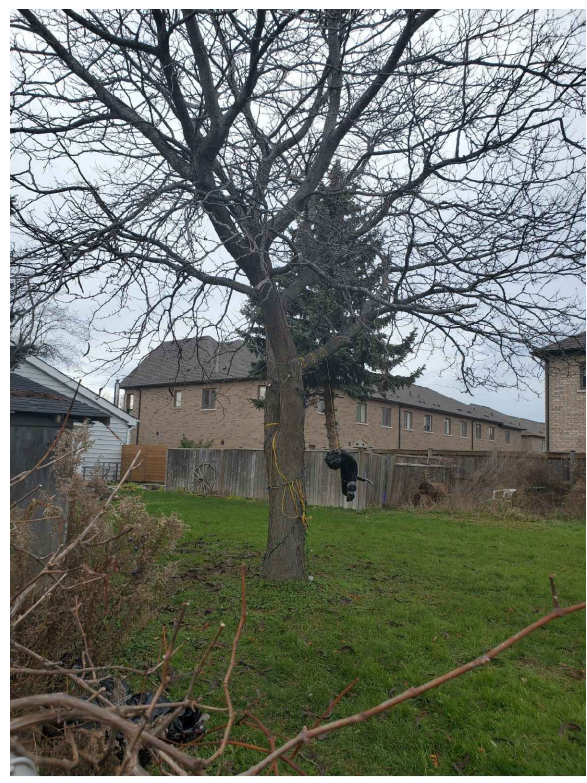
Tree 5

| Tree # | Species (Common Name) | Species (Botanical Name) | DBH (cm) | Crown Class* | Condition ** | Crown Width (m) | Comments | Potential Impacts from Construction | Ownership | Recommendation |
|---|---|---|---|---|---|---|---|---|---|---|
| 5 | Thornless Honeylocust | <i>Gleditsia triacanthos var. inermis</i> | 32 | D | G | 10 | Cord wrapped around trunk and branches, co-dominant leaders at 1.75m | mtpz encroachment due to proposed parking lot and curbs | Subject Site | REMOVE |

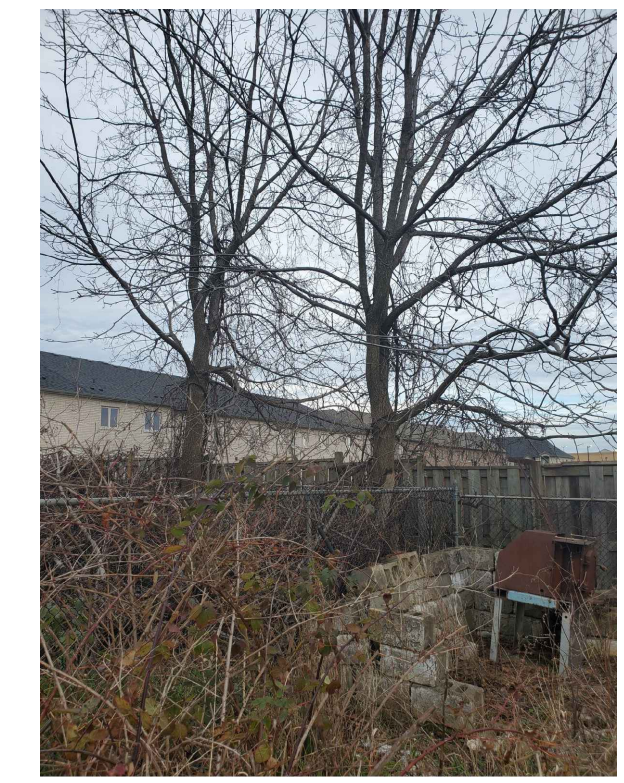
Trees 7-8

| Tree # | Species (Common Name) | Species (Botanical Name) | DBH (cm) | Crown Class* | Condition ** | Crown Width (m) | Comments | Potential Impacts from Construction | Ownership | Recommendation |
|---|---|---|---|---|---|---|---|---|---|---|
| 7 | Black Walnut | <i>Juglans nigra</i> | 28 | C | G-F | 6 | Grapevine competition, included bark, poor form | mtpz encroachment due to proposed parking lot | Boundary | REMOVE |
| 8 | Black Walnut | <i>Juglans nigra</i> | 25 | C | G-F | 5 | Grapevine competition, included bark, poor form | mtpz encroachment due to proposed parking lot | Boundary | REMOVE |

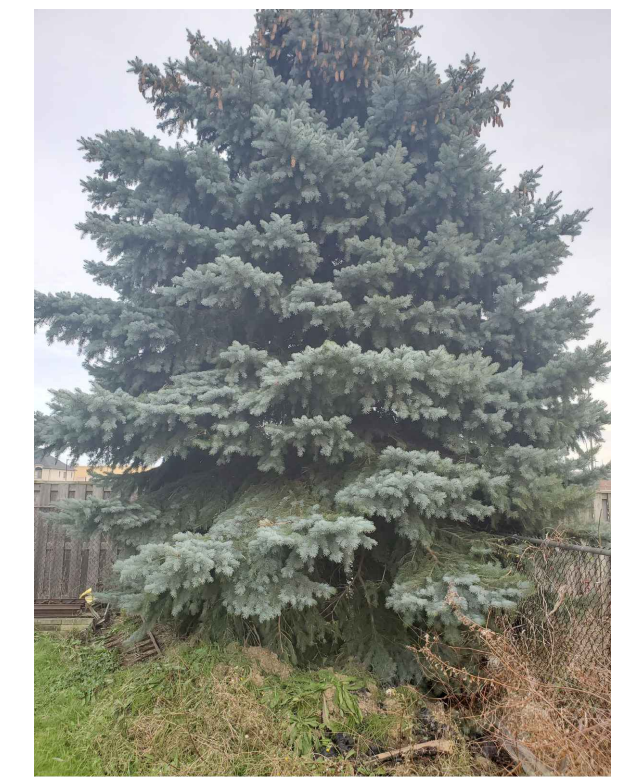
Tree 9

| Tree # | Species (Common Name) | Species (Botanical Name) | DBH (cm) | Crown Class* | Condition ** | Crown Width (m) | Comments | Potential Impacts from Construction | Ownership | Recommendation |
|---|---|---|---|---|---|---|---|---|---|---|
| 9 | Colorado Blue Spruce | <i>Picea pungens var. Glauca</i> | 34 | D | G | 7 | Soil piled around base | mtpz encroachment due to proposed parking lot | Subject Site | REMOVE |

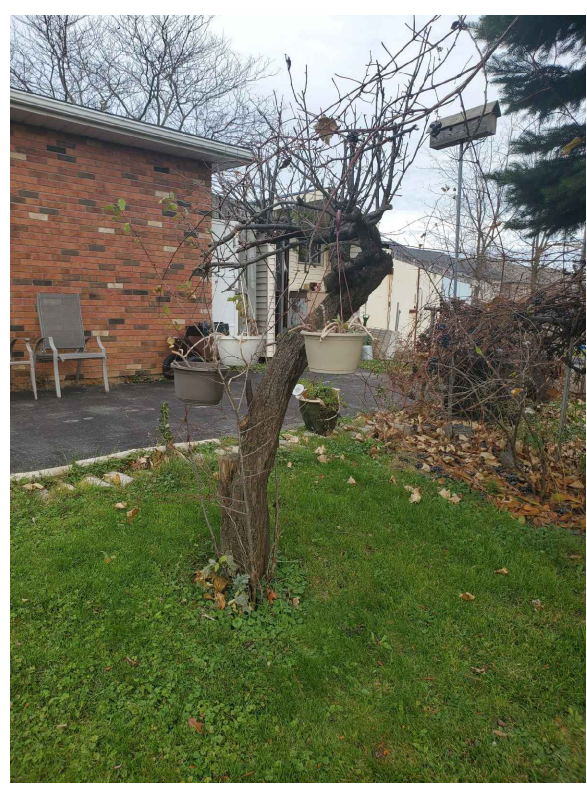
Tree 11

| Tree # | Species (Common Name) | Species (Botanical Name) | DBH (cm) | Crown Class* | Condition ** | Crown Width (m) | Comments | Potential Impacts from Construction | Ownership | Recommendation |
|---|---|---|---|---|---|---|---|---|---|---|
| 11 | Common Apple | <i>Malus sylvestris</i> | 14 | C | F-P | 2 | Heavily pruned, grapevine competition, healed longitudinal stem wound, watersprouts | mtpz encroachment due to proposed parking lot | Subject Site | REMOVE |

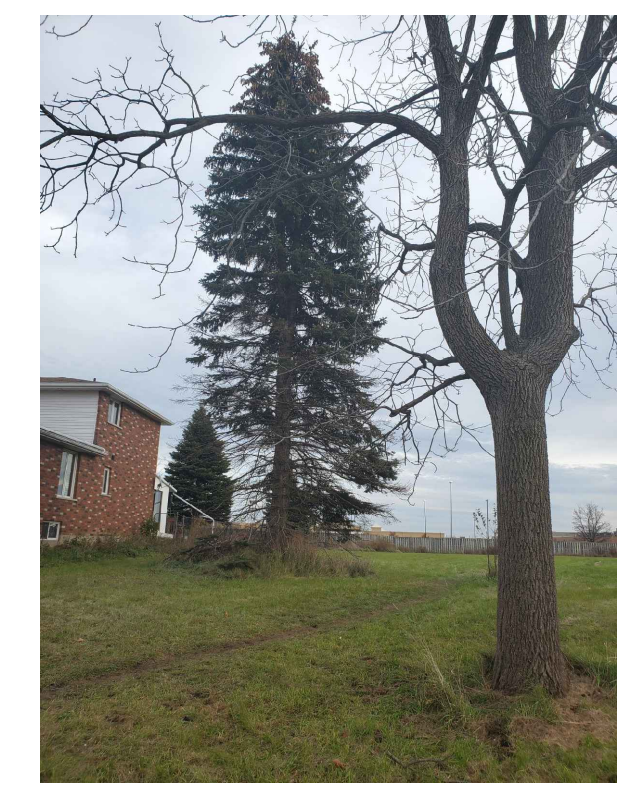
Trees 14-15

| Tree # | Species (Common Name) | Species (Botanical Name) | DBH (cm) | Crown Class* | Condition ** | Crown Width (m) | Comments | Potential Impacts from Construction | Ownership | Recommendation |
|---|---|---|---|---|---|---|---|---|---|---|
| 14 | Black Walnut | <i>Juglans nigra</i> | 46 | D | G | 9 | Broken branches in canopy (minor), 3 co-dominant leaders at 3m | mtpz encroachment due to proposed building footprint | Subject Site | REMOVE |
| 15 | Norway Spruce | <i>Picea abies</i> | 45 | D | F-P | 7 | Asymmetrical canopy, 30% canopy dieback | mtpz encroachment due to proposed building footprint | Subject Site | REMOVE |

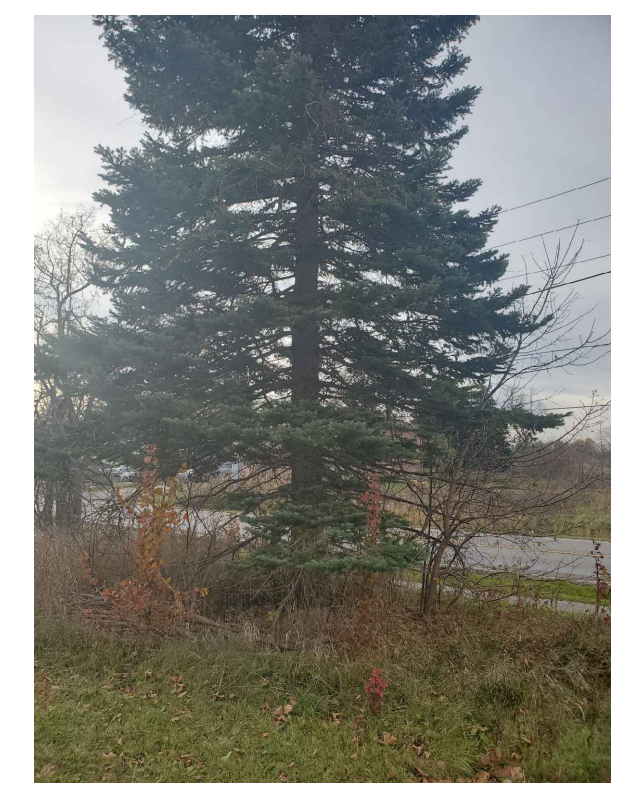
Trees 16-17

| Tree # | Species (Common Name) | Species (Botanical Name) | DBH (cm) | Crown Class* | Condition ** | Crown Width (m) | Comments | Potential Impacts from Construction | Ownership | Recommendation |
|---|---|---|---|---|---|---|---|---|---|---|
| 16 | White Mulberry | <i>Morus alba</i> | 8 | I | F | 4 | TREE NOT SURVEYED - light suppressed by Tree No. 18 | | Public | SAVE |
| 17 | Colorado Blue Spruce | <i>Picea pungens var. Glauca</i> | 44 | D | G | 7 | Grapevine competition, dead branches in canopy (minor) | | Public | SAVE |

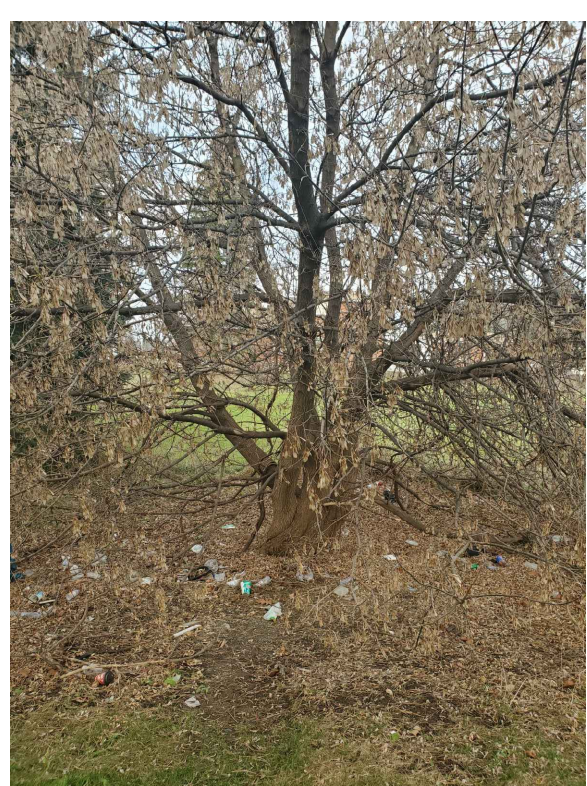
Tree 23

| Tree # | Species (Common Name) | Species (Botanical Name) | DBH (cm) | Crown Class* | Condition ** | Crown Width (m) | Comments | Potential Impacts from Construction | Ownership | Recommendation |
|---|---|---|---|---|---|---|---|---|---|---|
| 23 | Manitoba Maple | <i>Acer negundo</i> | 2x30, 2x24 | C | F | 10 | Poor form, broken and dead branches (moderate) | mtpz encroachment due to proposed building footprint and underground parking structure | Boundary | REMOVE |

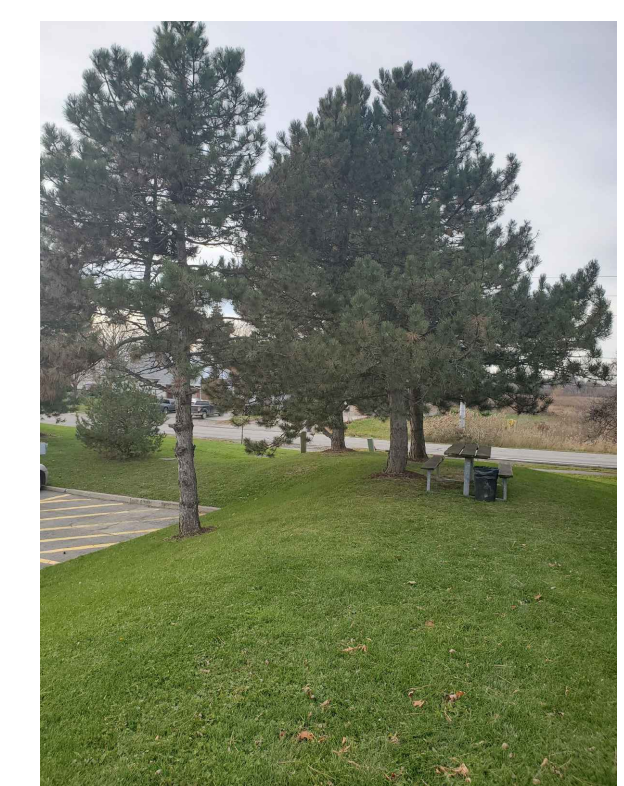
Trees 24-27

| Tree # | Species (Common Name) | Species (Botanical Name) | DBH (cm) | Crown Class* | Condition ** | Crown Width (m) | Comments | Potential Impacts from Construction | Ownership | Recommendation |
|---|---|---|---|---|---|---|---|---|---|---|
| 24 | Austrian Pine | <i>Pinus nigra</i> | 38 | C | F | 7 | Diplodia tip blight, asymmetrical canopy | | Neighbouring | SAVE |
| 25 | Austrian Pine | <i>Pinus nigra</i> | 39 | C | F | 7 | Diplodia tip blight, asymmetrical canopy | | Neighbouring | SAVE |
| 26 | Austrian Pine | <i>Pinus nigra</i> | 39 | C | F | 7 | Diplodia tip blight, asymmetrical canopy | | Neighbouring | SAVE |
| 27 | Austrian Pine | <i>Pinus nigra</i> | 32 | C | F | 6 | Diplodia tip blight, asymmetrical canopy | | Neighbouring | SAVE |

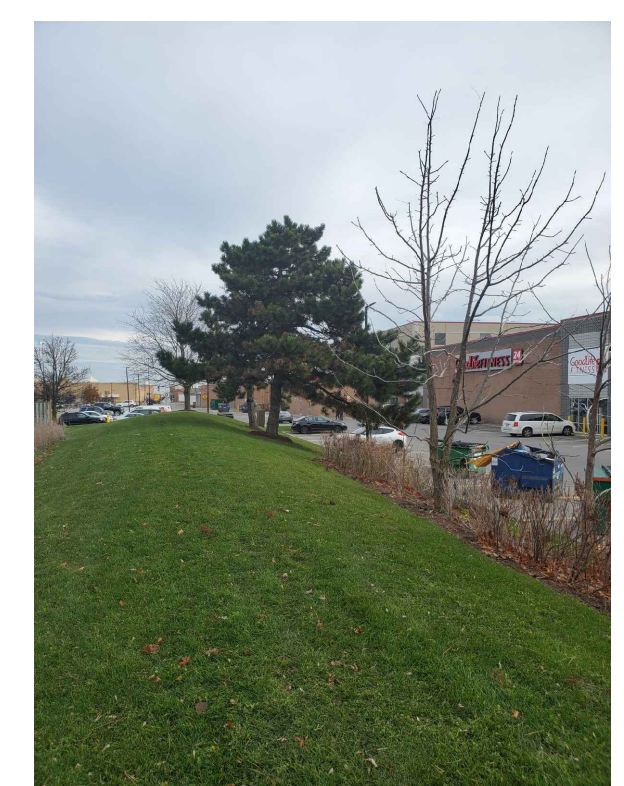
Trees 28-29

| Tree # | Species (Common Name) | Species (Botanical Name) | DBH (cm) | Crown Class* | Condition ** | Crown Width (m) | Comments | Potential Impacts from Construction | Ownership | Recommendation |
|---|---|---|---|---|---|---|---|---|---|---|
| 28 | Black Walnut | <i>Juglans nigra</i> | 15 | D | G | 5 | Co-dominant leaders at 0.5m | | Neighbouring | SAVE |
| 29 | Austrian Pine | <i>Pinus nigra</i> | 32 | D | G-F | 10 | Diplodia tip blight, asymmetrical canopy | | Neighbouring | SAVE |

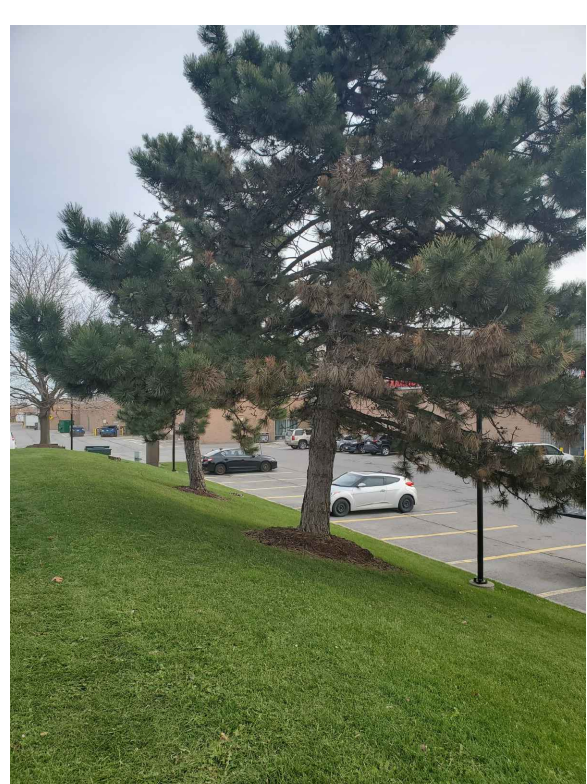
Trees 29-30

| Tree # | Species (Common Name) | Species (Botanical Name) | DBH (cm) | Crown Class* | Condition ** | Crown Width (m) | Comments | Potential Impacts from Construction | Ownership | Recommendation |
|---|---|---|---|---|---|---|---|---|---|---|
| 30 | Austrian Pine | <i>Pinus nigra</i> | 29 | D | G-F | 5 | Leaning south | | Neighbouring | SAVE |

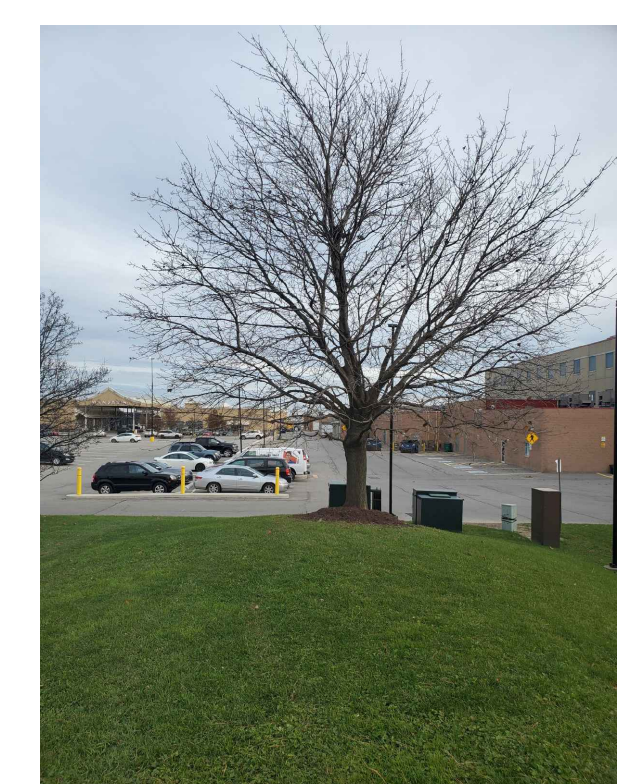
Tree 31

| Tree # | Species (Common Name) | Species (Botanical Name) | DBH (cm) | Crown Class* | Condition ** | Crown Width (m) | Comments | Potential Impacts from Construction | Ownership | Recommendation |
|---|---|---|---|---|---|---|---|---|---|---|
| 31 | Norway Maple | <i>Acer platanoides</i> | 34 | D | G | 10 | | | Neighbouring | SAVE |
