Phase Two Environmental Site Assessment

570, 580 Upper Ottawa Street, 1093, 1095, 1099, 1101, 1107, 1109, 1113,
1115 Fennell Avenue East, Hamilton, Ontario

HAM-00802070-A0

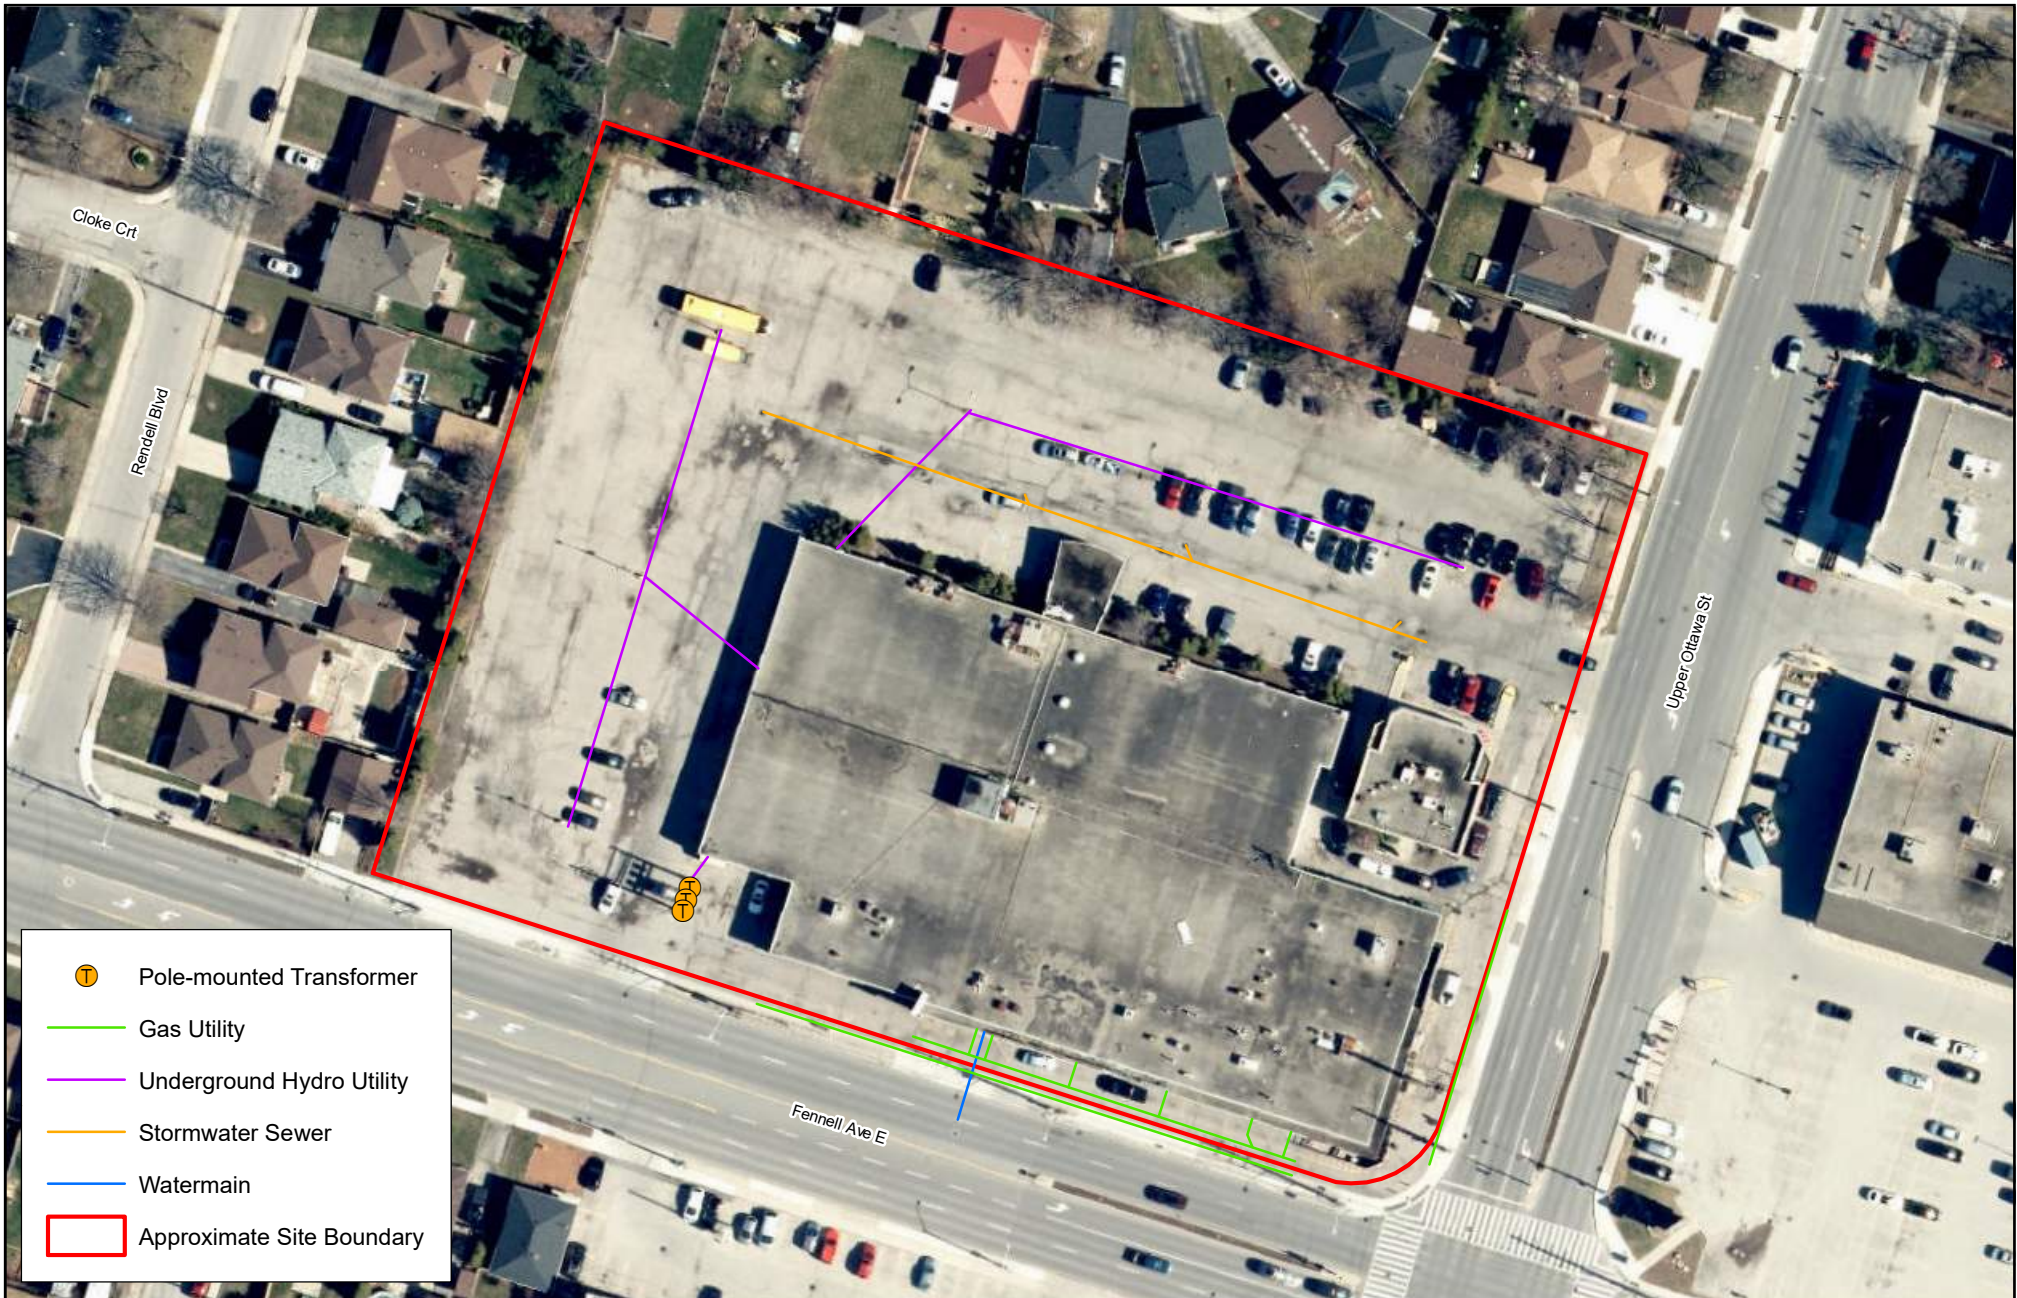
| DATE: NOVEMBER 2020 | FIG. No.: 3 |

TITLE AND LOCATION:
SITE PLAN AND UTILITIES
 Phase Two Environmental Site Assessment
 1093 - 1115 Fennell Avenue East and
 570, 580 Upper Ottawa Street
 Hamilton, Ontario

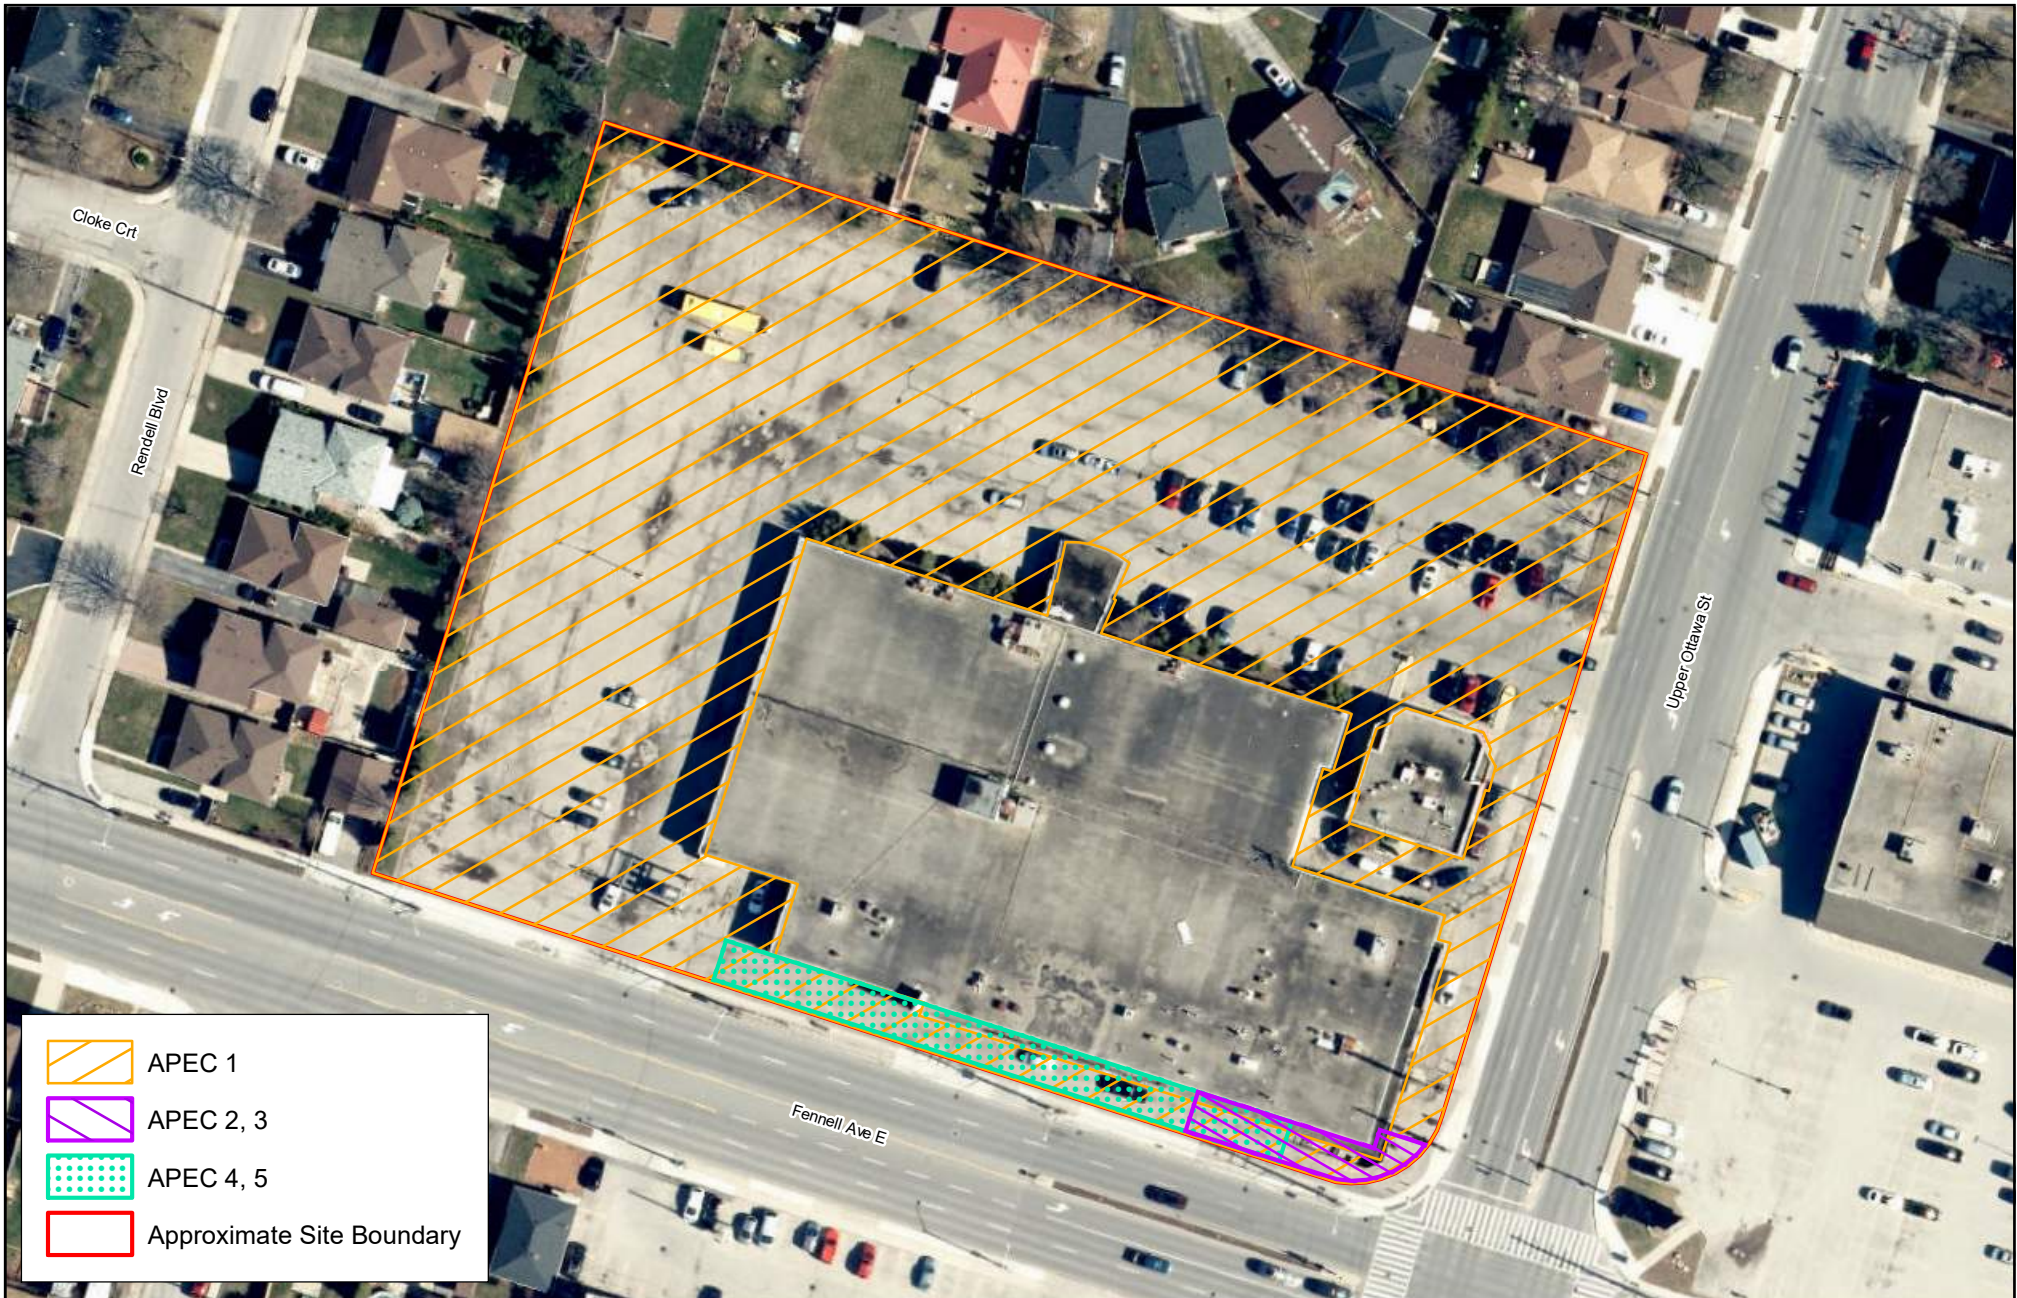
| | APEC 1 |
| | APEC 2, 3 |

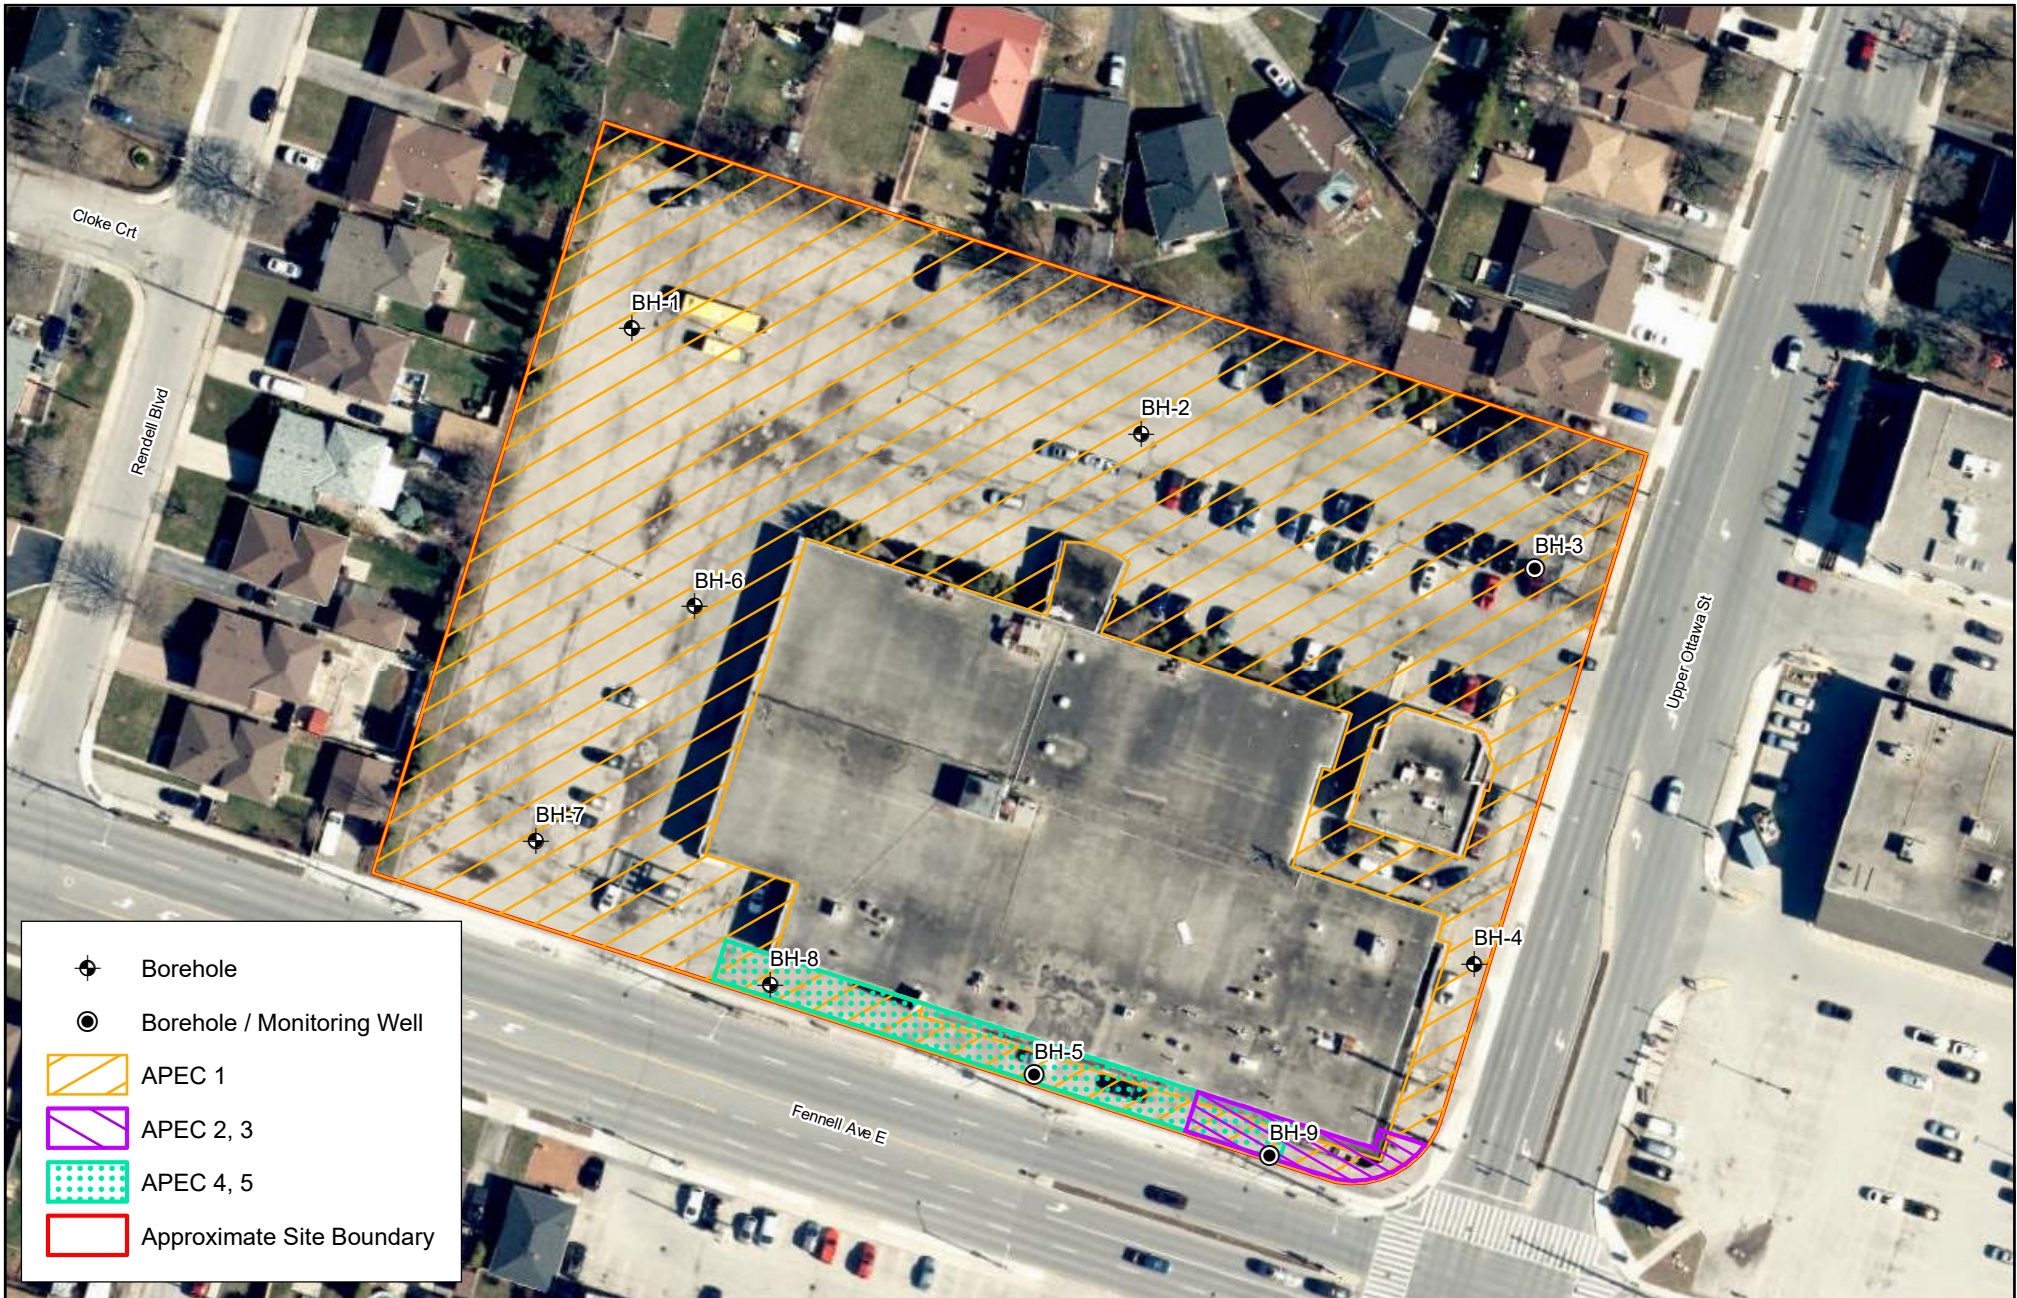
| DATE: NOVEMBER 2020 | FIG. No.: 5A |

- Borehole
- Borehole / Monitoring Well
- APEC 1
- APEC 2, 3
- APEC 4, 5
- Approximate Site Boundary

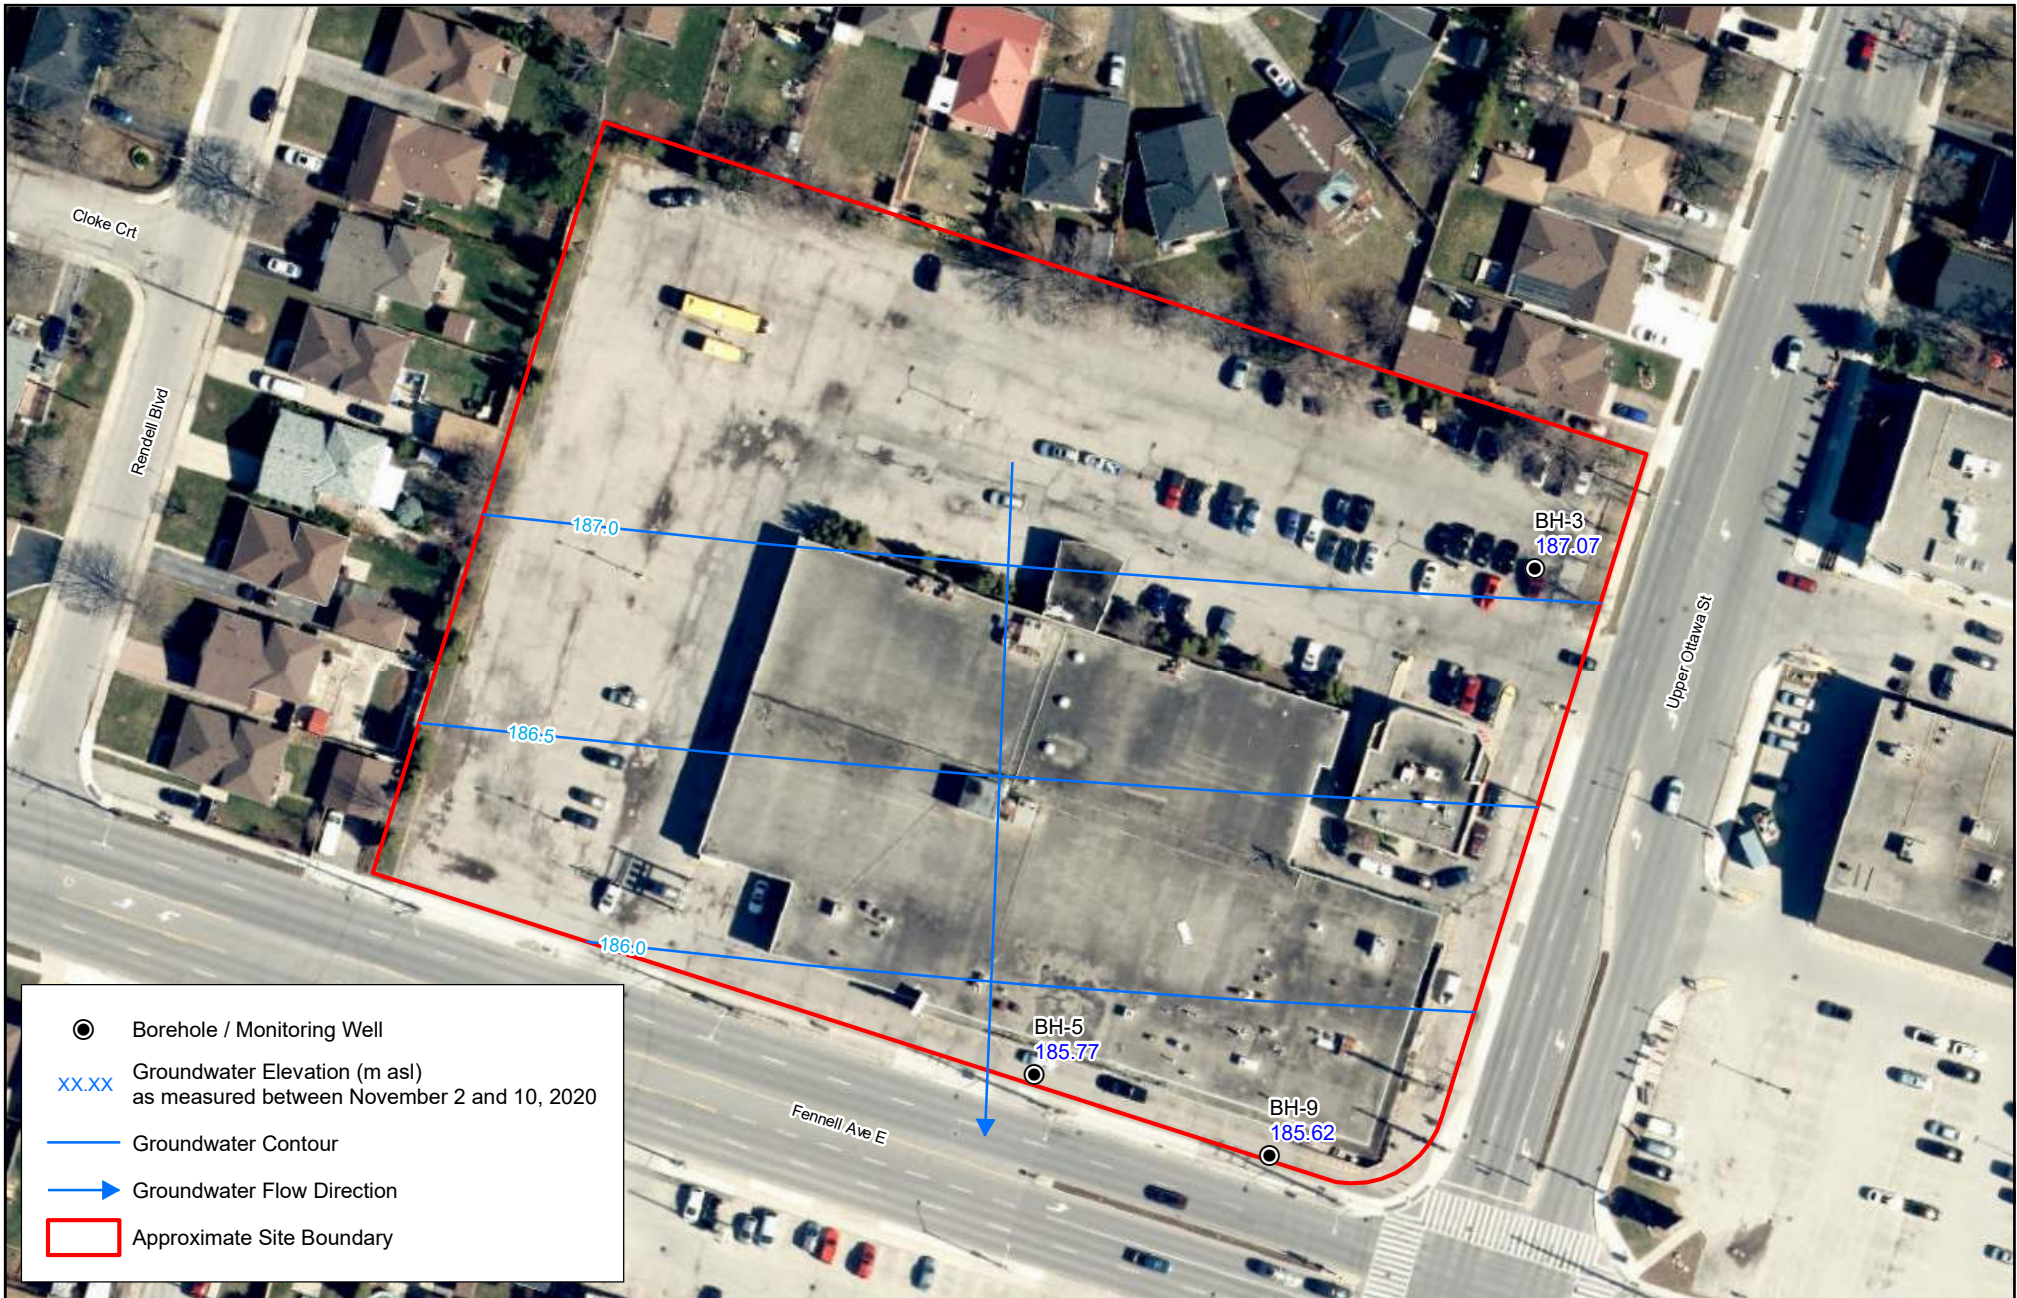
| DATE: NOVEMBER 2020 | FIG. No.: 6 |

- Borehole / Monitoring Well
- XX.XX Groundwater Elevation (m asl)
as measured between November 2 and 10, 2020
- Groundwater Contour
- ➔ Groundwater Flow Direction
- ▭ Approximate Site Boundary

- The horizontal hydraulic gradient on-Site ranged from 0.014 m/m (between MW3 and MW5) and 0.004 m/m (between MW5 and MW9).
- Soil samples were submitted for the analysis of petroleum hydrocarbons (PHCs), benzene, toluene, ethylbenzene and xylenes (BTEX) and/or metals. An exceedance of zinc above the MECP Table 3 SCS was noted at BH2 SS2 and BH4 SS2. All

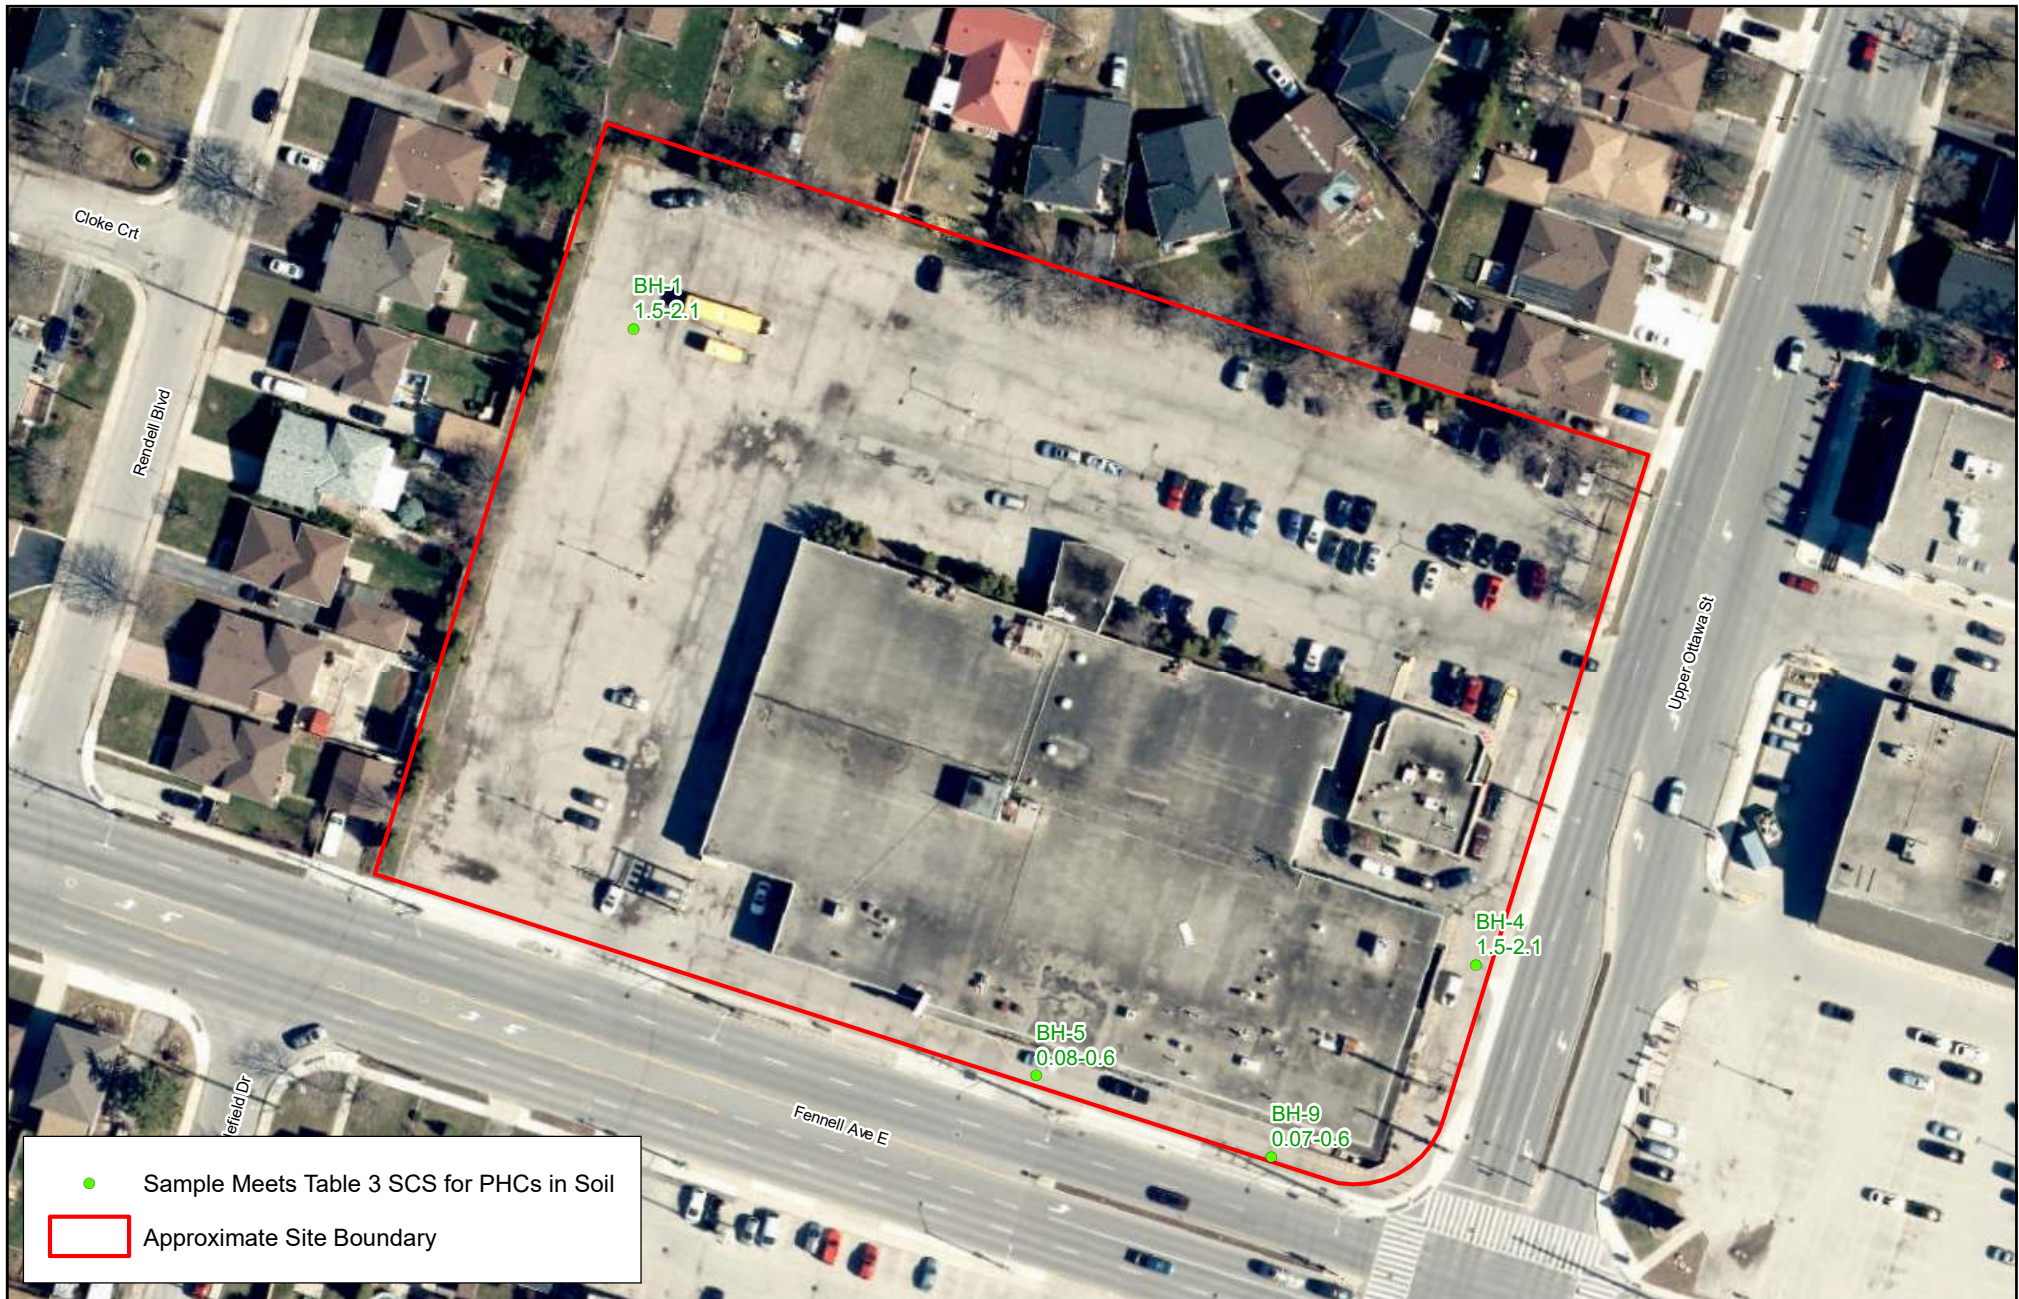
| DATE: NOVEMBER 2020 | FIG. No.: 7 |

● Sample Meets Table 3 SCS for PHCs in Soil
 □ Approximate Site Boundary

TITLE AND LOCATION:
**SOIL ANALYTICAL RESULTS -
 PETROLEUM HYDROCARBONS (PHCs)**
 Phase Two Environmental Site Assessment
 1093 - 1115 Fennell Avenue East and
 570, 580 Upper Ottawa Street
 Hamilton, Ontario

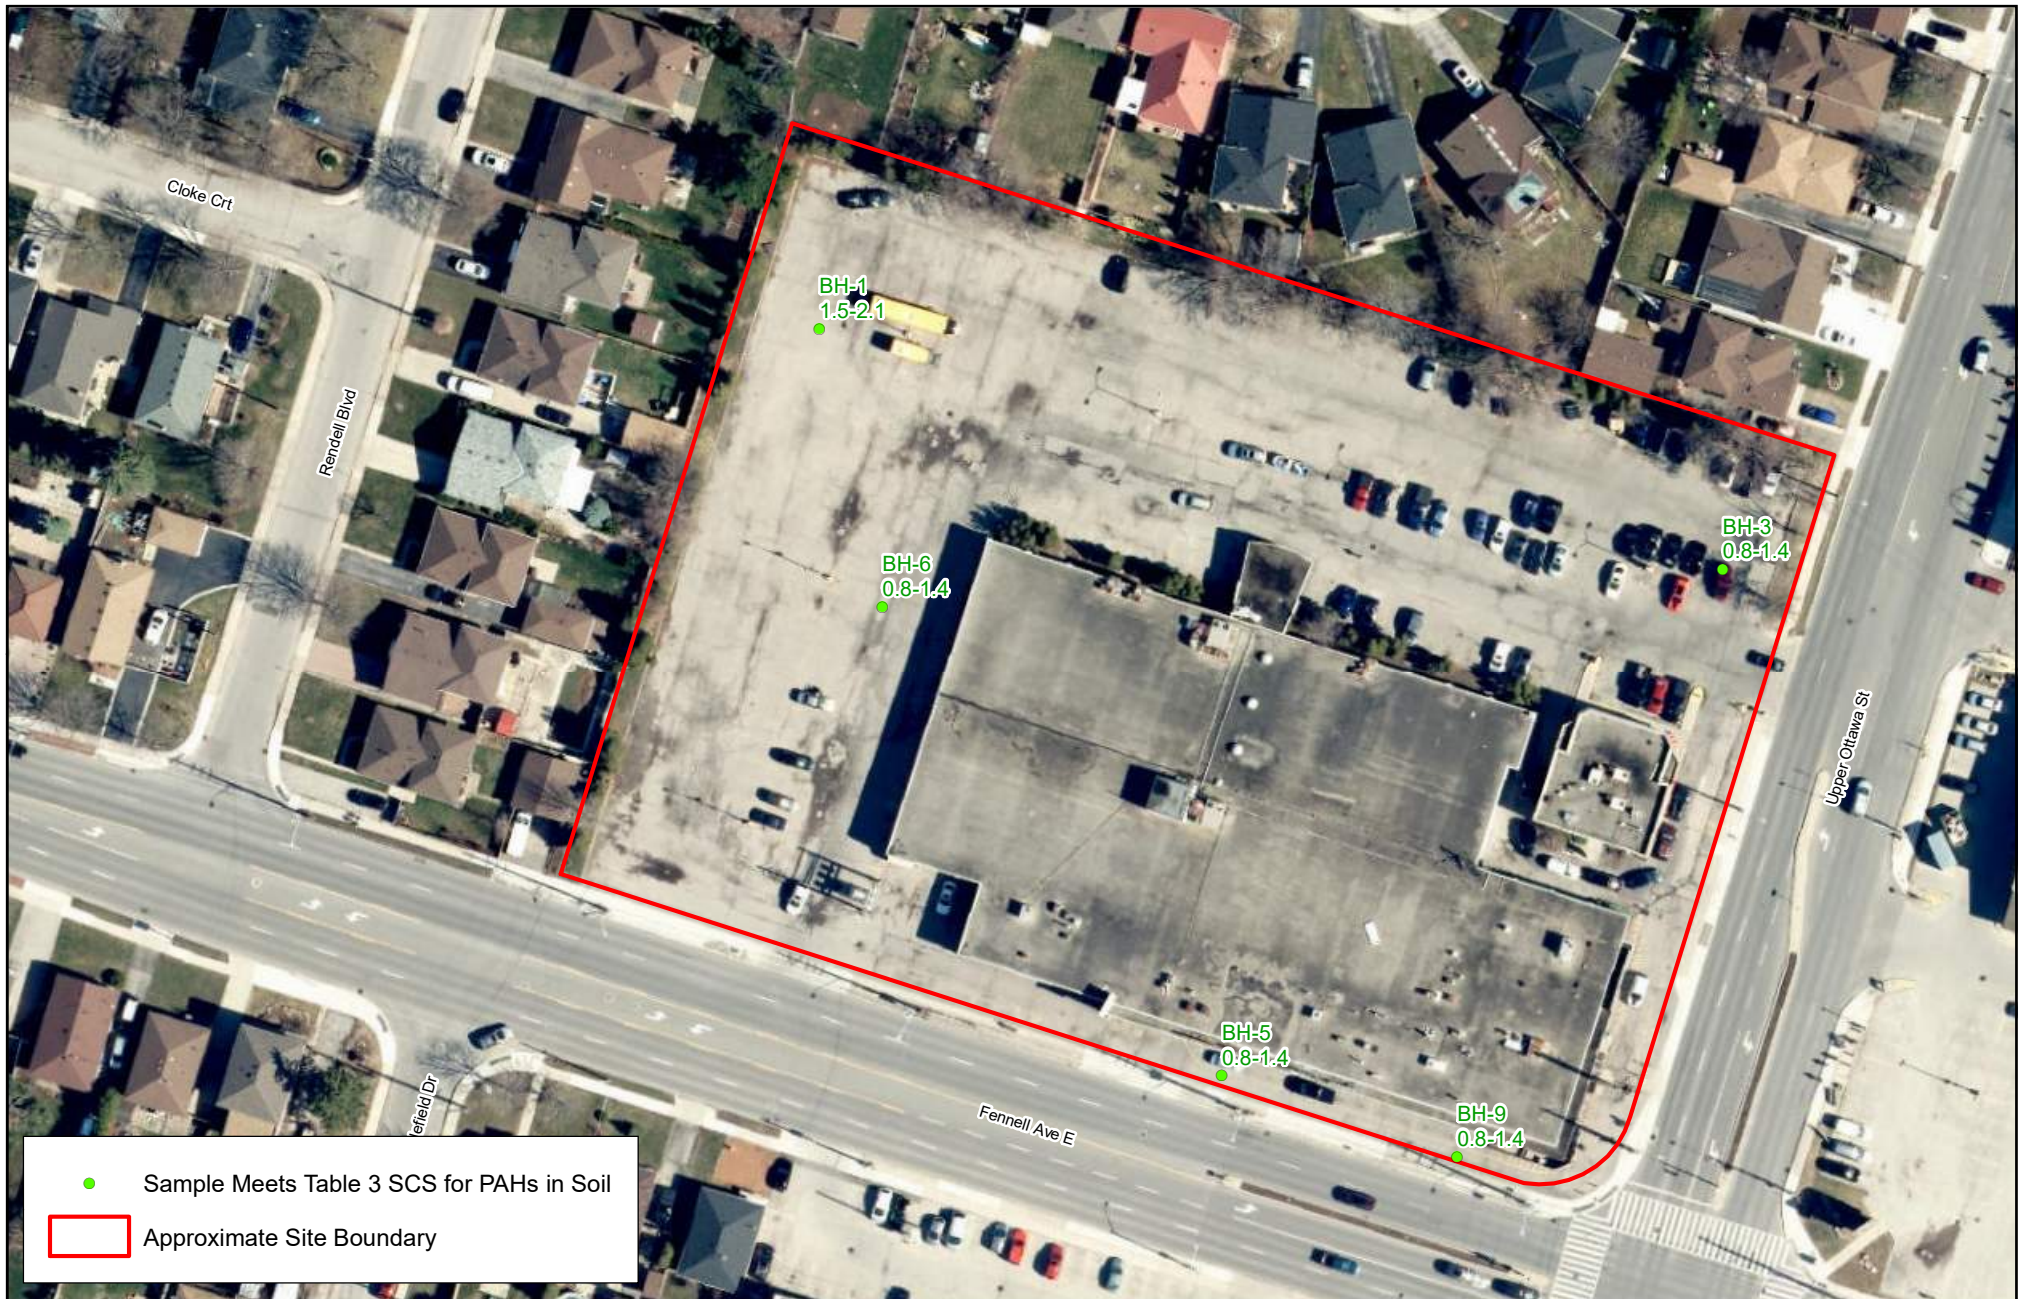
| DATE: | NOVEMBER 2020 | FIG. No.: | 9 |

● Sample Meets Table 3 SCS for PAHs in Soil
 □ Approximate Site Boundary

TITLE AND LOCATION:
**SOIL ANALYTICAL RESULTS -
 POLYCYCLIC AROMATIC HYDROCARBONS (PAHs)**
 Phase Two Environmental Site Assessment
 1093 - 1115 Fennell Avenue East and
 570, 580 Upper Ottawa Street
 Hamilton, Ontario

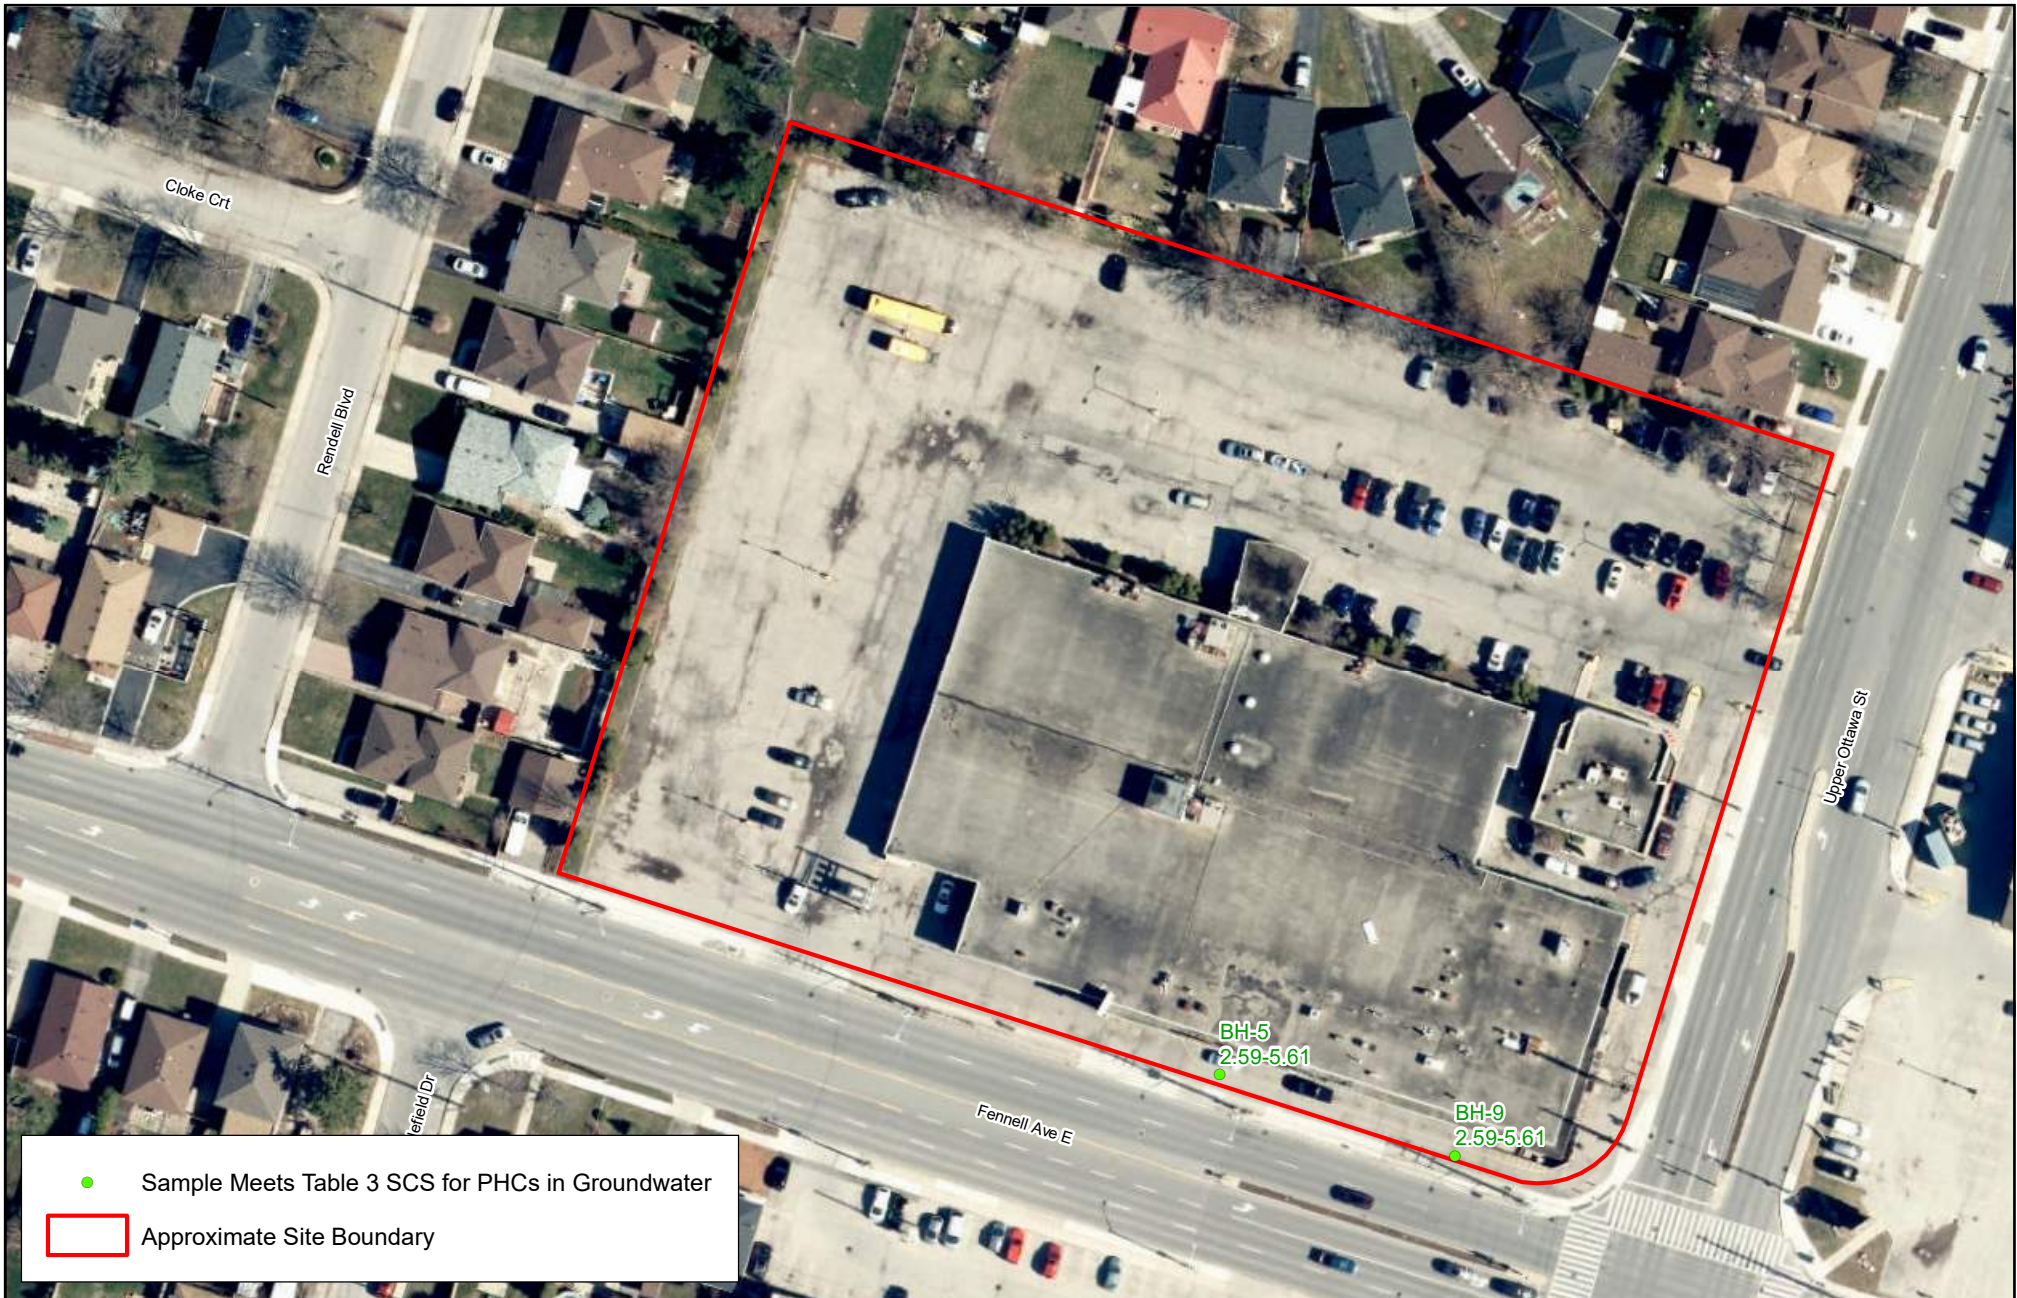
| DATE: | NOVEMBER 2020 | FIG. No.: | 10 |

● Sample Meets Table 3 SCS for PHCs in Groundwater
 □ Approximate Site Boundary

TITLE AND LOCATION:
**GROUNDWATER ANALYTICAL RESULTS -
 PETROLEUM HYDROCARBONS (PHCs)**
 Phase Two Environmental Site Assessment
 1093 - 1115 Fennell Avenue East and
 570, 580 Upper Ottawa Street
 Hamilton, Ontario

- Groundwater samples were submitted for the analysis of PHCs and VOCs. All parameters were either non-detected or detected below their applicable MECP (2011) Table 3 SCS.
- No evidence of free product (i.e. visible film or sheen), or odour was observed during soil sampling, groundwater purging, or groundwater sampling activities.

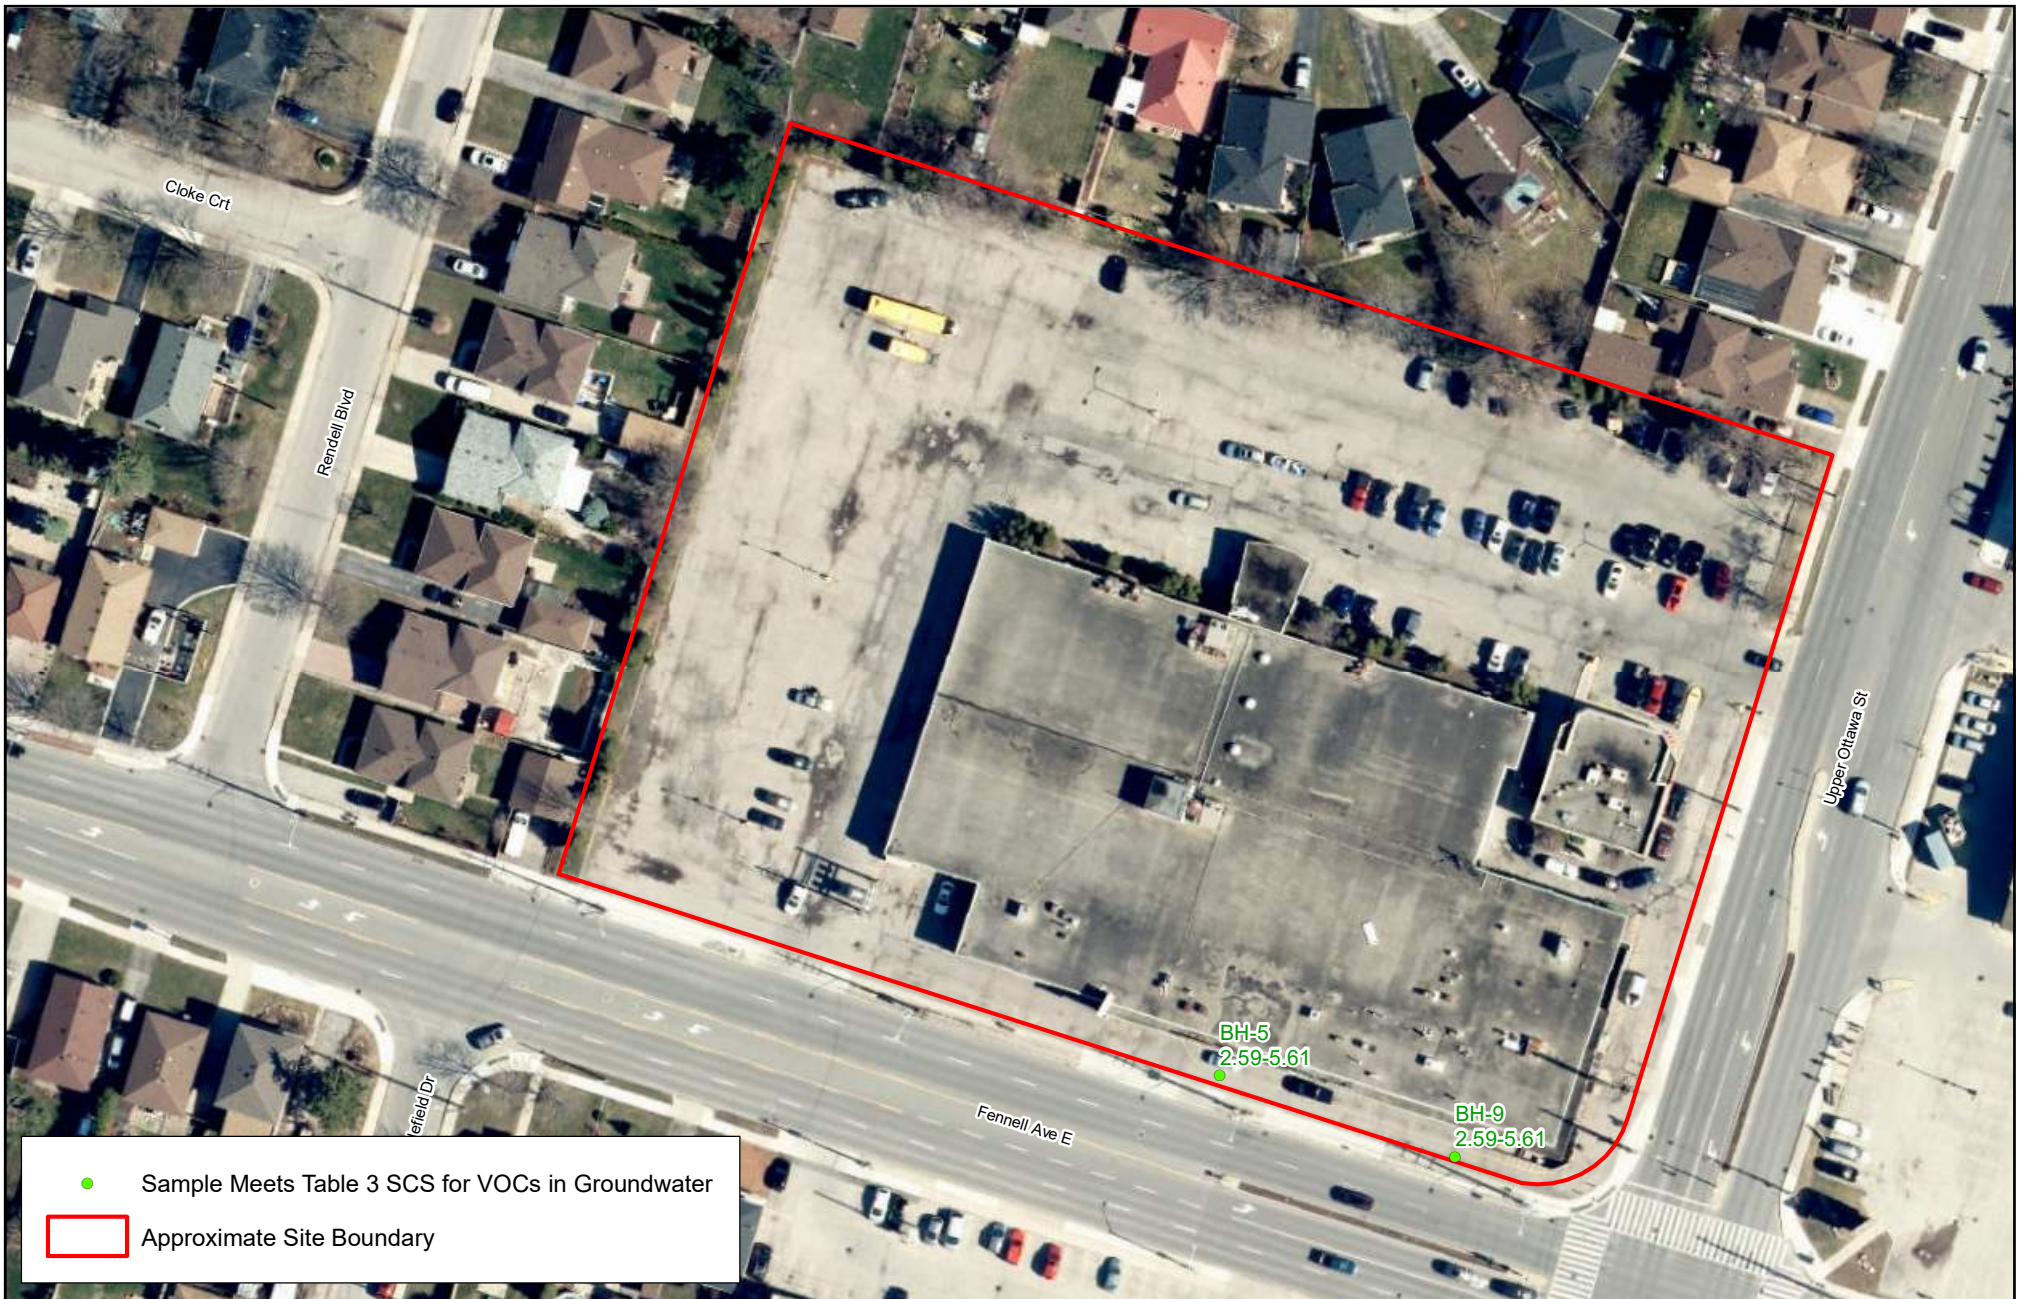
● Sample Meets Table 3 SCS for VOCs in Groundwater
 □ Approximate Site Boundary

TITLE AND LOCATION:
**GROUNDWATER ANALYTICAL RESULTS -
 VOLATILE ORGANIC COMPOUNDS (VOCs)**
 Phase Two Environmental Site Assessment
 1093 - 1115 Fennell Avenue East and
 570, 580 Upper Ottawa Street
 Hamilton, Ontario
