**Limited**  
**Phase 2 Environmental Site Assessment**  
509 Southcote Road  
Ancaster, Ontario  
L9G 3K9

File: 22352

October 2022

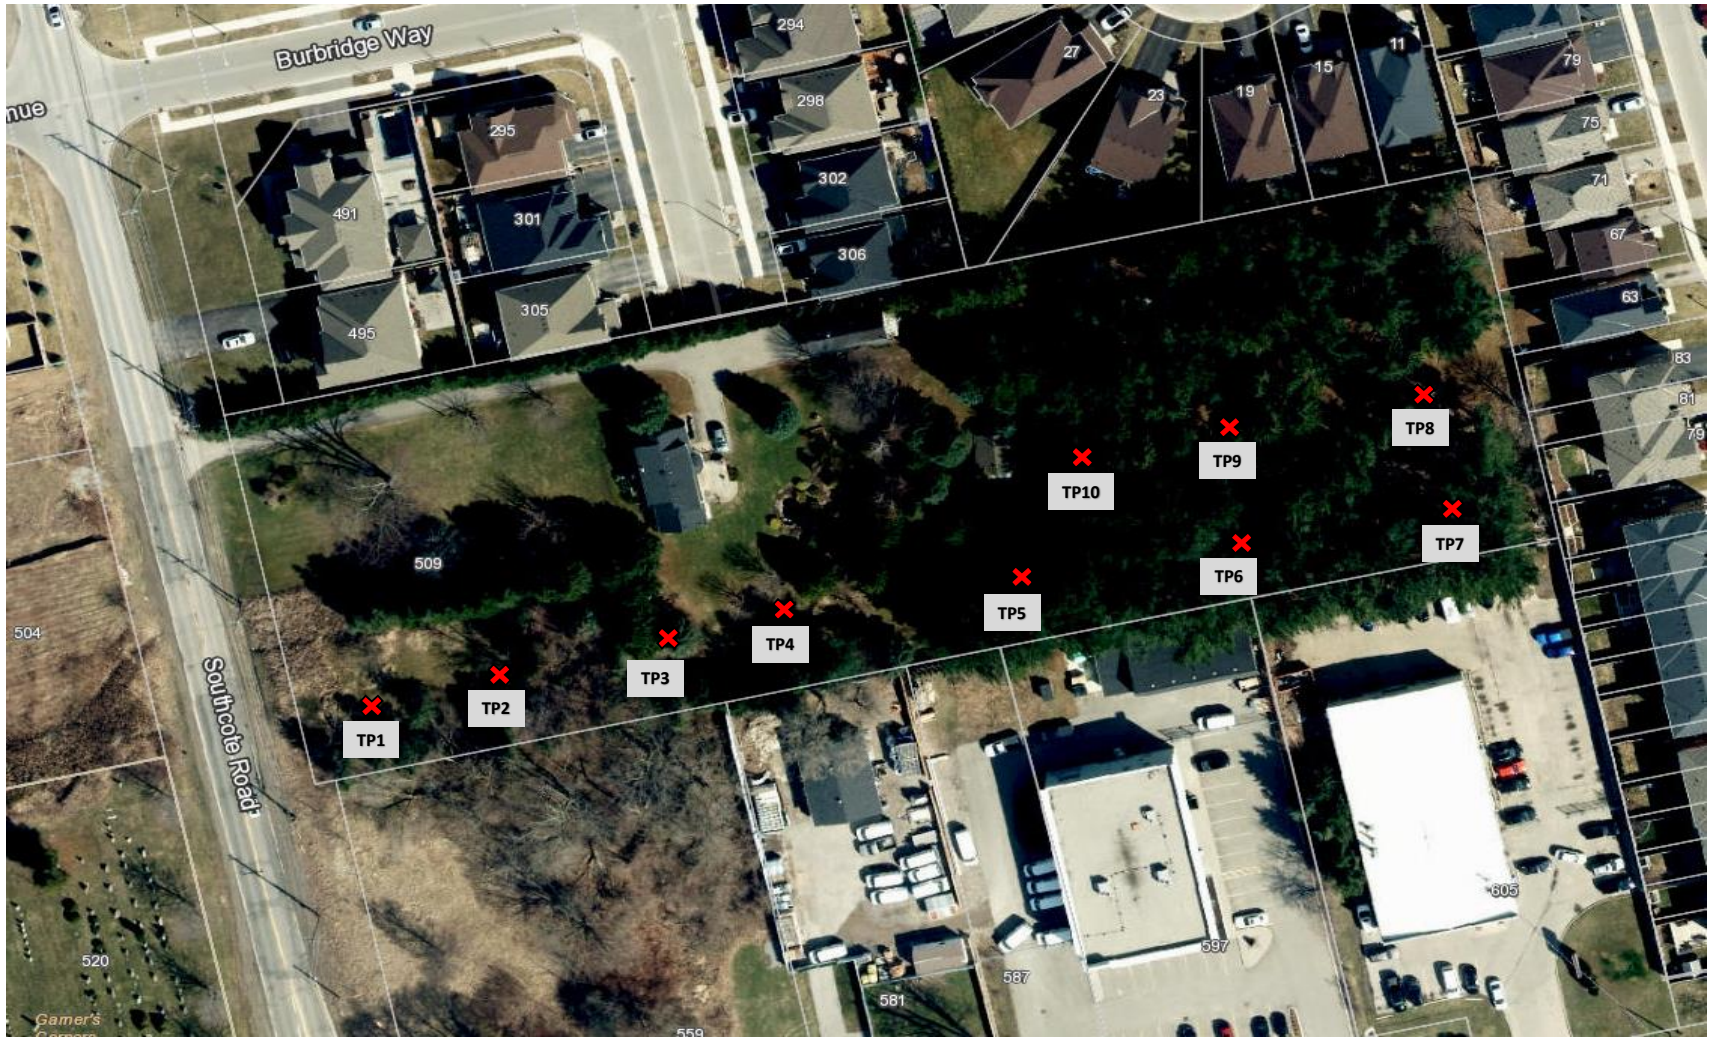
Figure 1: Sampling Location Plan

- Advancing ten (10) test pits to a maximum depth of approximately 4.3 m below ground surface (m bgs) (14 ft) or refusal at locations identified on **Figure 1**;

Sample locations are shown on **Figure 1**.
