Hydrogeological Investigation

Preliminary

559 Garner Road East, Ancaster, Ontario

HAM-00802098-B0

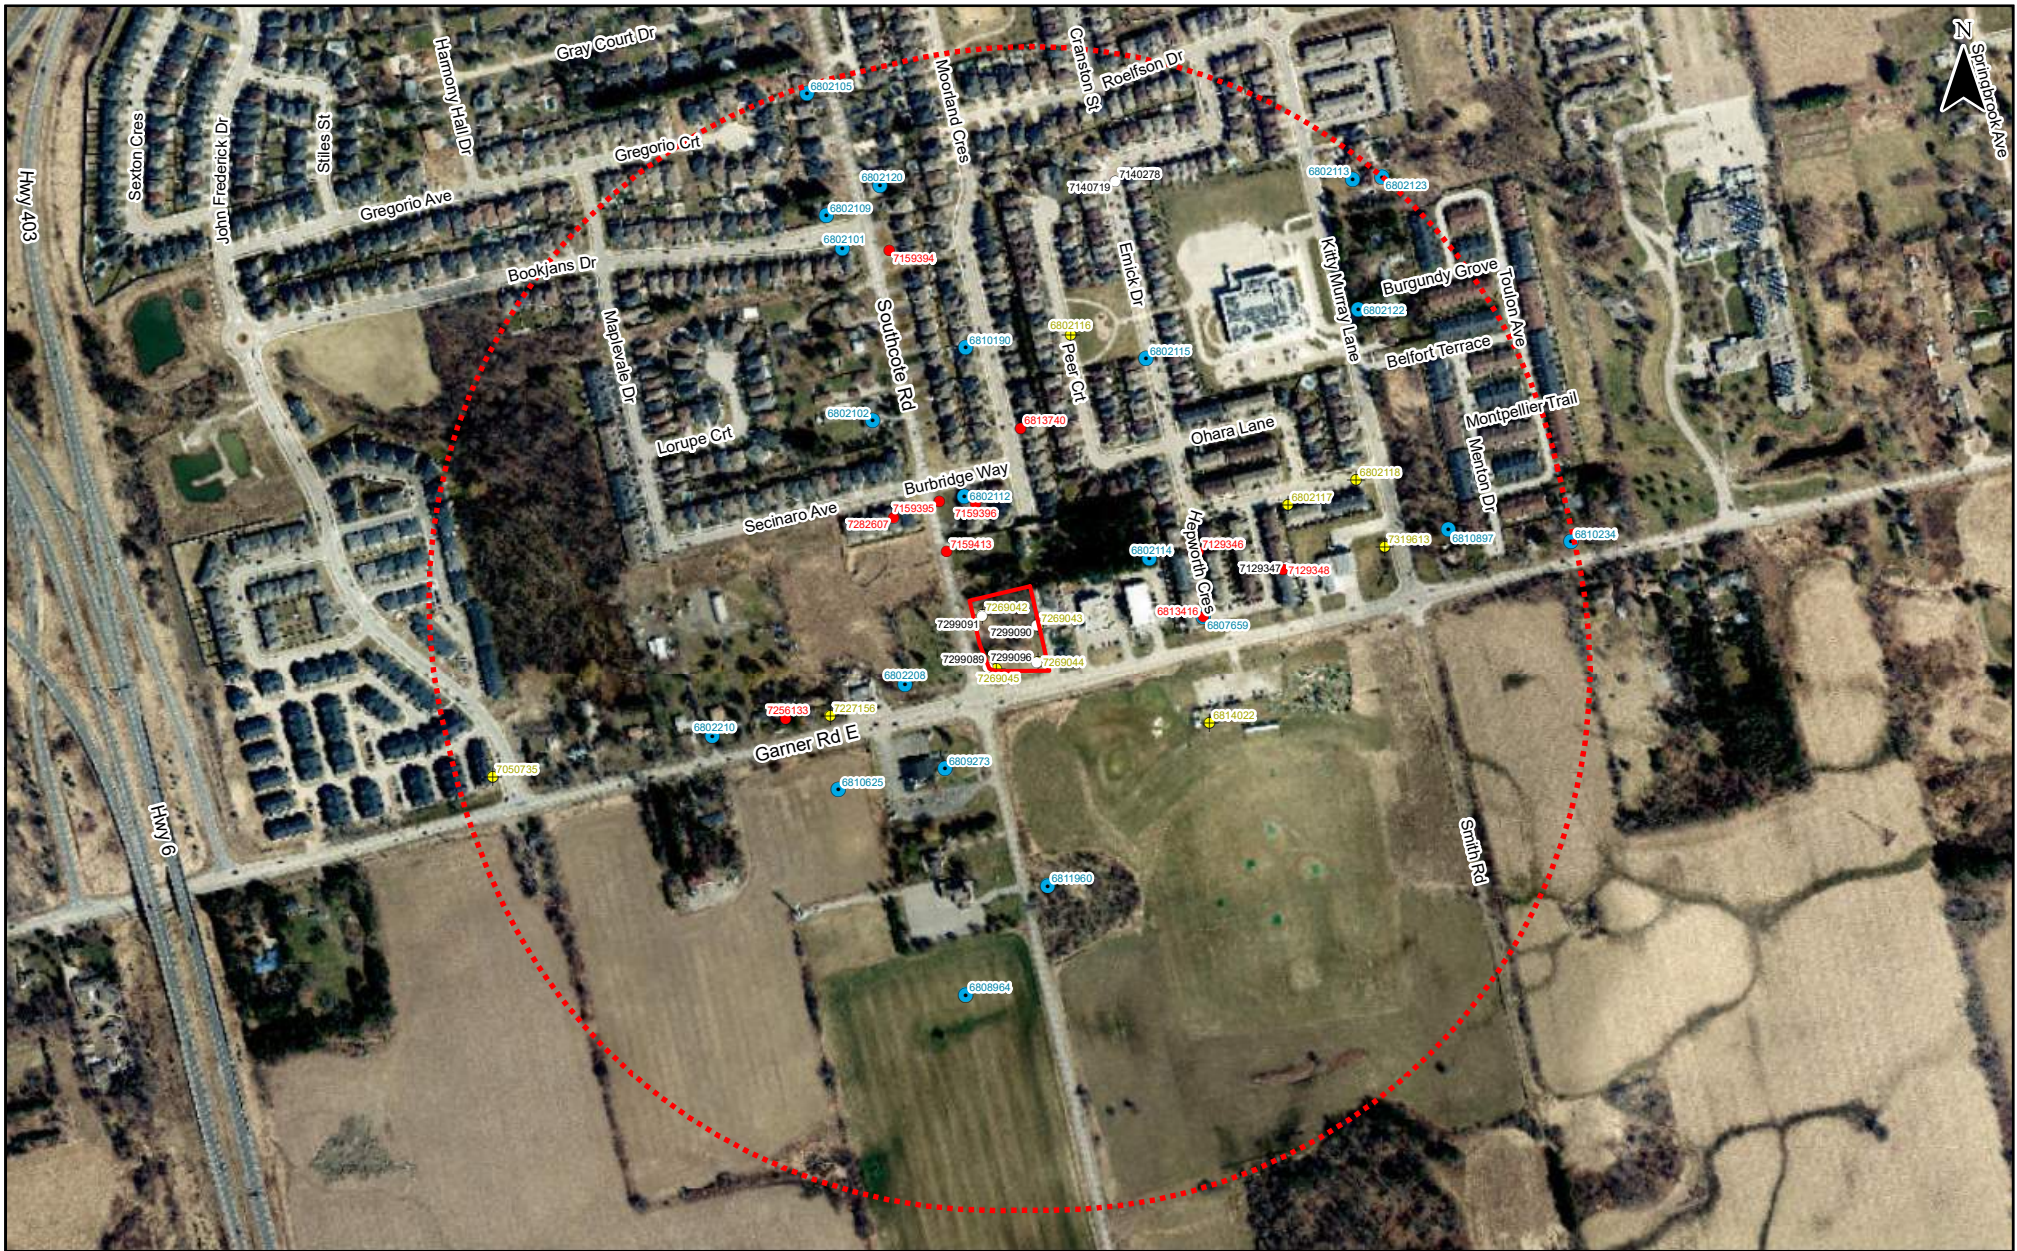
Water Well Records (WWRs) were compiled from the database maintained by the Ministry of the Environment, Conservation and Parks (MECP) and reviewed to determine the number of water wells documented within a 500-m radius of the Site boundaries. The locations of the MECP WWRs within 500 m of the Site are shown on Figure 3. A summary of the WWR is included in Appendix A.

The MECP WWR database indicates that forty-nine (49) records within a 500 m radius from the Site centroid where eight (8) well record are identified onsite (Figure 3 and Appendix A). Well distances are calculated relative to the Site centroid, therefore some distances in Appendix A exceed 500 m.

SOURCE:
 BASED ON GOOGLE EARTH IMAGERY DATED 2019,
 AVAILABLE WELL RECORD INFORMATION AS OF SEPTEMBER 2019

- LEGEND:
- MONITORING WELL / TEST HOLE
 - WATER SUPPLY WELL
 - ABANDONED WELL
 - UNCLASSIFIED / UNFINISHED WELL
 - APPROXIMATE SITE BOUNDARY
 - 500 m ZONE

The database indicates that the offsite wells are at an approximate distance of ninety-five (95) m or greater from the Site centroid. All offsite wells were reportedly identified as monitoring and observation wells, test holes, dewatering wells, water supply wells, abandoned and/or listed with unknown use.

There are twenty one (21) offsite water supply wells (16 domestic, 3 commercial, 1 industrial, and 1 irrigation/domestic). The Well Identification Number of the closest offsite water supply well is 6802208. It is reportedly 109 m from the Site boundary.

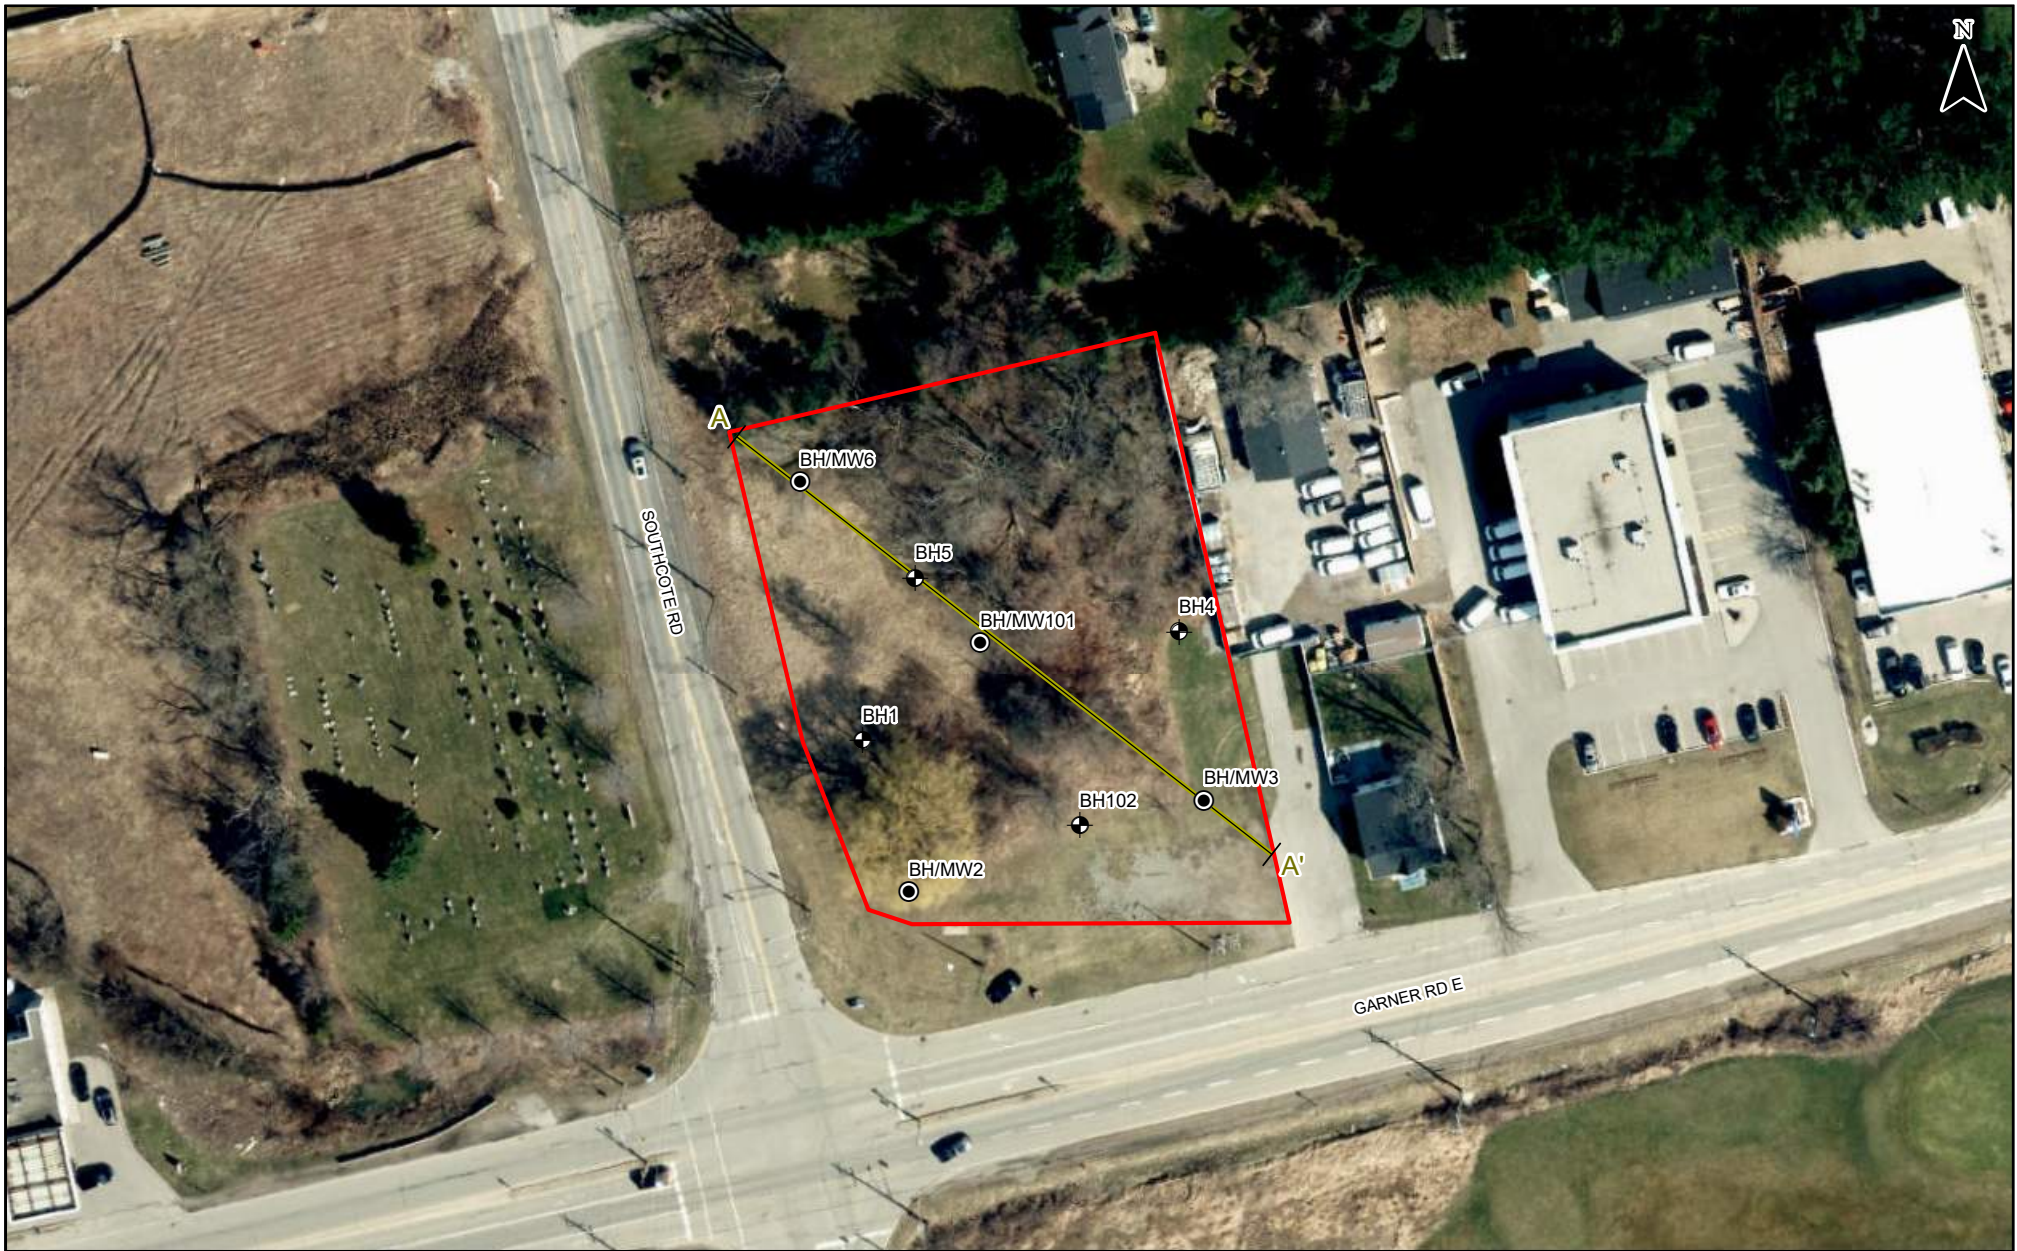
The borehole and monitoring well locations are shown on Figure 4. A geological cross-section was generated based on the available borehole logs completed as part of the previous and current investigations and shown on Figure 5 (Cross section A-A'). It is noted that the cross section shows a simplified representation of soil conditions and soil deposits may be interconnected differently than represented. Borehole logs used to generate both cross-sections are provided in Appendix B.

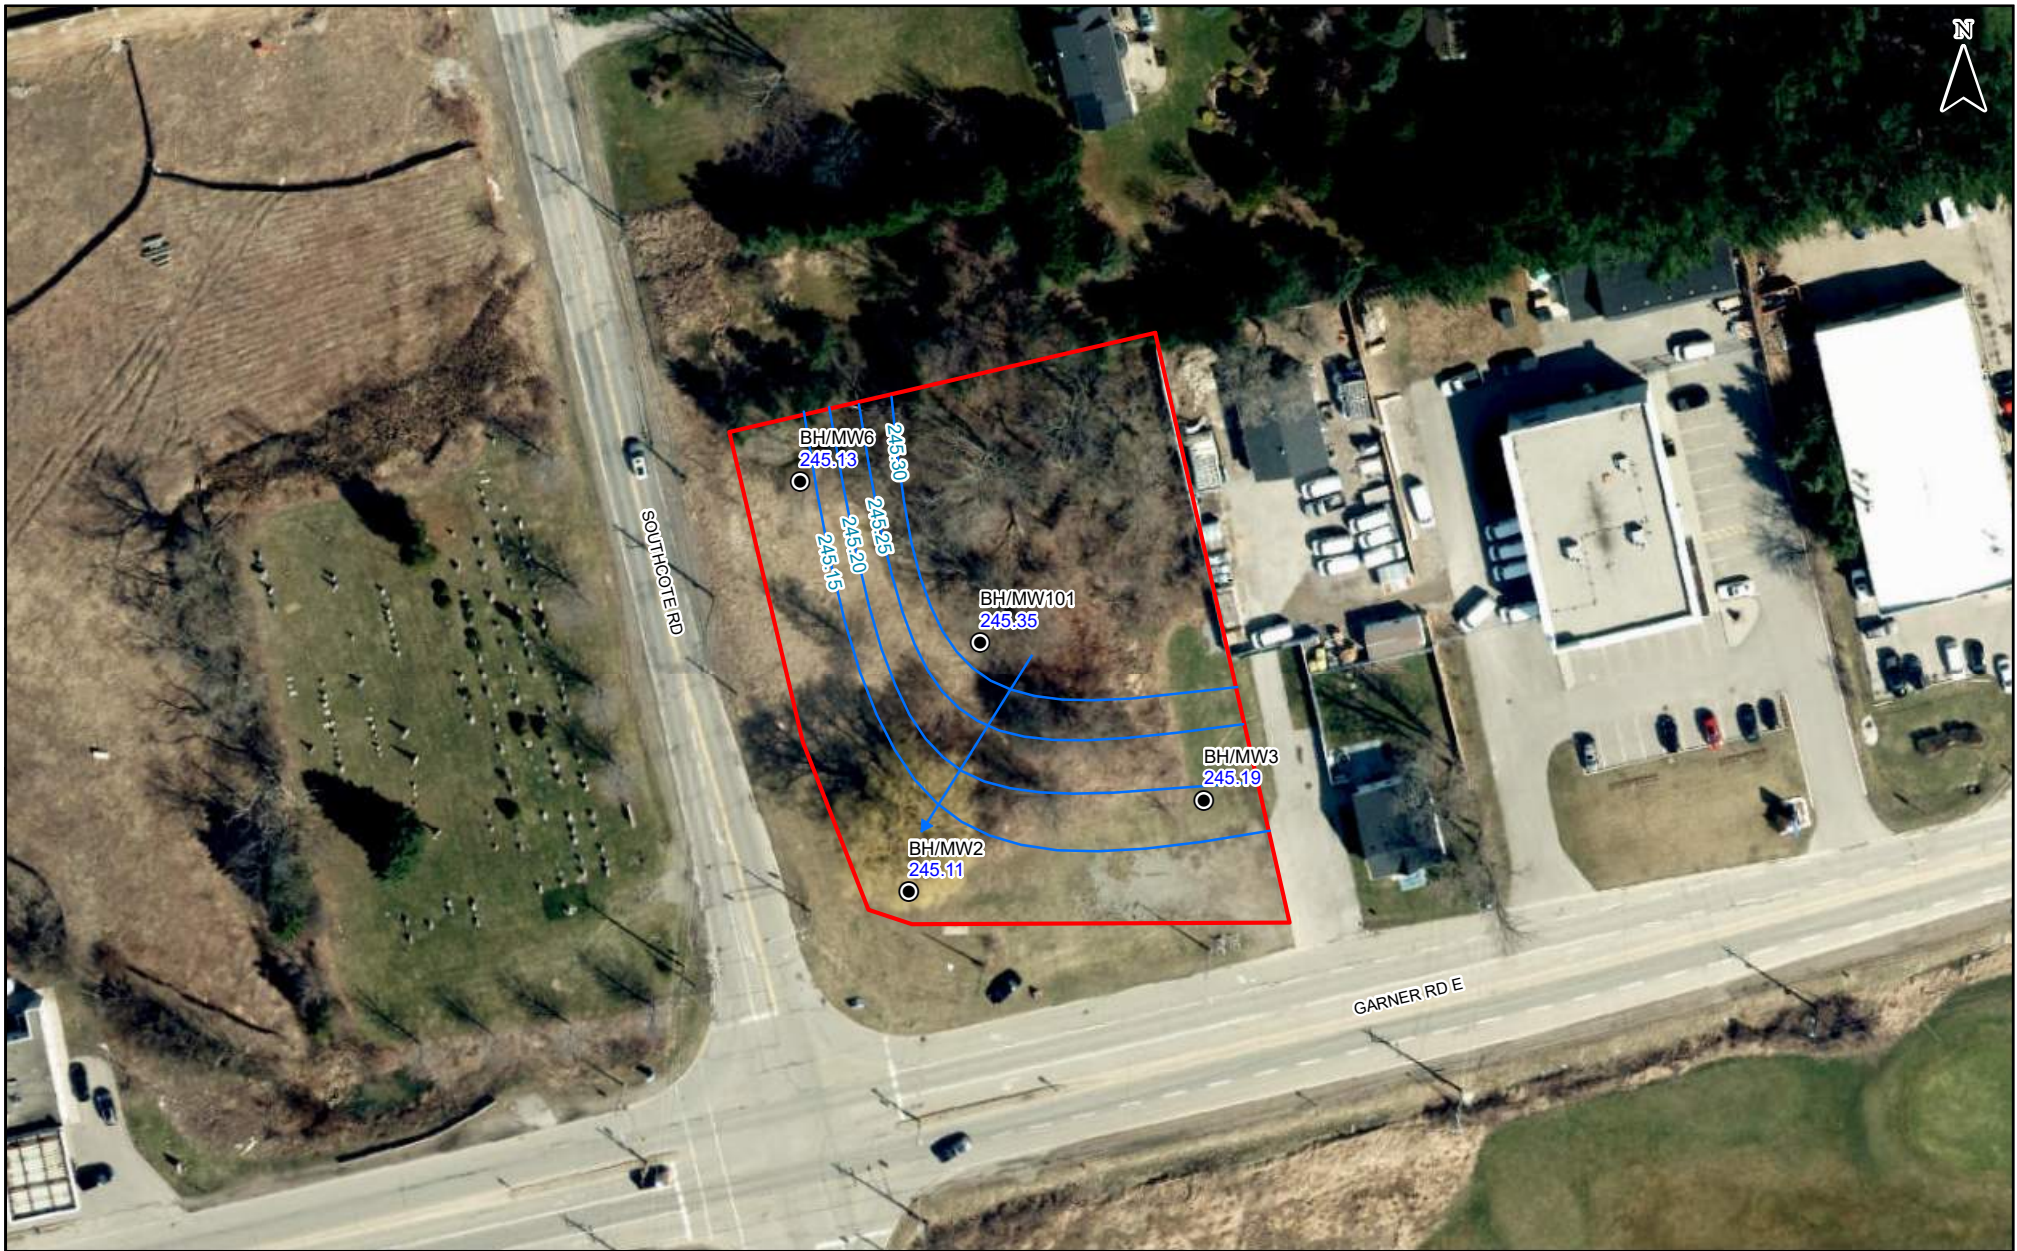
One map was created for the Site to show groundwater contours of the water-bearing zones (Figure 6). Accordingly, the groundwater flow direction is interpreted to be southwest of the Site. For the design of foundations without perimeter and foundation drainage systems, shallower wells need to be considered to evaluate the shallow groundwater table. The hydrogeologist needs to be consulted during the design process.

- BOREHOLE / MONITORING WELL (EXP, 2020)
- xx.xx GROUNDWATER ELEVATION (m asl) AS MEASURED ON JULY 14, 2021
- GROUNDWATER CONTOUR
- GROUNDWATER FLOW DIRECTION
- APPROXIMATE SITE BOUNDARY

Groundwater levels are expected to show seasonal fluctuations and vary in response to prevailing climate conditions. This may also affect the direction and rate of flow. It is recommended to conduct seasonal groundwater level measurements to provide more information on seasonal groundwater level fluctuations.
