White Church Boundary Expansion Area

Sub-Watershed Study

January 2025

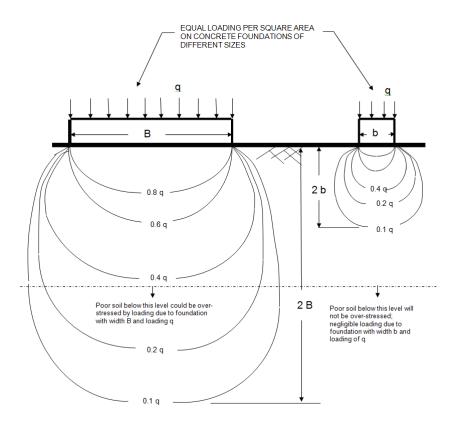
Figure 5.1.1.1: Illustration of Load Distribution below Variable Size Foundations with the Same Applied Loading

for the proposed development. The impact on foundation size and soil bearing pressure is illustrated in Figure 5.1.1.1 and emphasizes that foundation design sizes, bearing pressures, and bearing levels must be taken into account to avoid excessive consolidation settlements.

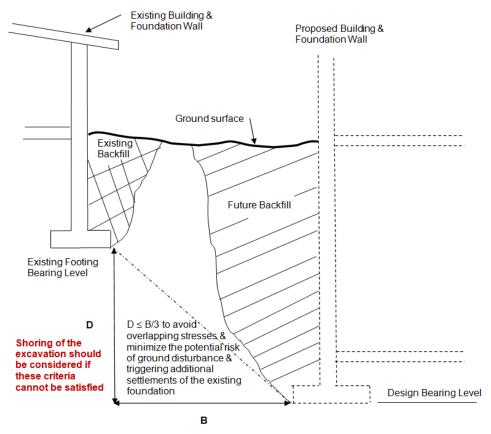
Figure 8.1.1: Criteria for Assessing Excavation Shoring Requirements (Not to Scale)

Excavations for new foundations will be required to satisfy the criteria given in the example shown in Figure 8.1.1. This is to avoid overlapping stresses and minimize the risk of undermining existing adjacent structures, including utilities, and/or triggering additional settlements of the existing structures due to soil disturbance.

Example: If the separation between existing and new proposed footings is 2 m the difference in bearing elevation should not exceed 0.67 m.

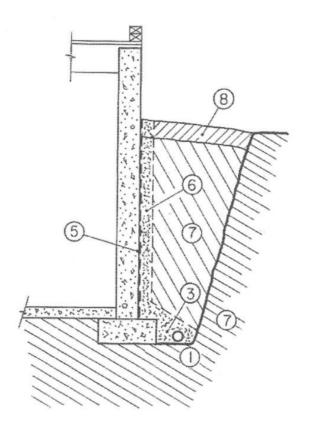
DRAWING 23354-03 - ENGINEERING COMMENTARIES - GENERAL REQUIREMENTS FOR UNDERFLOOR DRAINAGE SYSTEMS

- ① 100 mm, perforated or slotted pipe placed below the upper level of the floor slab.;
- Filter material that is compatible with the grain size characteristics of the fine grained foundation and backfill soils, as well as with the perforations of the pipe;

- Filter material continuously or intermittently placed next to the foundation wall to intercept water draining from window wells, down exterior walls and from low areas near the building;

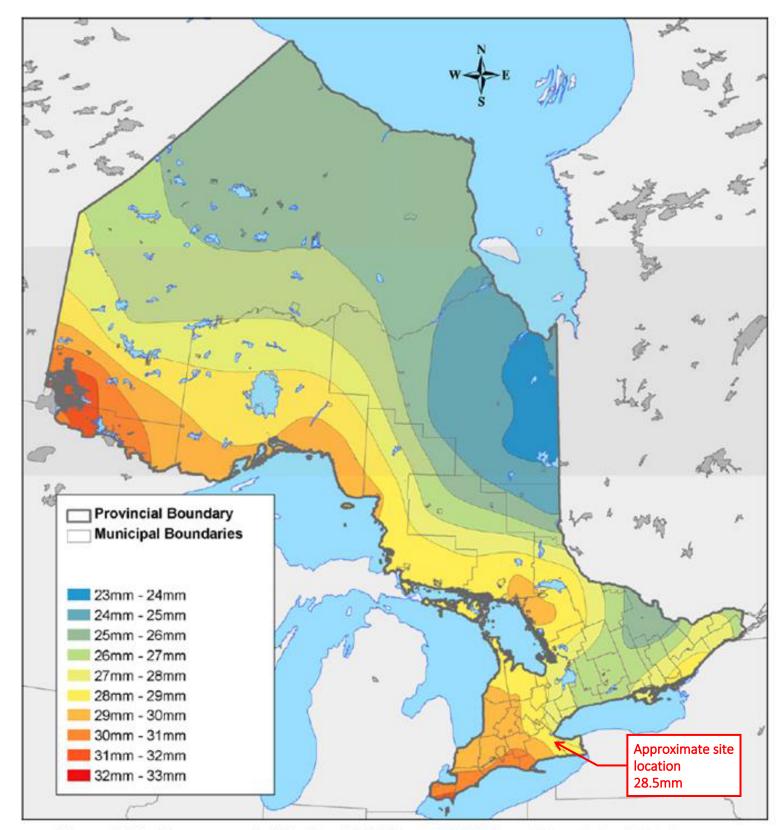
Figure 3.67 – Recommended Regional 90% Percentile Volume Targets for Ontario (represented by the 95th percentile daily rainfall contours April - October, where daily volume exceeds 2mm).

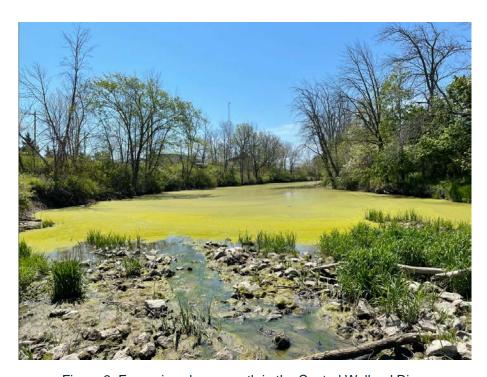
Based on the 2019-2023 data, elevated concentrations of total phosphorus are a widespread cause of water quality impairment in the Welland River. Greater than 95% of samples collected in the main Welland River exceeded the PWQO with some concentrations greater than 20 times the PWQO. High phosphorus in the Welland River has stimulated the overgrowth of algae and duckweed throughout the watershed. When these plants transpire, and decompose they deplete dissolved oxygen in the water and this in turn stresses aquatic organisms such as fish and benthic invertebrates. Manure from livestock operations, sewage discharges, soil erosion, fertilizers, and pesticides are sources of total phosphorus in the Welland River.

Figure 3: Excessive algae growth in the Central Welland River
