CULTURAL HERITAGE IMPACT ASSESSMENT

43-51 King Street East, Hamilton, ON
Former S.S. Kresge & Co. Store

FINAL REPORT

28 Feb 2017

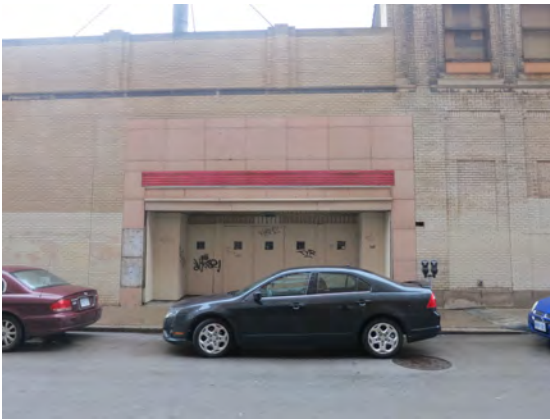
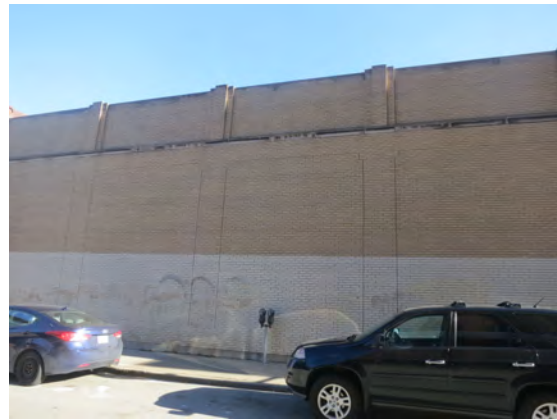
Hughson Street entrance in the one-storey rear section and blank wall with very little architectural character.

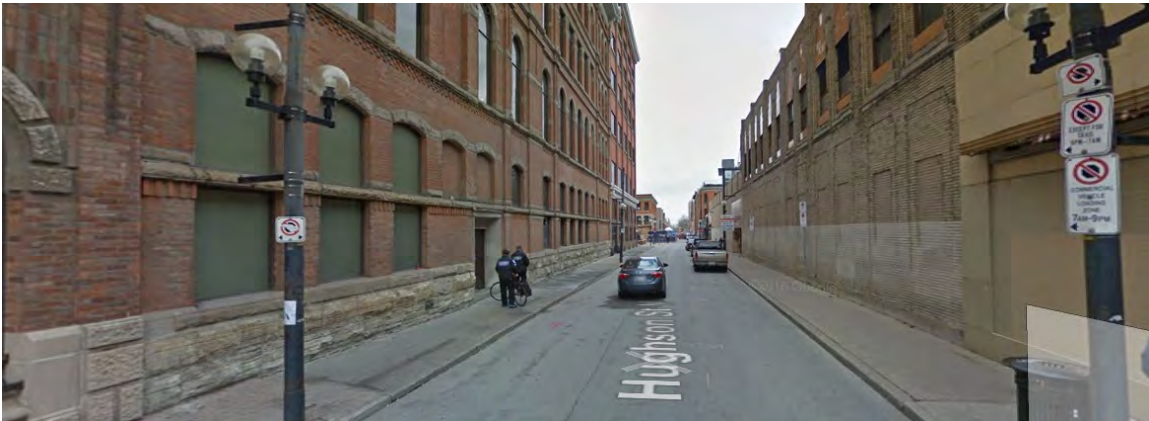
Hughson Street is a narrow one-way street. The block from King Street East to King William Street is framed by the subject property (east side) and the Right House (west side). The Right House is a four-storey red brick building that also has blind windows at street level. As a result, this section of Hughson Street North has the character of an alley between two buildings.

Blind windows on Hughson Street North create a tunnel like effect.

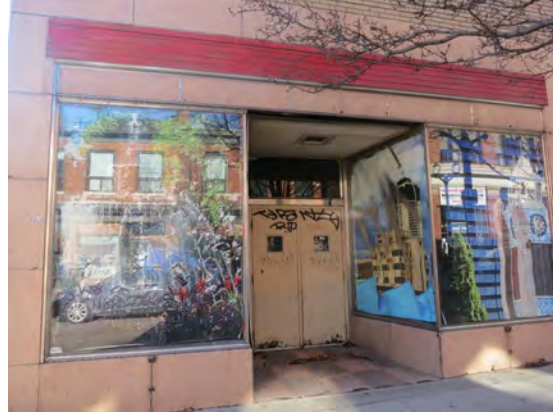
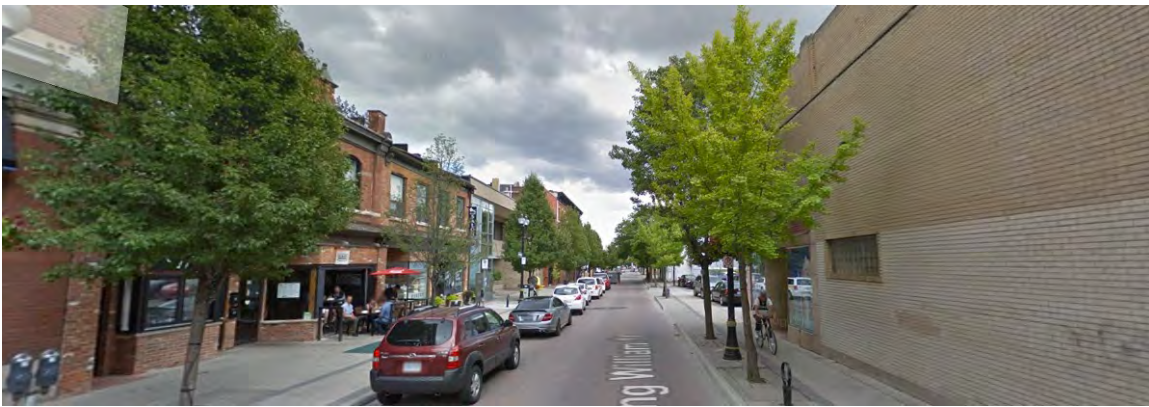
Un-articulated brick wall on King William Street.

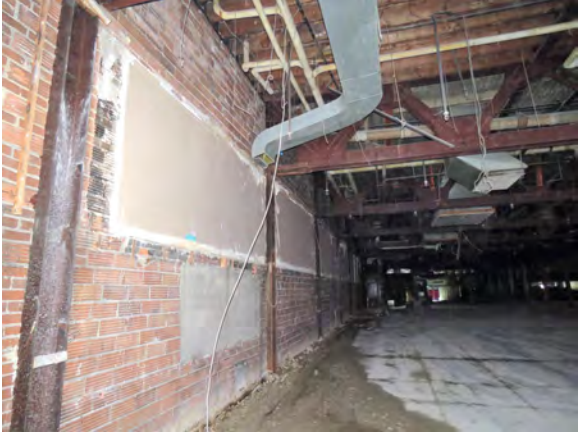
Investigation of the structural components revealed that the building was constructed in two phases. The original structure displays early steel frame construction because it is used in conjunction with wood joists and floor decks and partially load-bearing exterior masonry walls. The interior is spanned by Warren trusses with riveted plates at the joints. The span of the trusses is 50 feet and they are supported by steel posts imbedded in the exterior masonry walls on Hughson Street and a row of freestanding steel posts in the interior. This type of construction is typical of commercial and industrial buildings constructed in Ontario in the interwar years.

Steel trusses with a 50 foot span supported by steel posts embedded in the exterior masonry wall on Hughson Street.

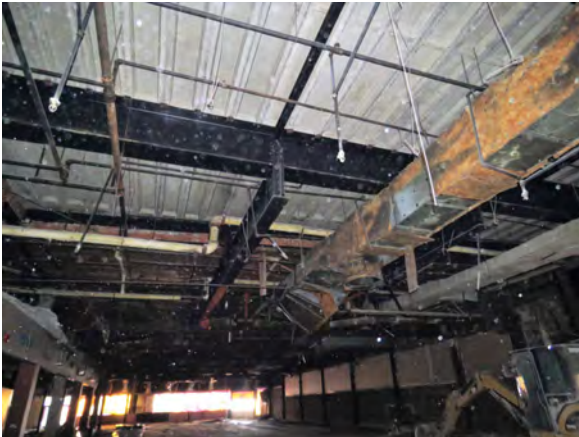
Later additions were done using a more modern steel frame and concrete slab assembly. The concrete slabs are pre-cast panels. This type of construction is typical of commercial and industrial buildings constructed in Ontario after World War II.

Steel frame and pre-cast concrete slab floor construction in the rear and east portions of the building.

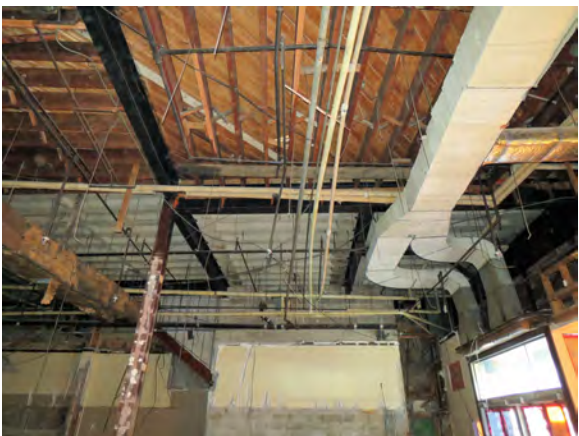
Transition between the wood framing and floors in the older portion of the building and the pre-cast concrete slab floors in the later additions.

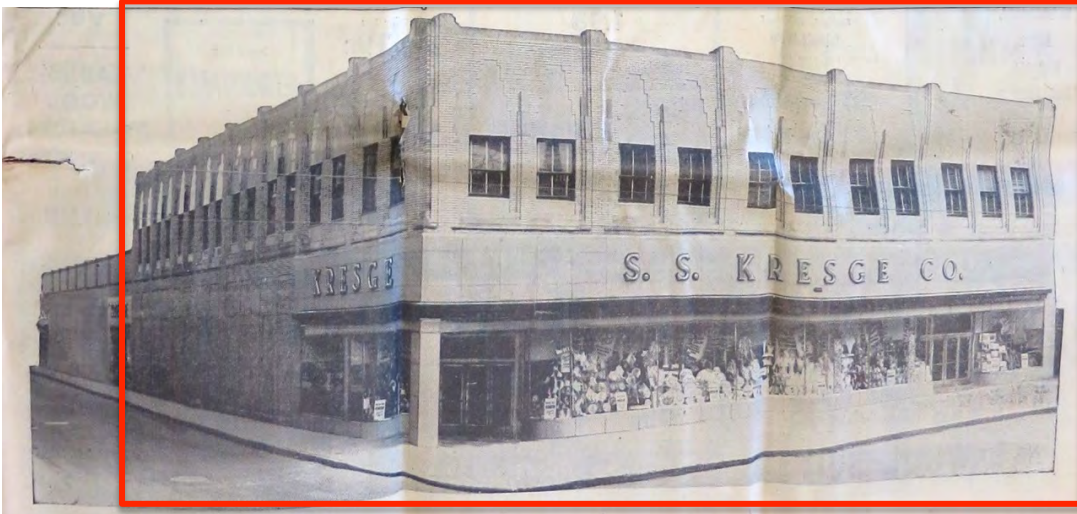
The 2-storey facades on King Street East and Hughson Street North have cultural heritage value.

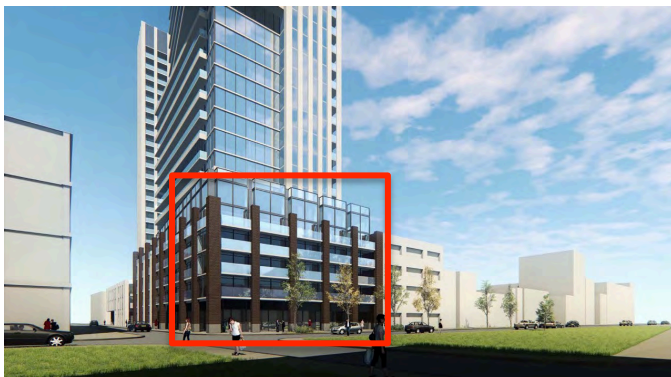
The front 2-storey portion of the building, including the original Kresge store constructed in 1930 and later modifications carried out in 1948-50, has architectural value as a modified example of Art Deco commercial architecture that contributes to the character of the Gore Park Cultural Landscape and is associated with retail activities on the north side of King Street East in the period from 1930 to 1996. Retention of architectural values associated with the 2-storey portion of the building, comprising 5 bays on King Street East and 8 bays on Hughson Street North, is therefore recommended.

Revise podium design to include a reconstruction of the 2-storey portion of the S.S. Kresge & Co. Store.

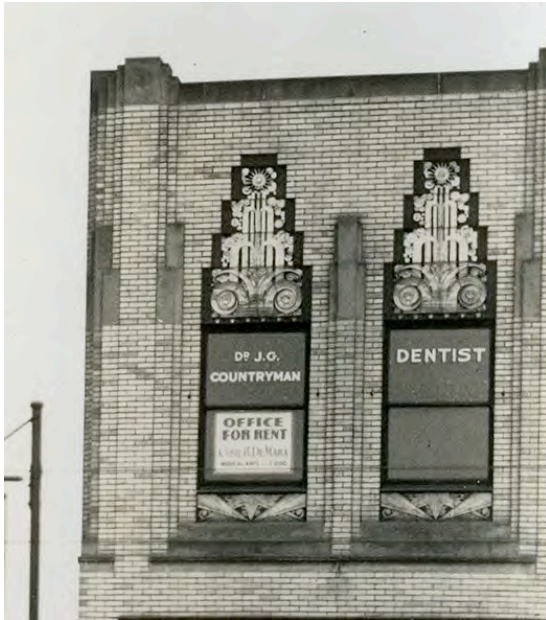
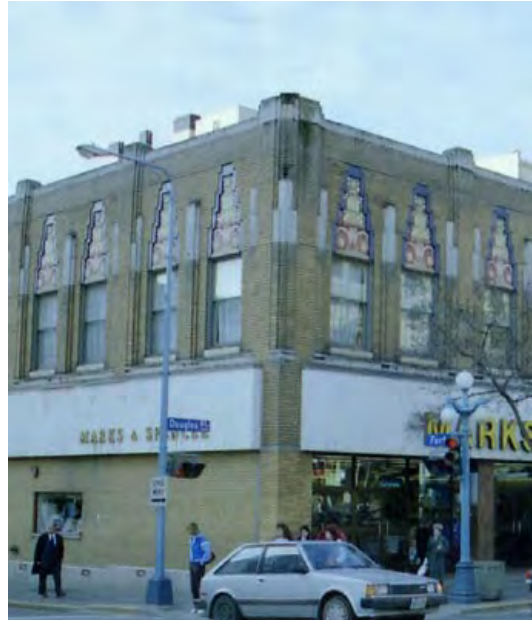
Art Deco ornamentation on the S.S. Kresge & Co. store in Hamilton (left) was originally painted and gilded, similar to an identical store in Victoria, BC (right) that was documented prior to its demolition in 1988.

When the King Street elevation was extended in 1948-50 and new storefronts were installed, the Art Deco carvings were chiseled off and vitrolite tiles were installed over them. Rather than attempting to match the intricate carvings produced in 1930, the installation of vitrolite tiles in the window panels was undertaken as an inexpensive way of modernizing the look of the store.

The re-development of this property provides an opportunity to restore these missing features and enhance its heritage value as an example of Art Deco architecture in downtown Hamilton. There is sufficient physical evidence and documentation to accurately reproduce this feature.
