Reference # 13267.101.L1.Rev1_Shore hazard assessment

RE: 526 WINONA ROAD LiUNA GARDENS SHORELINE HAZARD ASSESSMENT AND SETBACK REQUIREMENTS

Executive Summary

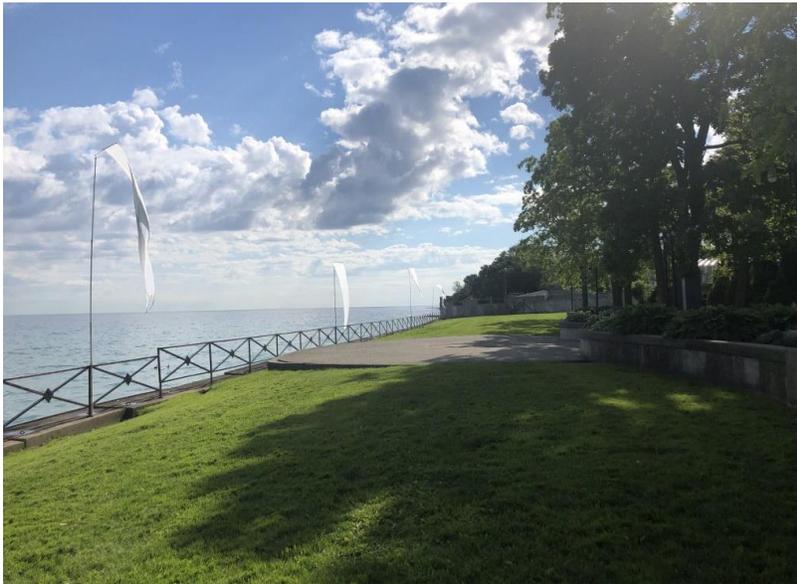
Figure 3: Backshore landscaping at banquet hall

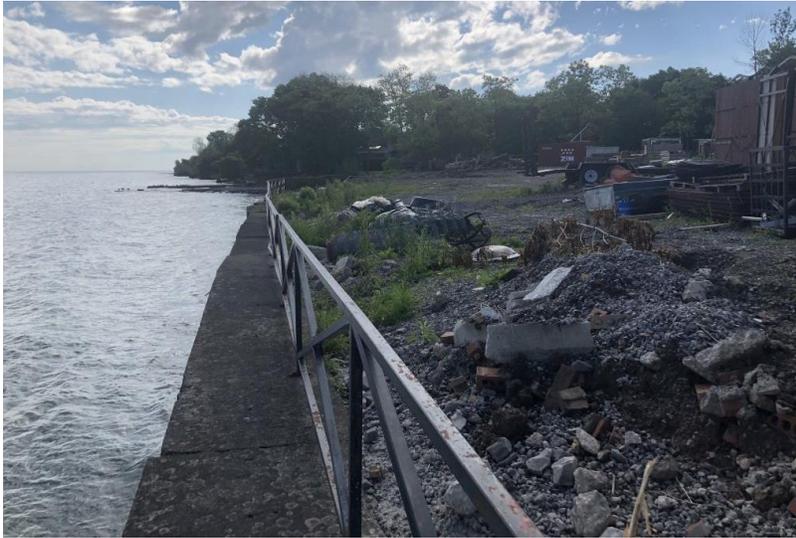
Figure 4: Backshore at easterly portion of property

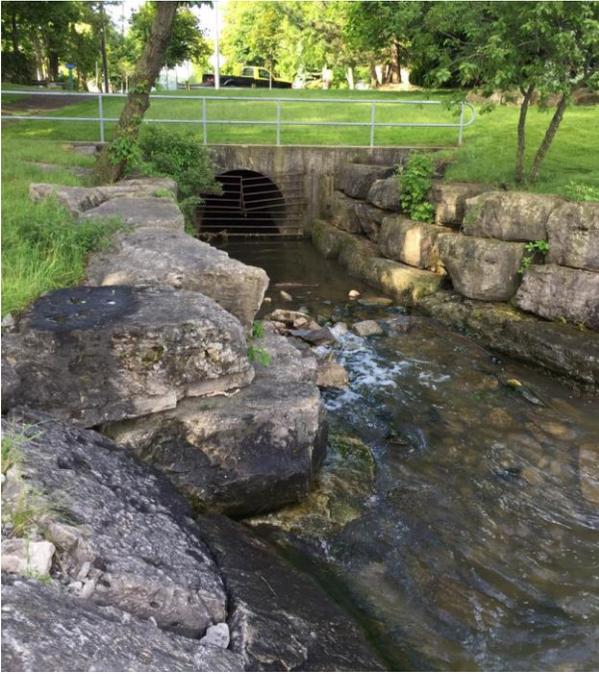
The site is bounded to the west by Winona Road. A concrete headwall with a storm water drainage pipe and grate is located at the end of Winona Road (Figure 8). The storm drain discharges into an outlet channel that is lined with armour stone on both sides and extends to the shoreline at the Lake (Figure 9).

Figure 8: Concrete headwall with storm water pipe and grate at end of Winona Road

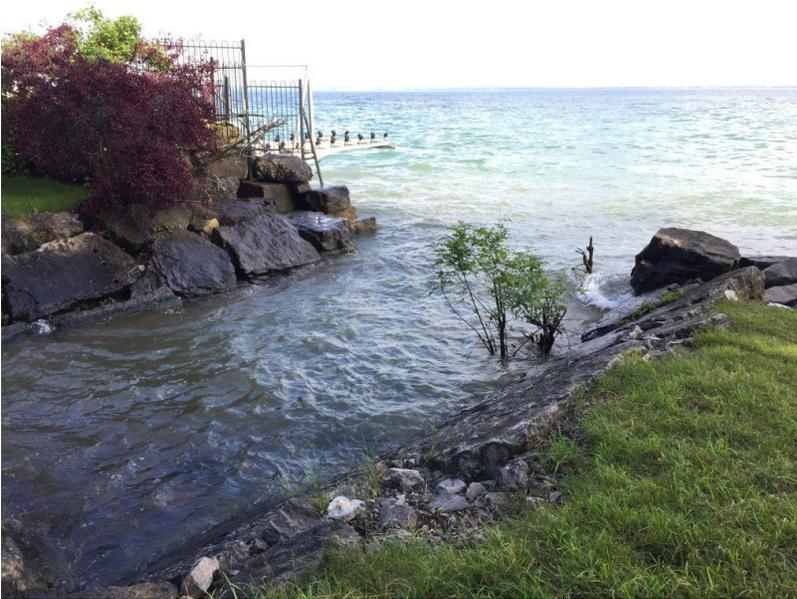
Figure 9: Armour stone-lined storm water discharge channel at Winona Road

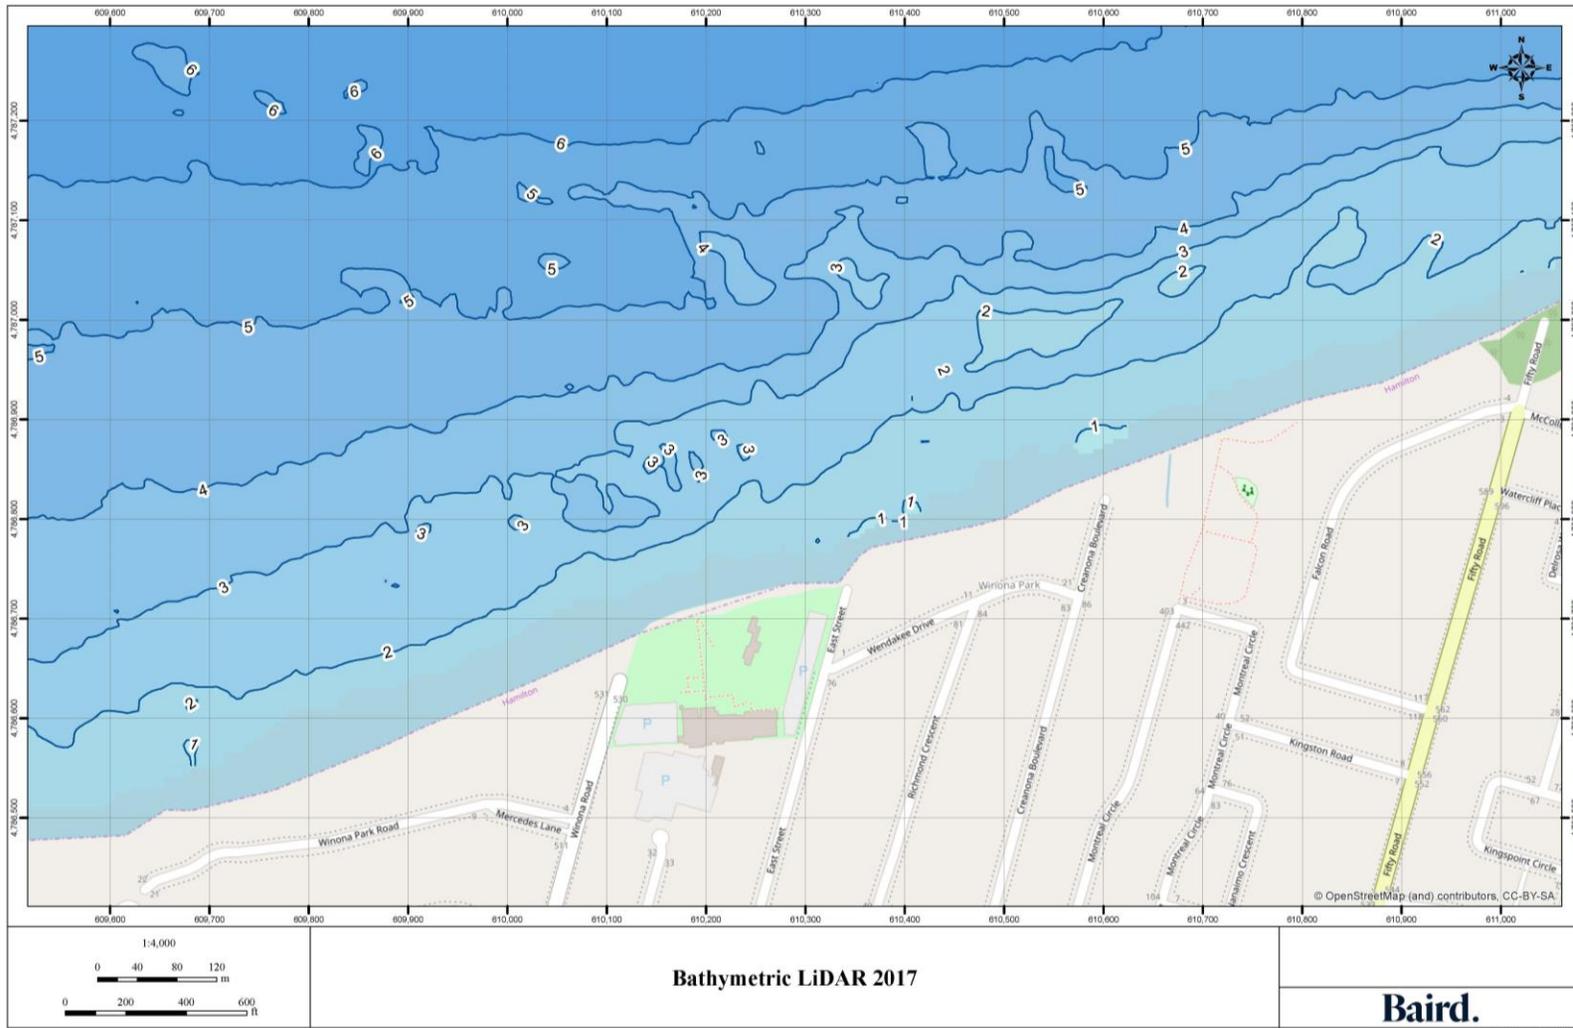
The bathymetry³ in the vicinity of the site is presented in (Figure 15). Approximately 80 m offshore the depth is 2 m below chart datum (CD); CD is 74.2 m IGLD1985 and is an elevation that the water level rarely goes below. The bathymetric survey does not include the area close to the seawall. From the initial site visit the lakebed elevation at the base of the seawall is estimated to be elevation 74.0 m IGLD, or about 0.2 m below CD. A nearshore survey extending from the shoreline seawall out to about 2 m to 3 m below chart datum (74.2 m IGLD1985) is proposed for the spring of 2020 to confirm the conditions for final design.

Figure 15: Bathymetry (in metres below chart datum 74.2 m IGLD1985; ref. CHS LiDAR 2017)

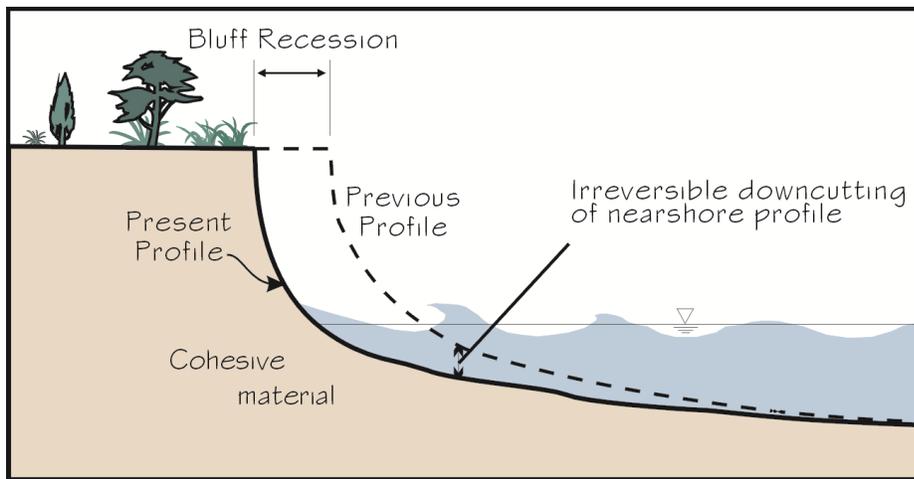
The controlling process for the recession of a cohesive shoreline bluff is the downcutting, or downwards erosion of the nearshore cohesive lakebed profile by the wave induced forces and water pressures. Figure 16 presents a schematic of cohesive shoreline nearshore downcutting and bluff recession processes. The ongoing downcutting of the nearshore profile eventually results in the toe of the shoreline bluff being undercut. Continued undercutting of the bluff will over-steepen the bluff face and it will collapse, resulting in recession of the crest. If the backshore composition of the shoreline is the same, the cohesive shoreline recedes over time without a change in the shape of its profile. The erosion or downcutting of the cohesive material in the nearshore profile is irreversible and ongoing. Even though the process is governed by the downward cutting of the nearshore bottom by wave action, the visible effect is a horizontal translation of the entire shoreline profile at the long-term average bluff recession rate.

Figure 16: Cohesive shoreline nearshore downcutting and bluff recession

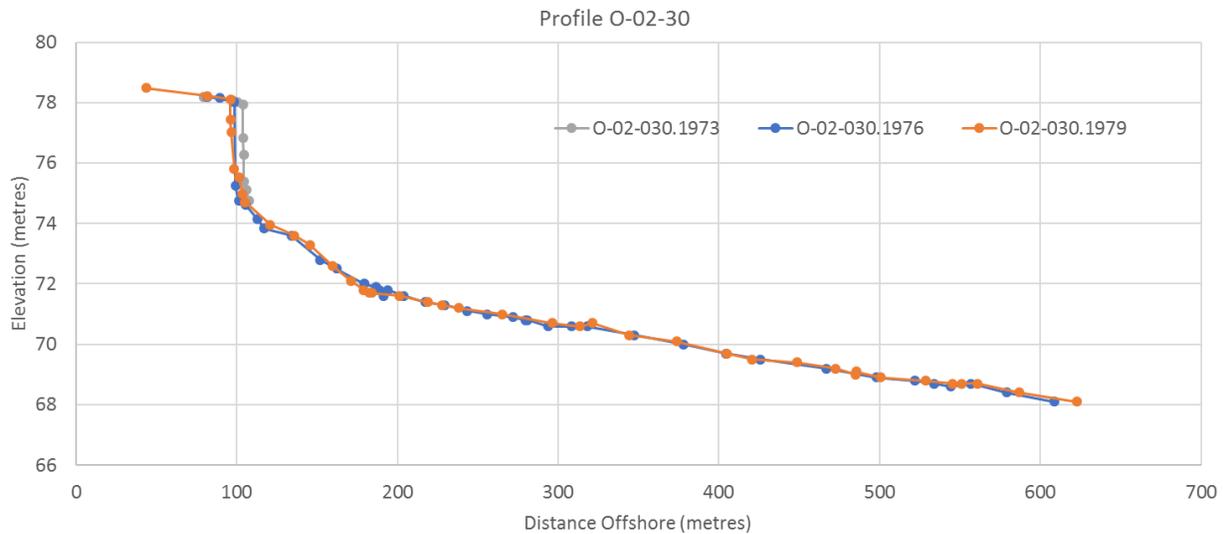
Cohesive shoreline nearshore profiles in predominantly fine-grained material (i.e., relatively high percentage of silts and clays with relatively lower percentages of sand and gravel or cobbles) are characterized as distinctively concave. The constant concave profile shape over time indicates that the downcutting rate is the greatest at the shoreline and gets less towards the offshore. A nearshore profile at Winona Road (Erosion Profile O-2-13) is presented in Figure 17 and demonstrates this concave shape, characteristic of a cohesive shoreline profile, with a nearshore slope of approximately 1:30 (vertical:horizontal) in the first 80 m.

Figure 17: Nearshore profile at Station O-02-30 (at Winona Road), 1973 to 1979 (ref. MNR shoreline profile database)

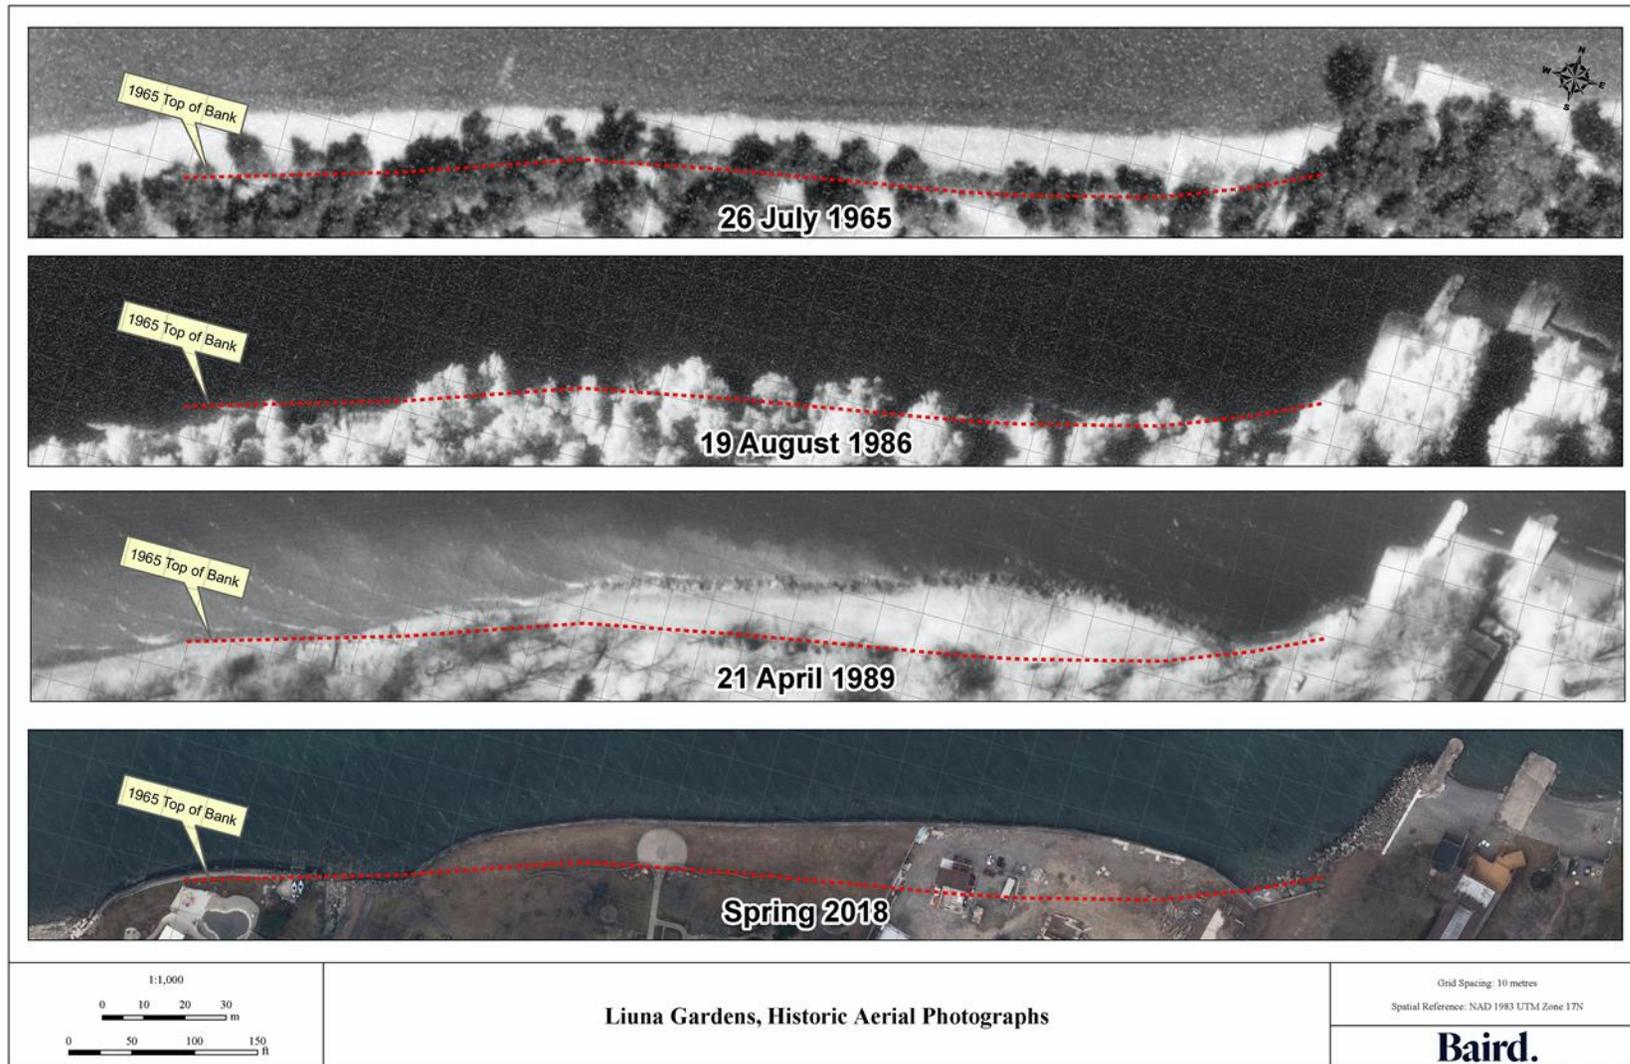
Circa 1988 – 1989 the shoreline at the site was filled with construction rubble to protect the eroding shoreline; the lakefilling can be seen in Figure 18 (April 21, 1989 photo). The concrete block seawall was added to contain the perimeter of the lakefilling. Because of the addition of the shoreline protection, only air photos and surveys prior to 1988 - 1989 were used in the recession rate analysis for this study.

Figure 18: 1965 top of bank superimposed on aerial images from 1965, 1986, 1989 and 2018

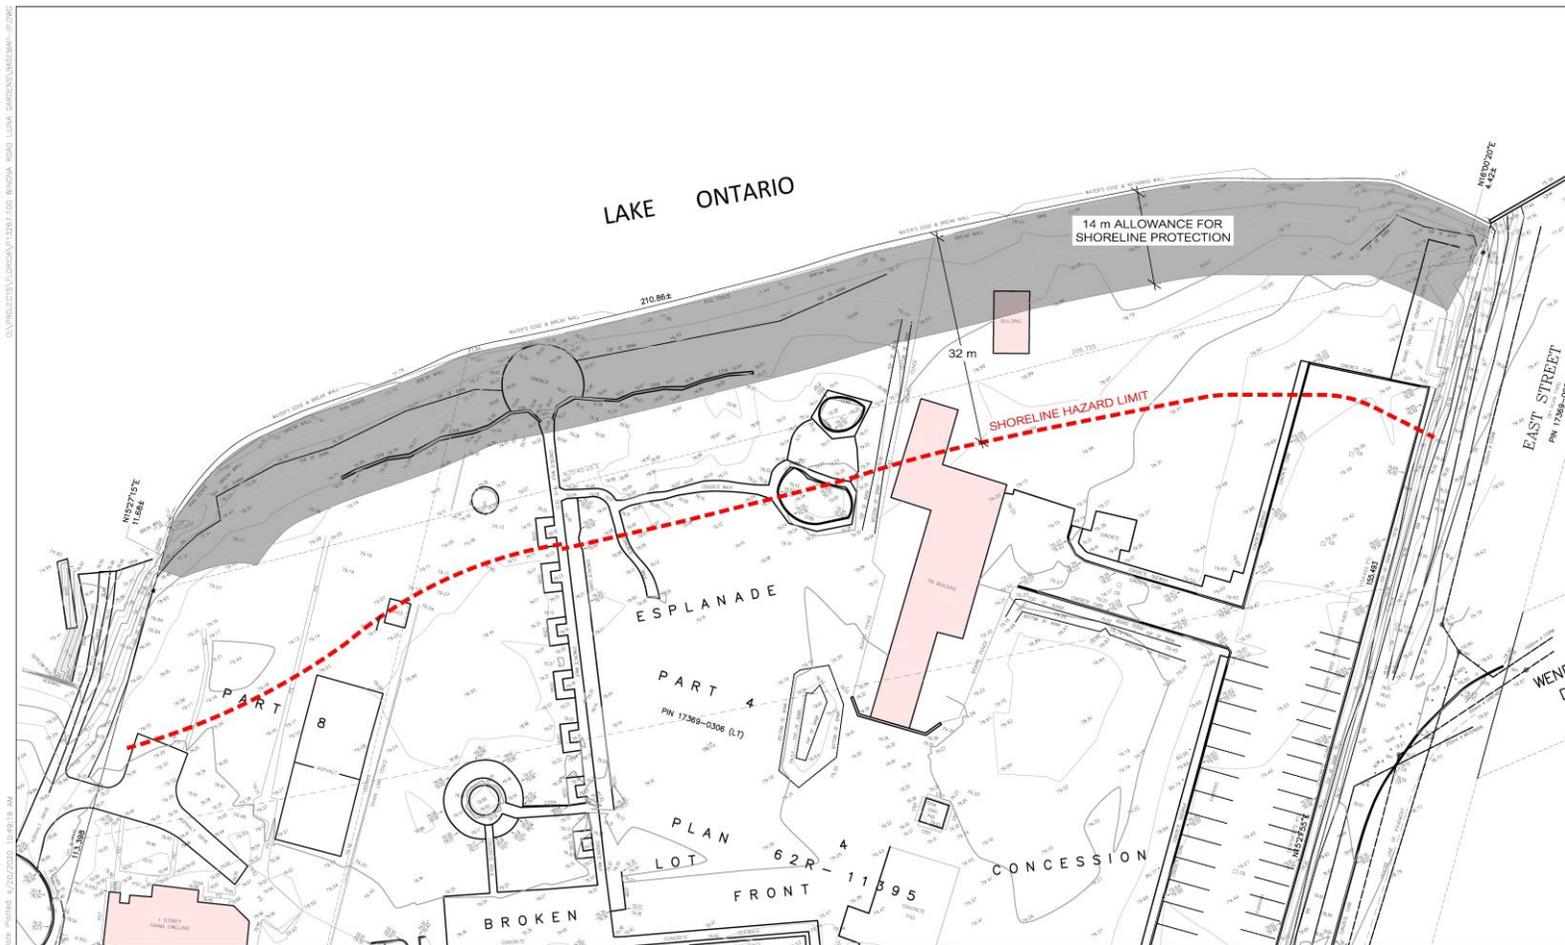
The proposed shoreline hazard limit, as governed by the erosion hazard limit, is located 32 m measured from the back edge of the top row of concrete blocks in the existing seawall. The 32 m dimension is comprised of an allowance of 8 m required for the construction of new shoreline protection (with a design life of 50 years), measured to the back of the proposed protection at elevation 75.0 m, plus a 15 m erosion allowance (50 years @ 0.3 m/year) plus a 9 m stable slope allowance (from elevation 75.0 m to elevation 79.2 m @ 2.1:1). Figure 20 shows the location of the 32 m development setback limit in plan view with new shoreline protection with a minimum design life of 50 years. Figure 21 shows the cross-section of the 32 m shoreline hazard limit. The site plan should provide for a 6 m wide access to the shoreline from either of the municipal roads adjacent to the site and a 6 m wide access along the shore for future maintenance, repairs and upgrading of the protection.

Figure 20: Shoreline hazard development setback (32 m from shore side of existing concrete seawall) and allowance for new protection

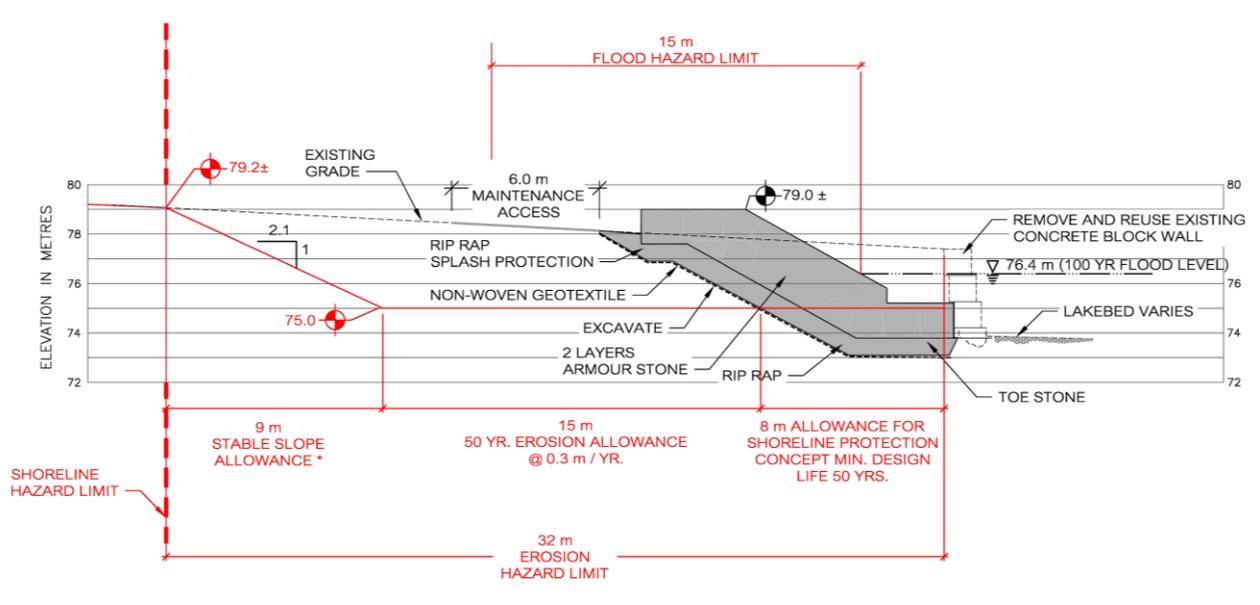
Figure 21: Shoreline hazard limit with shoreline protection concept, erosion allowance and stable slope allowance and incorporating 6 m wide maintenance access

The erosion hazard limit also includes a stable slope allowance of 9 m (Figure 21). The stable slope allowance was determined by extending up from elevation 75.0 m at a stable slope inclination of 2.1:1 (reference Landtek geotechnical investigation) to the existing elevation of 79.2 m in the backshore. A detailed stable slope analysis will be submitted by Landtek under separate cover.

The flooding hazard limit is contained within the shoreline hazard limit (Figure 21). The flooding hazard is defined by the 100-year flood level and a 15 m horizontal allowance for wave uprush and other water related hazards.

Additionally, the flooding hazard limit as established by the standard 15 m horizontal offset for wave uprush measured from the contour of the 100-year flood has been delineated and is contained within the erosion hazard limit (see Figure 21).

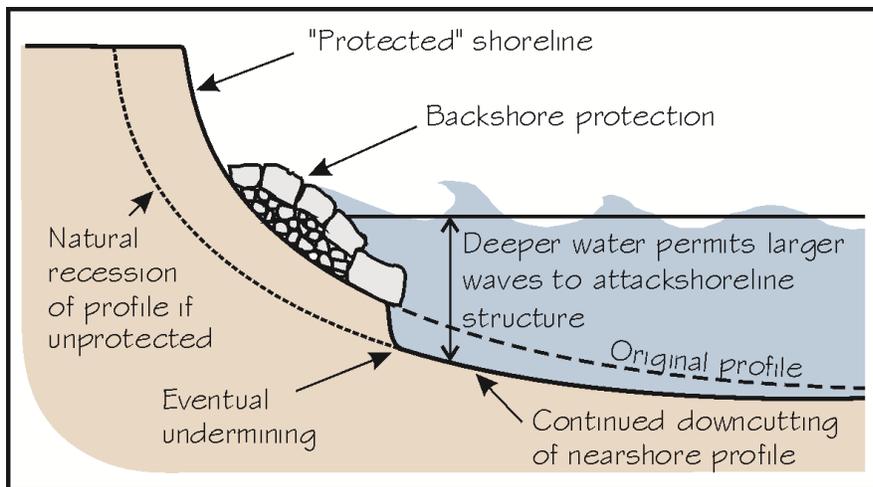
Figure 22: Limited design life of shoreline protection due to continued downcutting of nearshore

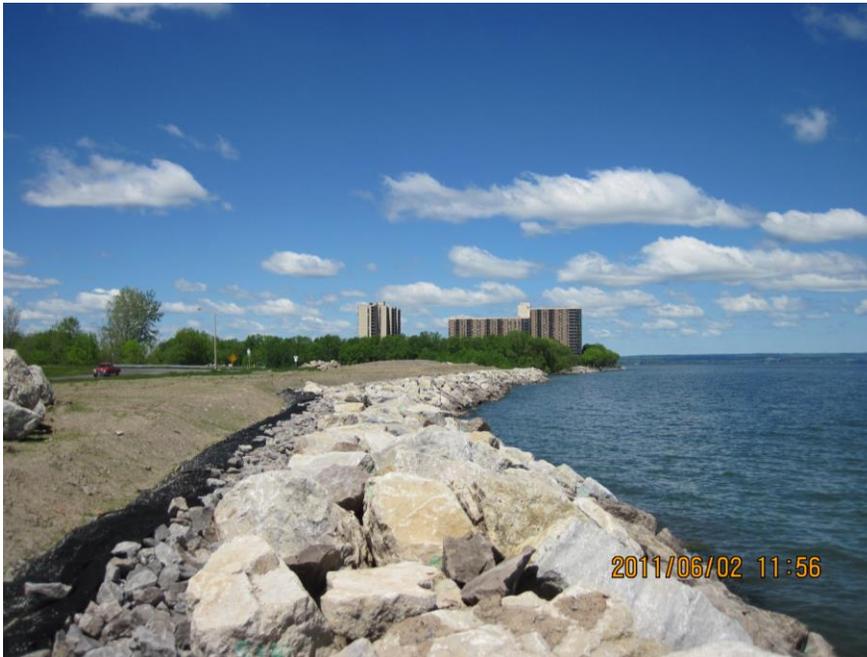
Figure 23: Example of double layer armour stone revetment (west of Millen Road)
