3054 Homestead Drive Erosion Threshold Assessment

Hamilton, Ontario

January 26, 2023
PN22063

Report Prepared by: GEO Morphix Ltd.
36 Main Street North
PO Box 205
Campbellville, ON L0P 1B0

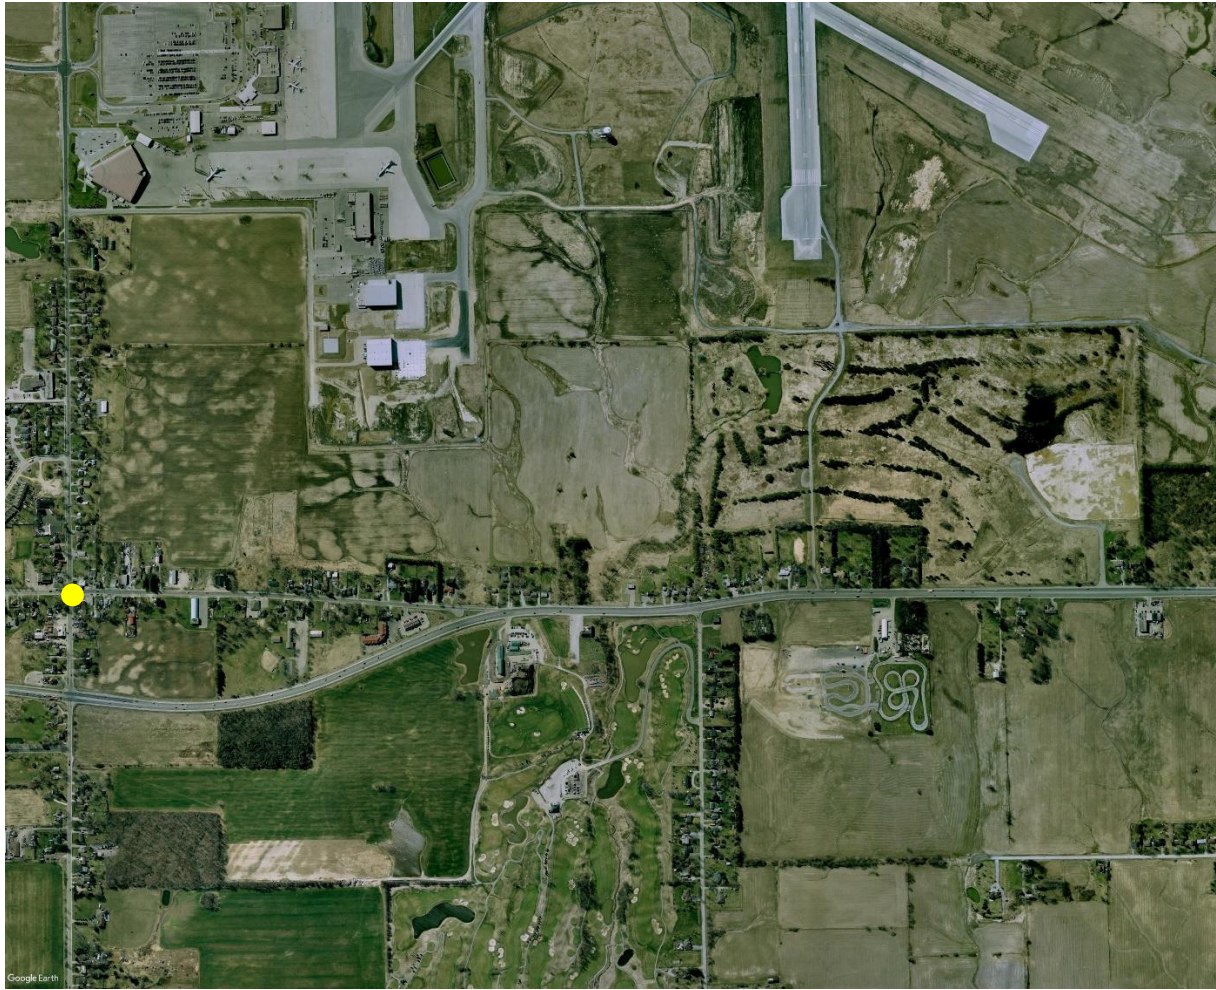
Location: Hamilton, ON
Year: 2005
Scale: N/A (orthoimagery)
Yellow Marker: Intersection of Airport Road and Homestead Drive

Between 2005 and 2009 a distinct riparian vegetation buffer (approximately 17 m wide) is evident along all headwater tributaries within, and near by the subject property. With the exception of the beginning stages of an Amazon facility being constructed, minor changes in landuse and headwater features are evident between 2009 and 2013. Between 2018 and 2021, the Amazon facility finished construction. No other changes are noted in landuse and headwater features between 2013 and 2021. No changes in landuse or headwater features draining to Three Mile Creek occur downstream of the subject property during the reviewed time period.

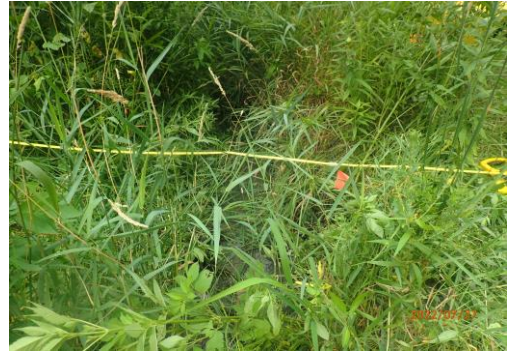
Representative Cross-Section #3

Photograph at cross section 3 (looking upstream)

Reach H1S3 is a short length of channel that flows northeast towards Willow Valley golf course and discharges into a tributary of Twenty Mile Creek. The channel has evidently been modified, straightened and armoured previously, likely as part of the adjacent sod farm activities. A meandering planform is re-developing within the channel corridor, and outer banks are typically eroded and exposed. Riparian vegetation was comprised of grasses, cattails, and occasional mature trees. Channel substrate ranges from silty clays within pools to medium-sized gravels within riffles. Bank materials consist of silty clays which increase in compaction moving down towards the toe of the bank slope. Flows during the day of assessment were imperceptible.
